**Reconnaissance-Level Investigation of Sediment  
Sources and Channel Morphology,  
and Recommendations for Management,  
Pine Creek, Shoshone County, Idaho**

**Bureau of Land Management  
1808 North 3rd Street  
Coeur d'Alene, Idaho 83814**

20 June 1996

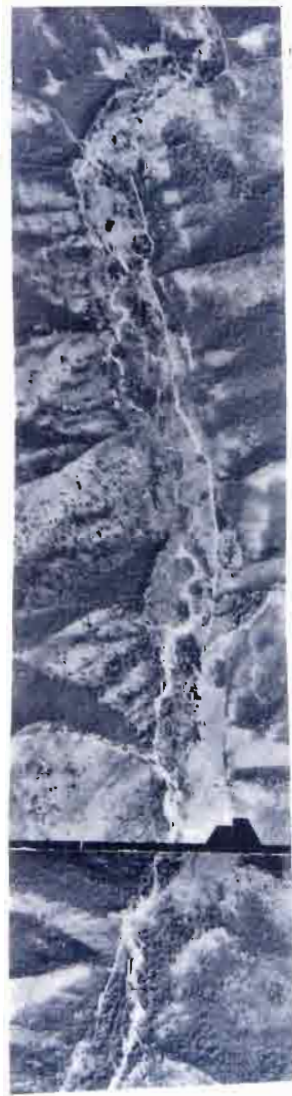
1956

Some channel widening, particularly downstream Langlois Creek confluence. Still lack of defined channel in most of the reach upstream of that point.

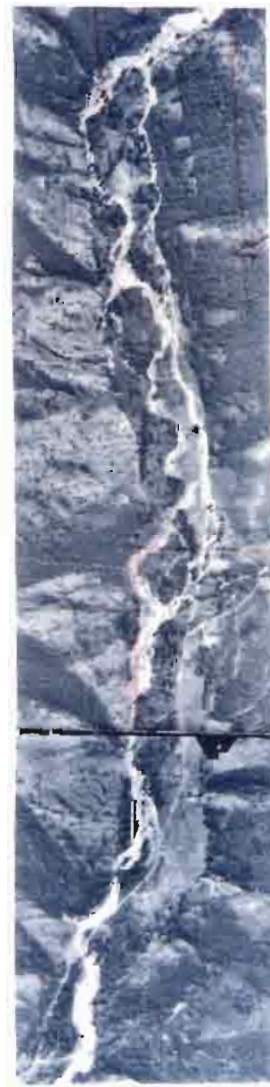
1968

Channelized reach downstream of County Road Bridge #2. Effects of 1964 flood evident in channel widening. Note flood channel cut following road along upstream of Langlois Creek confluence.

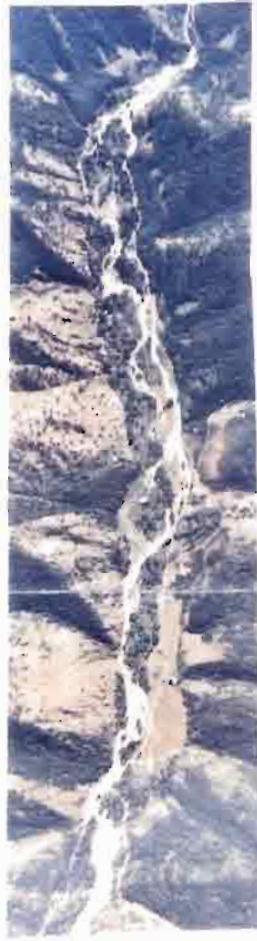
1975

Generally little change from 1968, despite passage of large 1974 flood. Most of flow appears to have been down left channel. Right channel meanders are revegetating opposite Langlois Creek confluence.

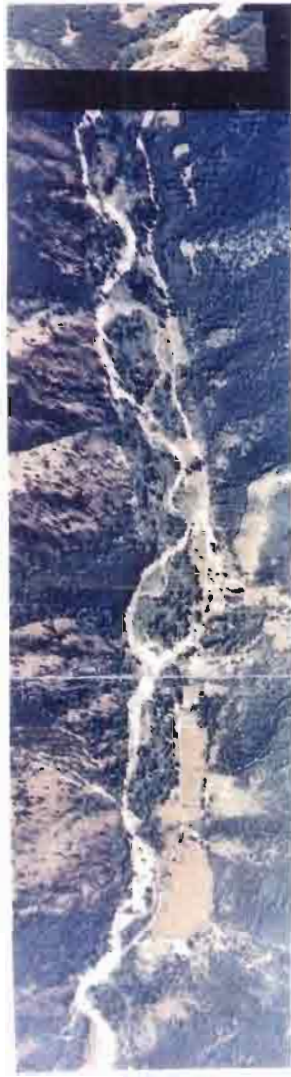
1984

Most flow appears to have returned to the right channel. Channel continues to widen in many places. New channel cut through riparian along right side of valley bottom upstream of Langlois Creek.

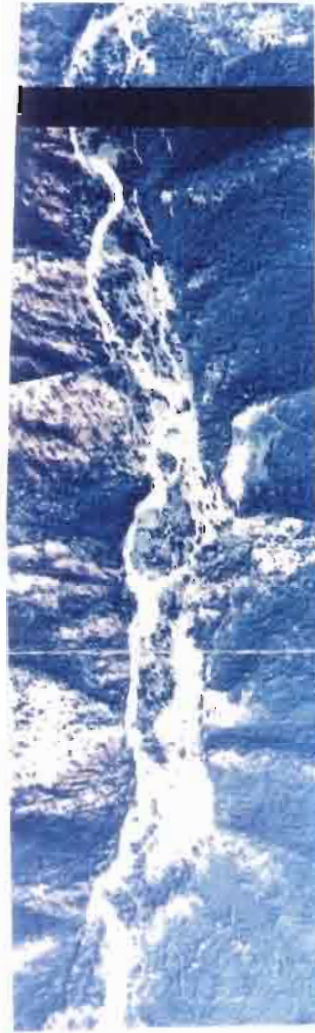
1991

Left channel now appears abandoned. Main channel continues to widen throughout reach.

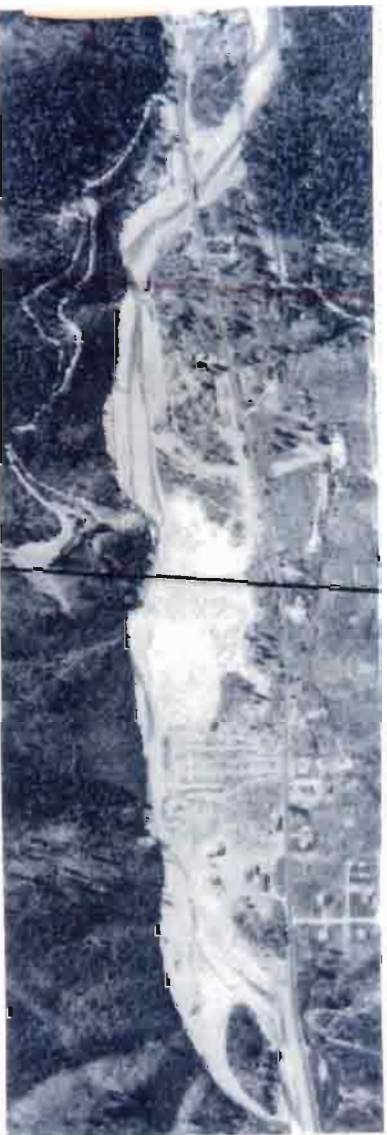
1968

Note much narrower channel upstream of Liberal King mine, compared to present conditions. Car junkyard occupies most of floodplain, including much of active channel. Channel at downstream island is directly against road riprap.

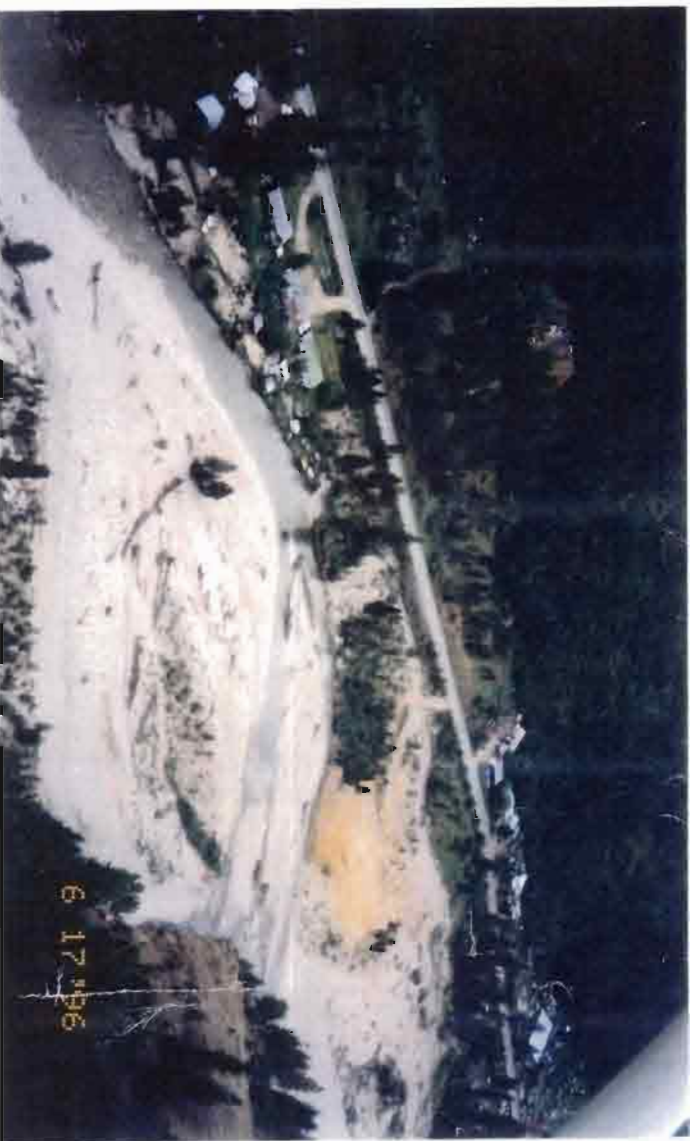
Several residences are threatened with erosion in this reach, which appears to be caused by the deposition of mid-channel bars and channel braiding from sediment generated upstream that is beyond the capacity of the channel in this reach to transport. In addition, mine tailings are threatened by lateral migration of the channel. Erosion of the tailings would have downstream water quality impacts.

Channel has widened substantially upstream mine. Deposition of mid-channel bar is deflecting flows towards residence on left bank. Vegetation is beginning to establish on center of bar. Tailings protected by temporary riprap to prevent erosion at low to moderate flows. Downstream translation of meander will likely outflank tailings and riprap.

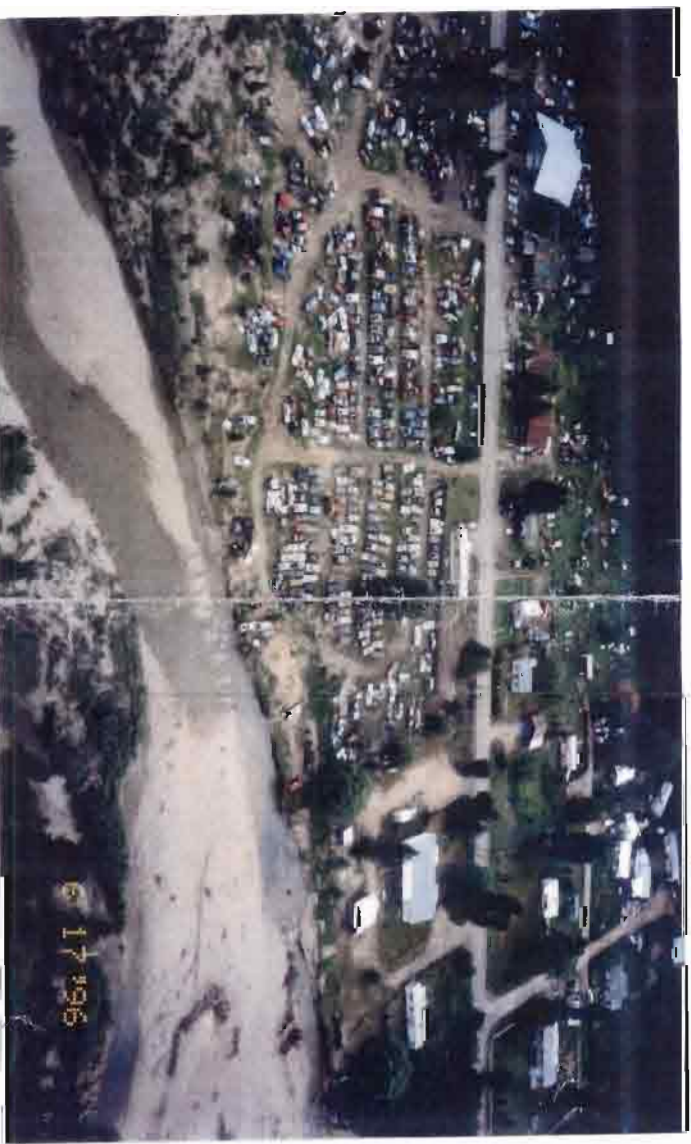
established island (Figure 4). Flood waters eroded a portion of the left bank at the junkyard and again entrained various vehicles (Figure 4), depositing them in the channel or on mid-channel bars just downstream.

Erosion continues at junkyard. Entrained vehicles are visible on mid-channel bar downstream.

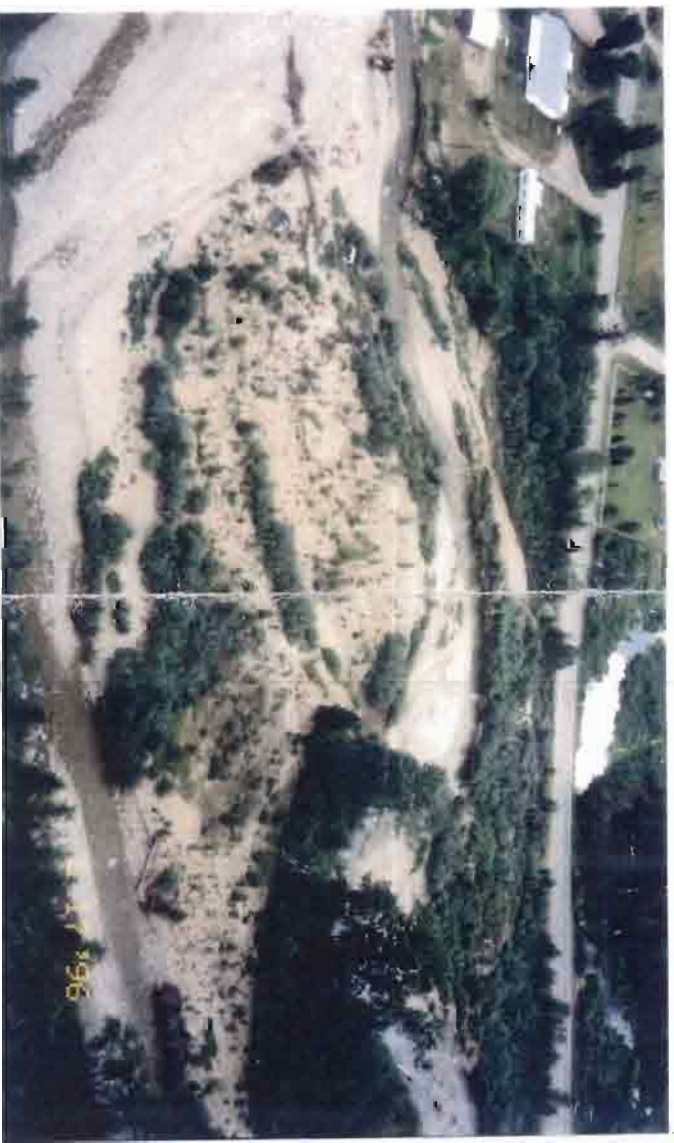
Vegetation becoming established on mid-channel bar, upstream of older island. Vegetation on 1968 channel adjacent to highway is being eroded as meanders translate downstream.

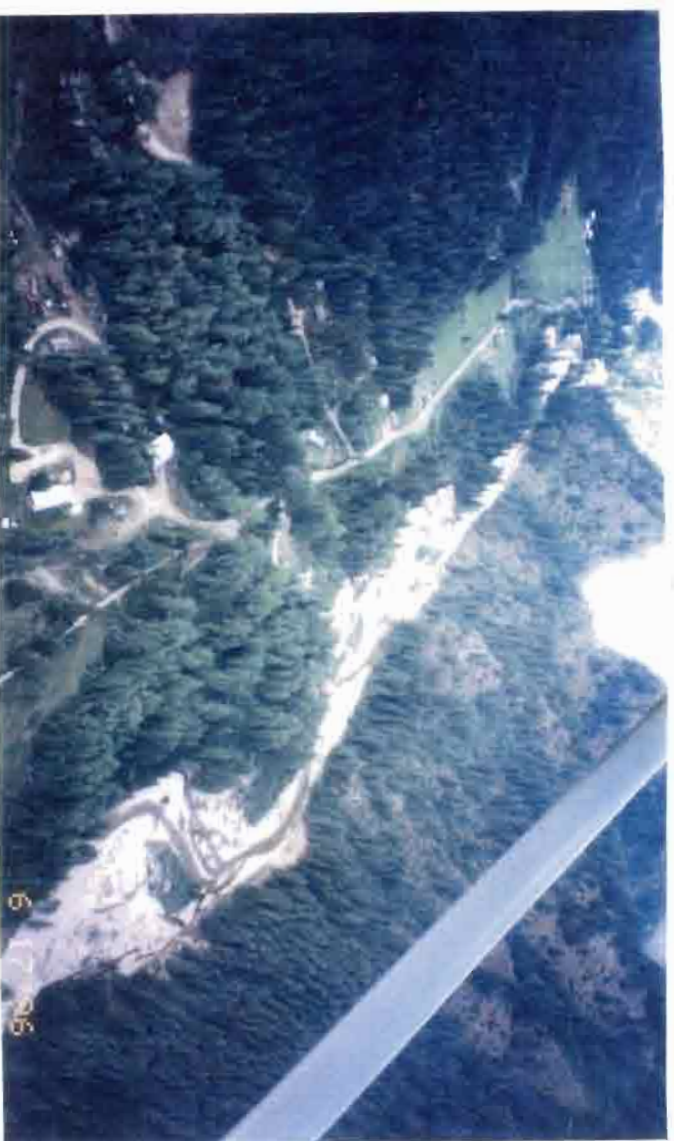
View downstream of the confluence of Langlois Creek and vicinity. Wide, shifting unstable channel occurs throughout this reach. One site of hillside erosion is visible where channel impinges on right side of valley.

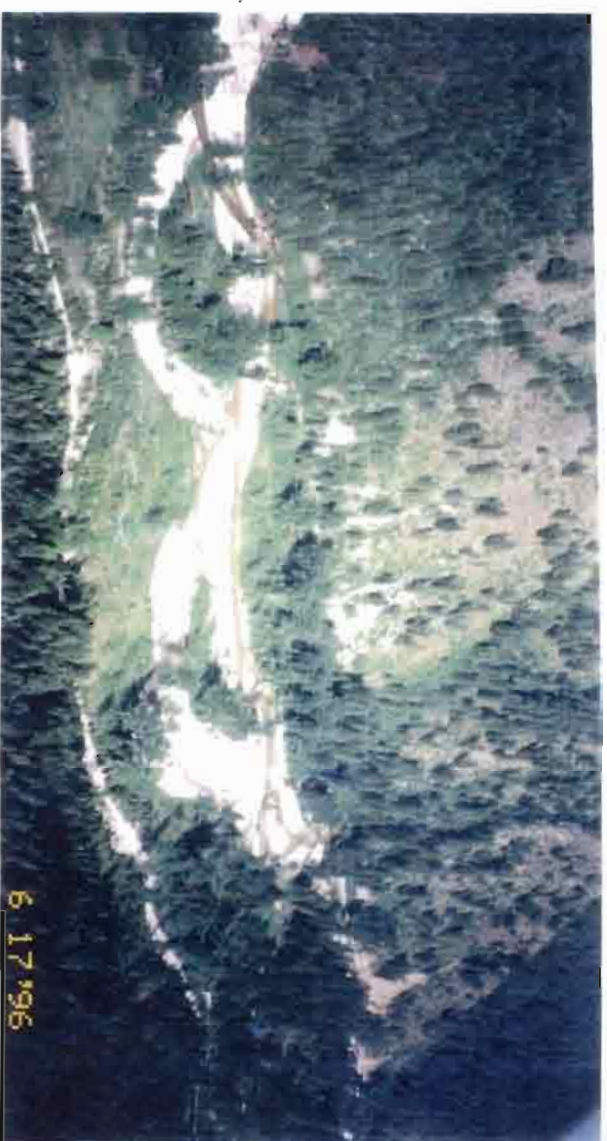
View of channel just upstream of Langlois Creek confluence. New channels were cut through riparian vegetation during floods of 1996.

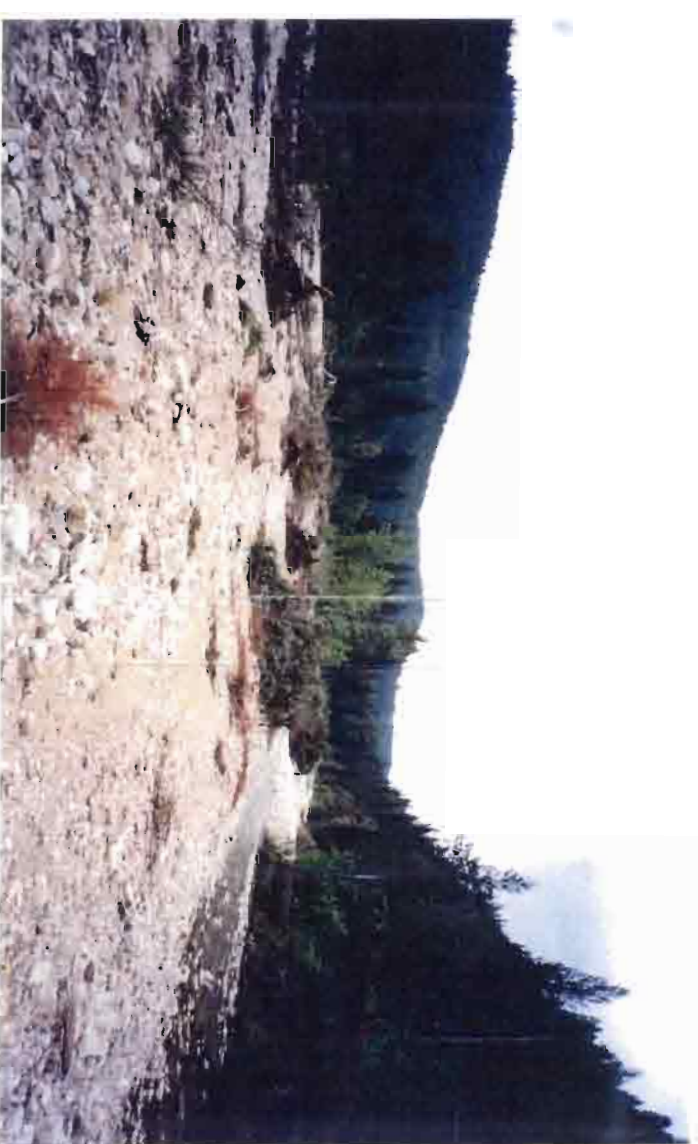
View downstream from confluence of Langlois Creek. Woody debris has been deposited on large gravel bars, assisting in creating blockages and diverting flow towards the streambanks.

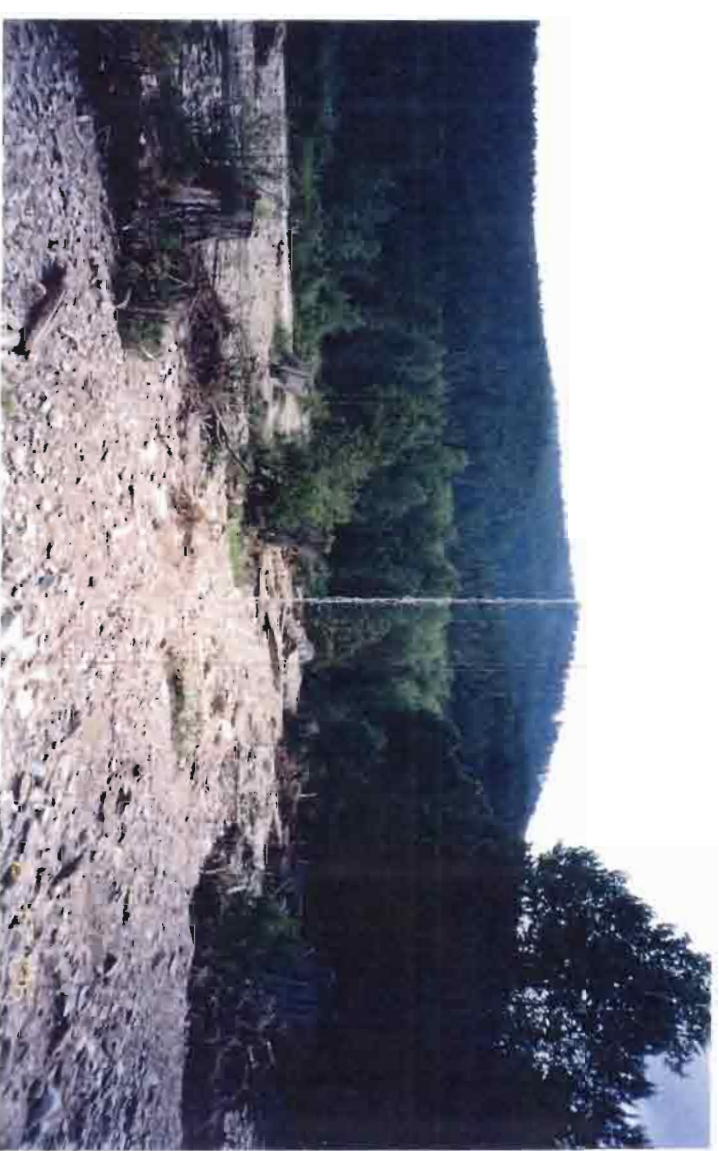
Typical view upstream of confluence of Langlois Creek. Large cedar stumps are being slowly eroded and floodplain material remobilized.

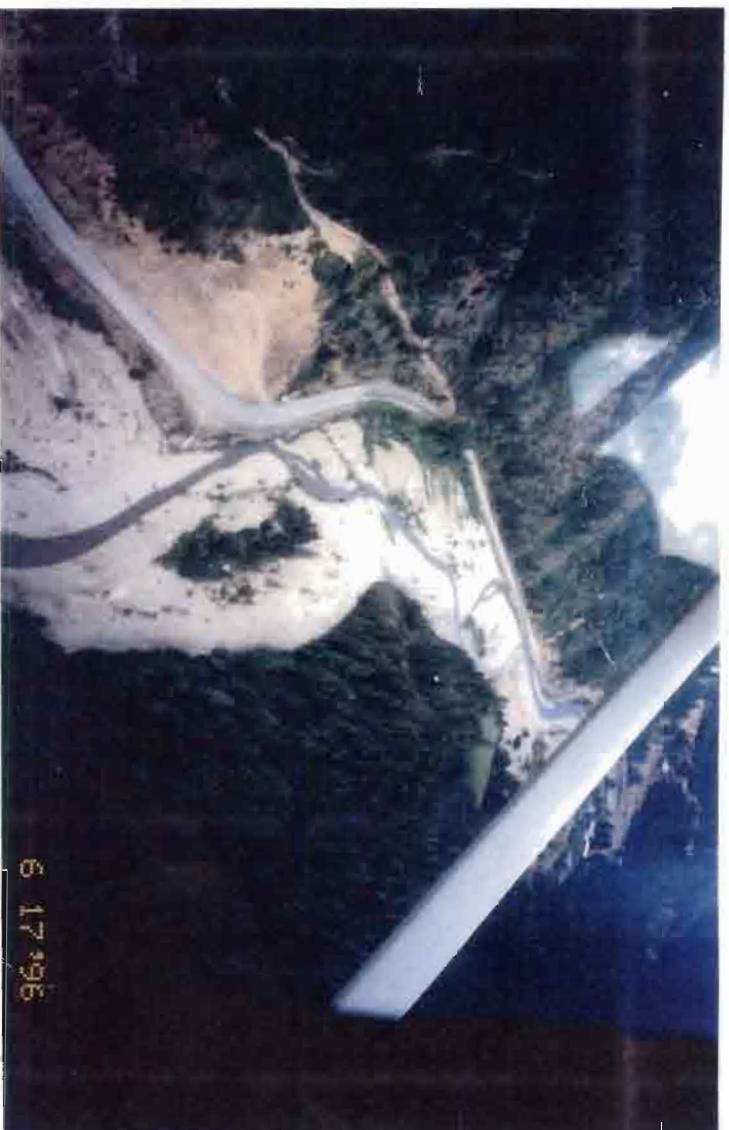
View upstream along the East Fork to the confluence of Nabob Creek. Channel shifted across active floodplain during the three storm events in Water year 1996. Remnants of riparian vegetation visible on islands and along margins of channel.

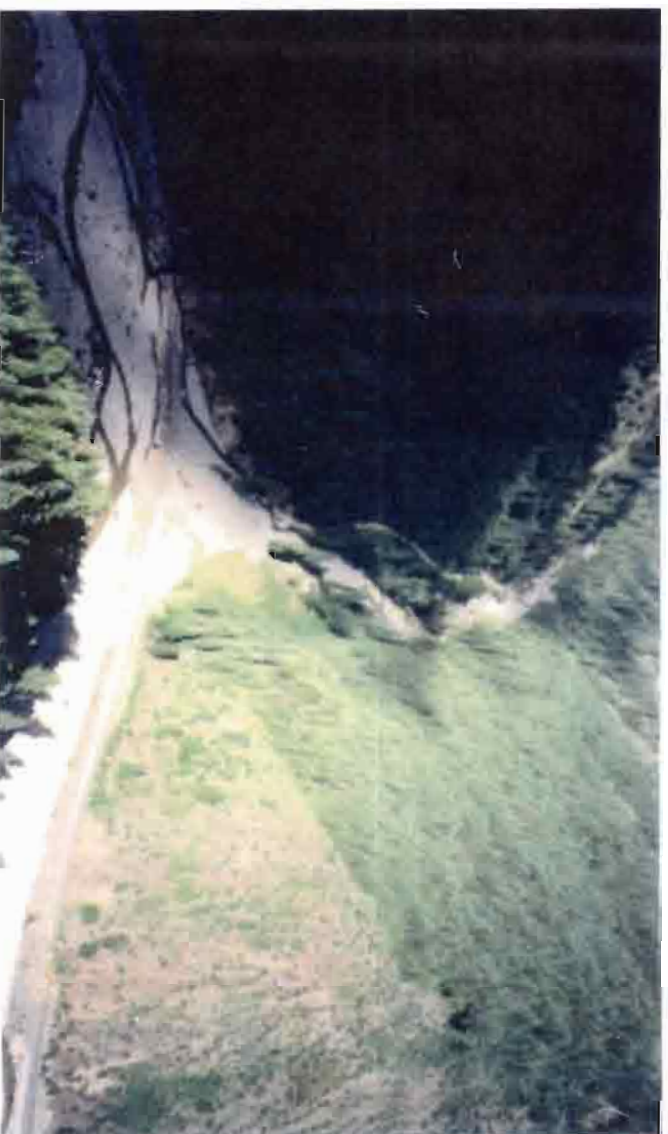
View of Highland Creek confluence. County Road acted as debris dam after undersized culvert clogged. Creek finally washed out road. Note large amount of stored sediment in creek channel upstream.

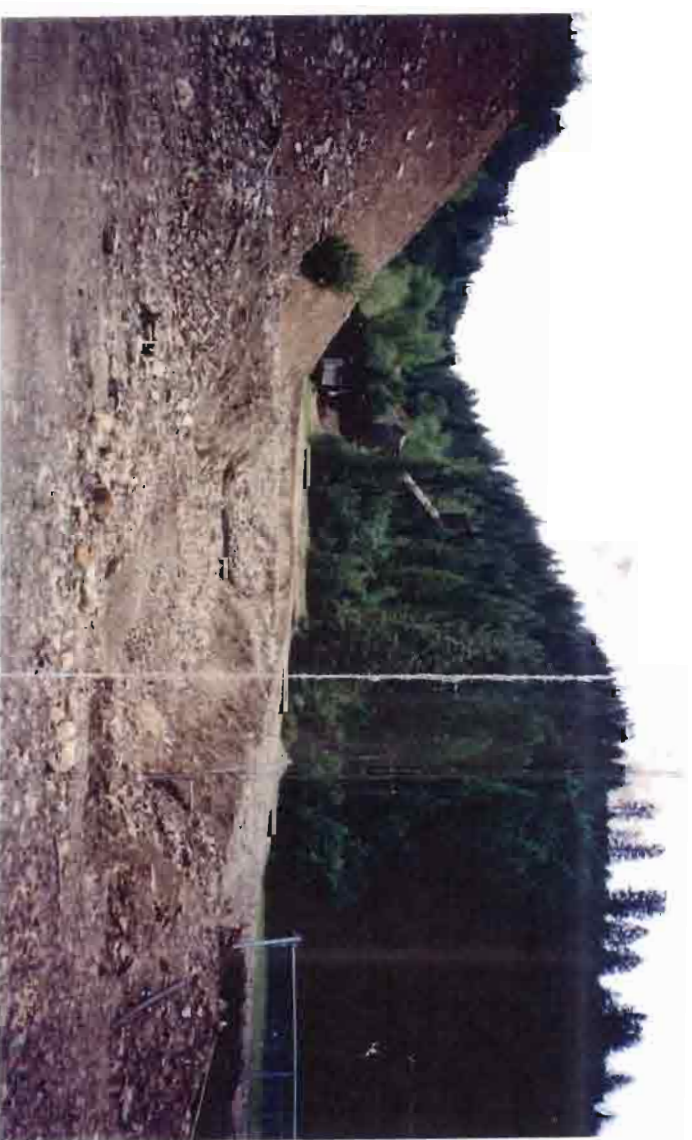
View of sediment fan at confluence of Nabob Creek. Culvert was clogged by large influx of sediment, and overtopped road.

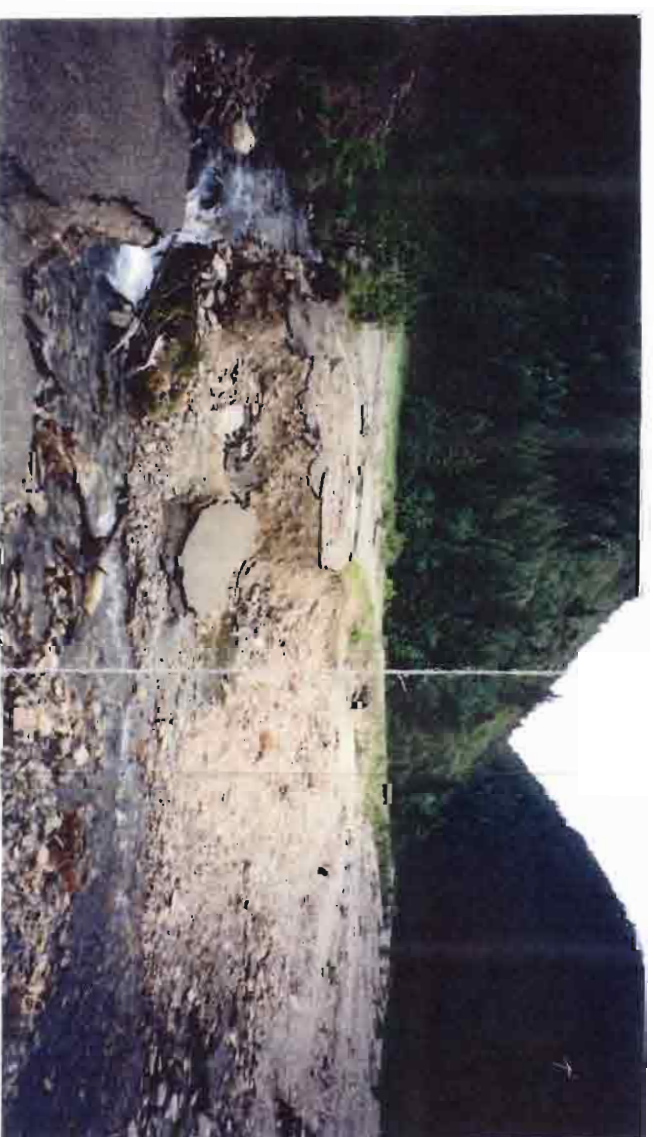
View upstream of confluence of Highland Creek and washed out County Road. Large tributary sediment input is probably the major factor in the instability of the East Fork channel.

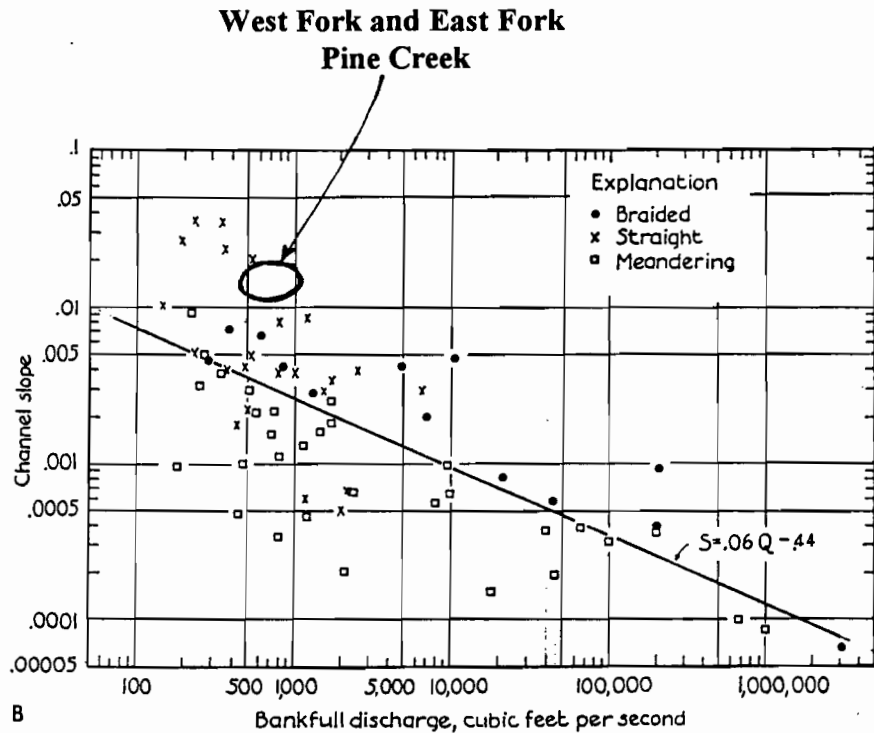
**FIGURE 7**  
**Comparison of Pine Creek with Braided/Meandering Planform Relationship**  
**to Bankfull Discharge after Leopold et al. (1964)**

The potential instability of these channels is indicated by its position on the braided/meandering field of Leopold et al. (1964), on which braided and meandering channels are plotted against channel slope and bankfull discharge (Figure 7). For the East and West Forks, the gradients are 1.5 percent and 1.7 percent respectively. The bankfull discharge is unknown, and references with which the 2-yr flood (a potential surrogate discharge) could be estimated using regional relations are unavailable to us, except for the relations for the Salmon River drainage developed by Emmett (1975) and reflecting annual average precipitation of only about 20 inches. Nonetheless, if we assume that the bankfull (or 2-yr discharge) lies between 500 to 1,000 cubic feet per second (cfs), it is clear that both forks of Pine Creek plot well within the braided and straight channel range.

The gradient of West Fork Pine Creek in its alluvial reach is .015, while the gradient of the East Fork Pine Creek is .017. Although the bankfull discharge is not known, the U.S. Army Corps of Engineers, as reported by HUD (1979), computed the 10-year storm flow for the West Fork as 2255 cfs. Bankfull discharge is commonly found to have a recurrence interval of from 1.5 to 5 years. Based on the COE calculations, bankfull discharge would likely be in the range of 500-1000 cfs. This area is shown on the channel slope versus bankfull discharge from Leopold et al. (1964) above. The West and East Forks plot well into the braided field, indicating that in the absence of bank stabilizing factors such as a dense riparian forest, these channels would likely have a braided pattern.
