Abbreviated Preliminary Assessment for Baldy Mountain Road Landfill Site

Bonner County

**State of Idaho
Department of Environmental Quality**

December 2012

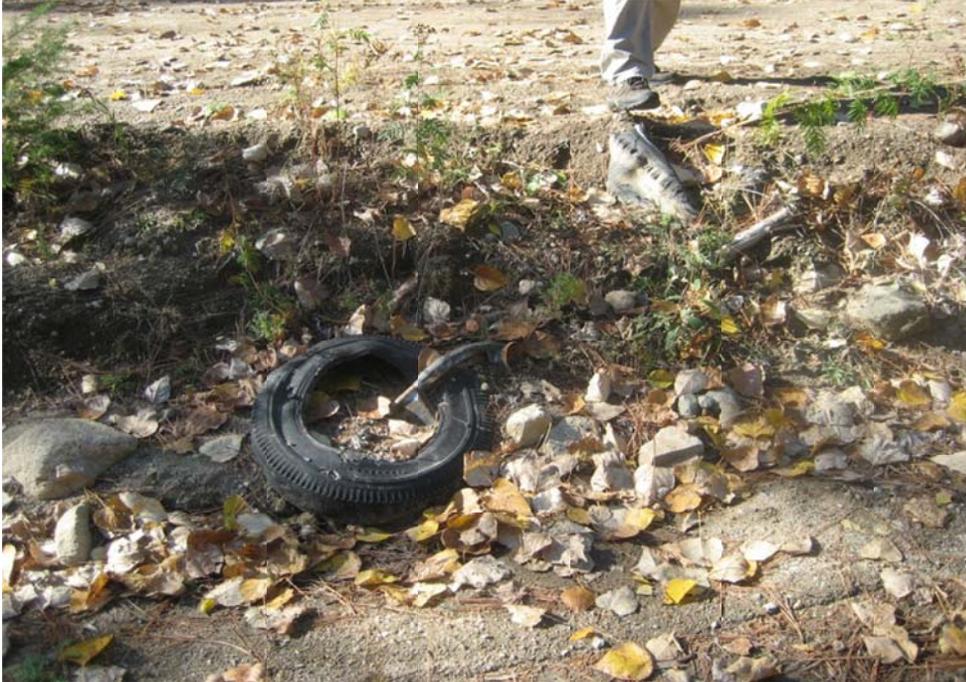
Photo 1 shows tires exposed by excavation at the edge of the Baldy Mountain Road Landfill.

Photo 1. Tires exposed by excavation on Baldy Mountain Road Landfill site.

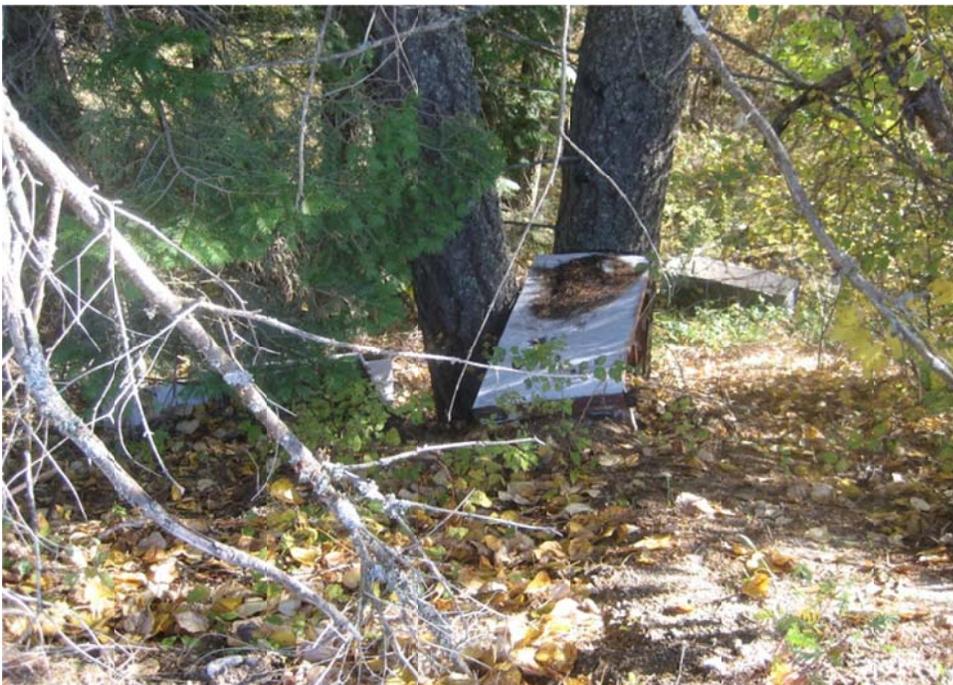
Photo 2 shows the general surface of the landfill and some of the appliances that are exposed in a few locations.

Photo 2. Waste appliances found across landfill surface.

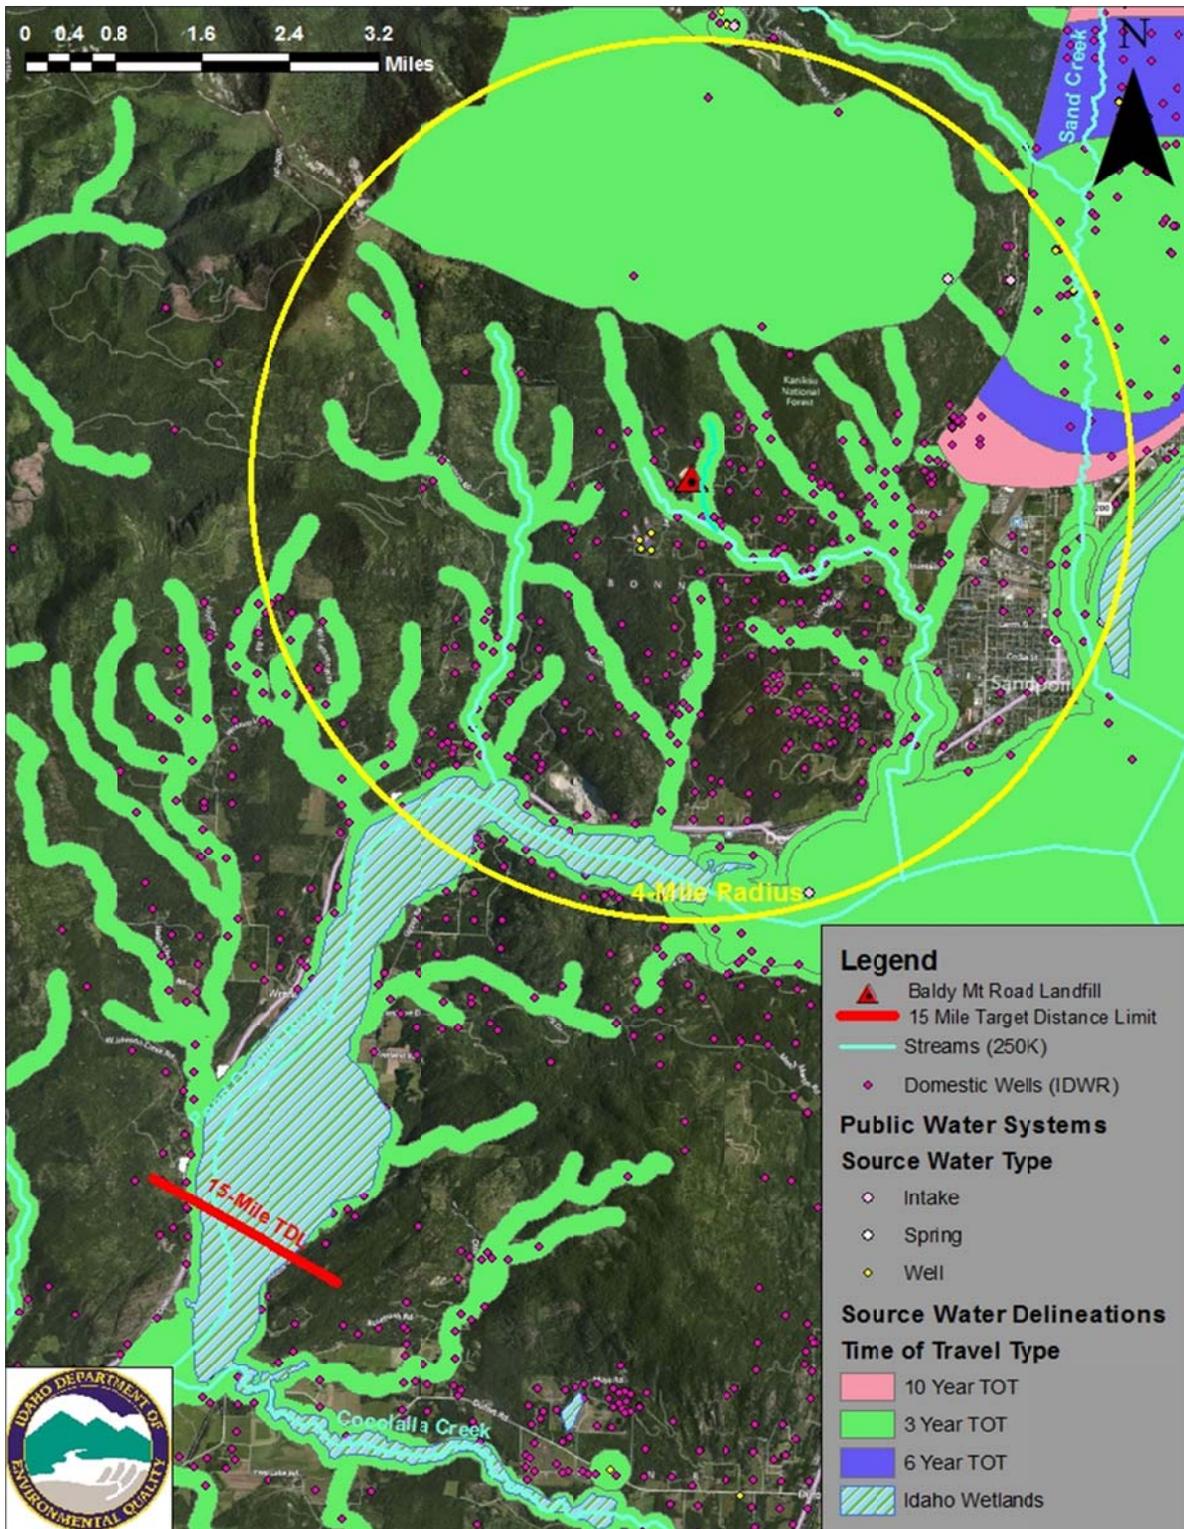
Figure 5. Domestic well and public water system locations.

There are several domestic wells or public water systems within the 4-mile radius, 15-mile TDL. There are two significant wetlands within a 4-mile radius and in the general area; the largest wetland is approximately 1640.672 hectares.

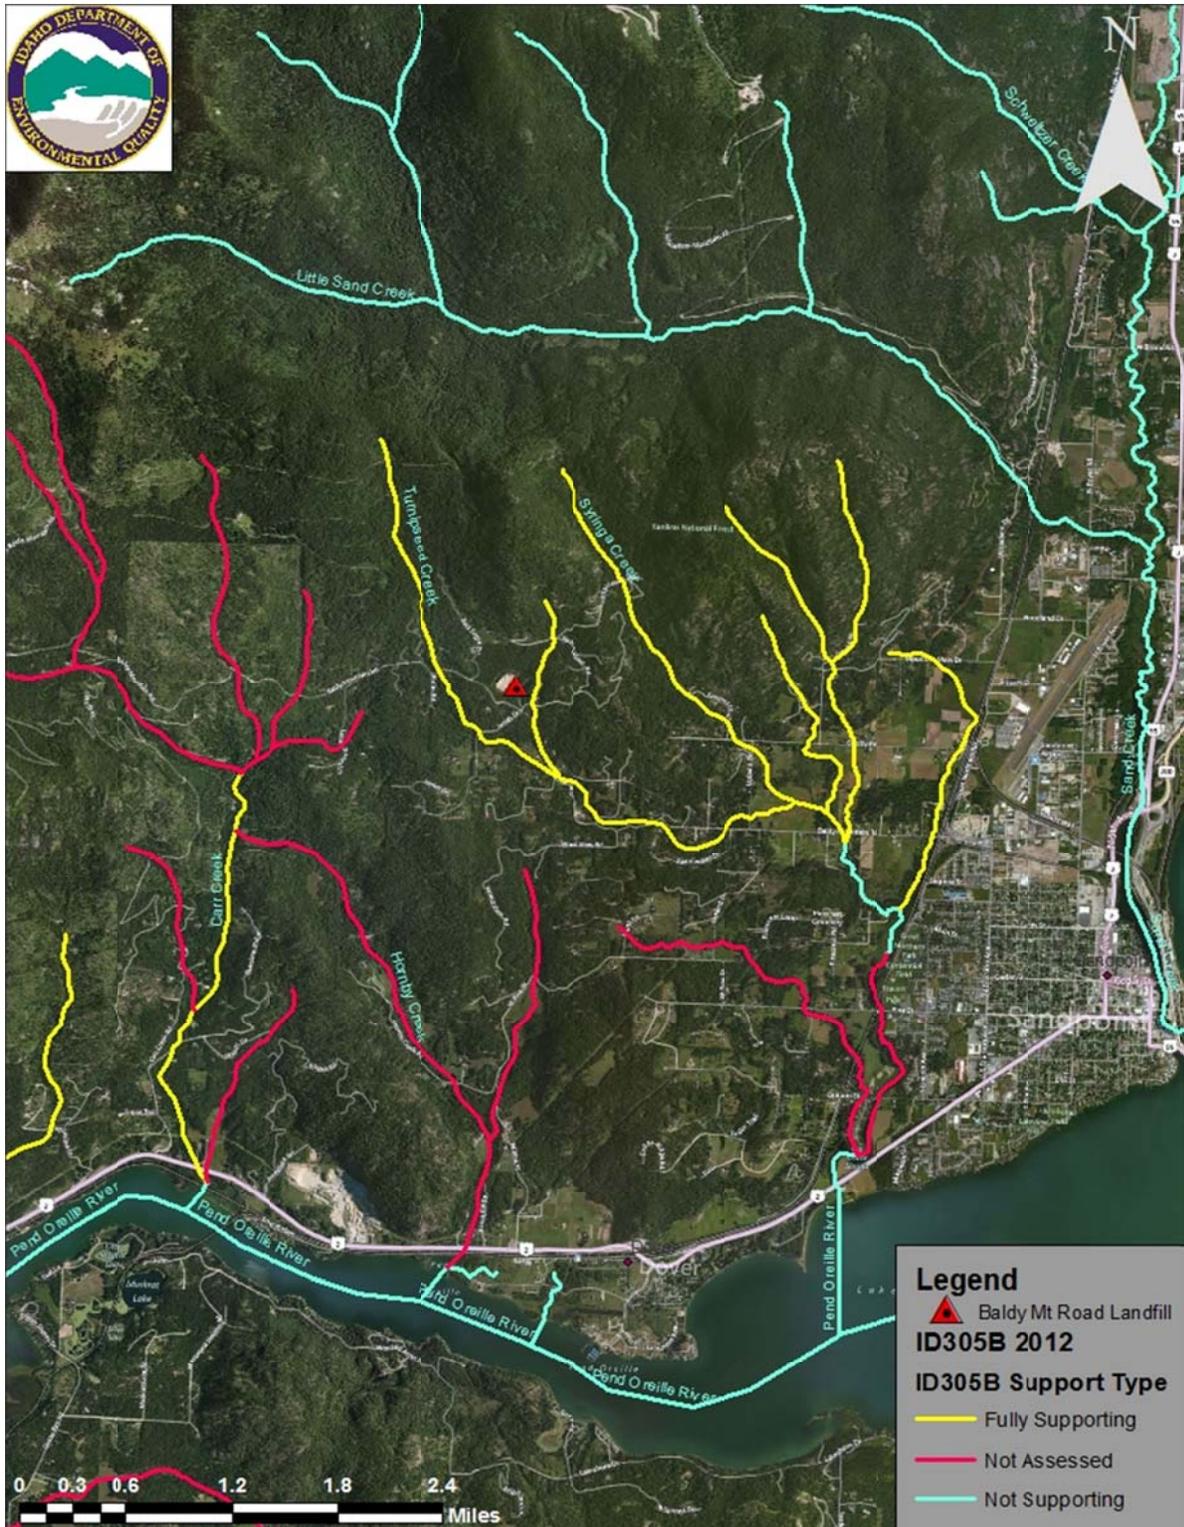
Figure 6. Sensitive streams located in the vicinity of the Baldy Mountain Road Landfill.

Turnipseed Creek is shown as “Fully Supporting” until it reaches Syringa Creek.
