Beaver Creek Watershed Assessment Shoshone County, Idaho

March 2013

Idaho Panhandle National Forests Resource Advisory Committee
North Fork Coeur d'Alene River Watershed Advisory Group

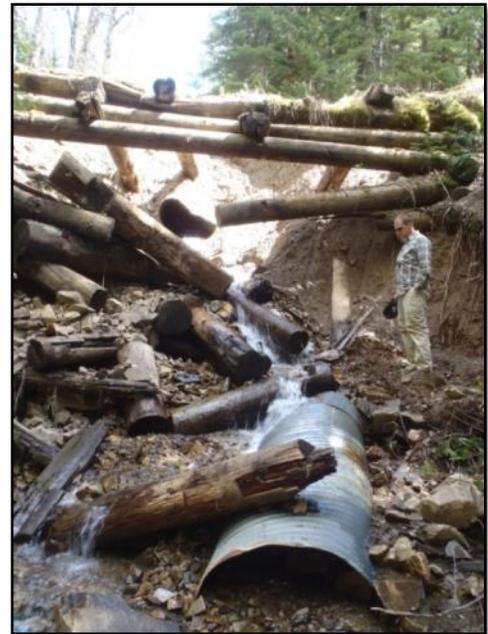
Figure 5. Culvert failures are a major threat to water quality in the watershed

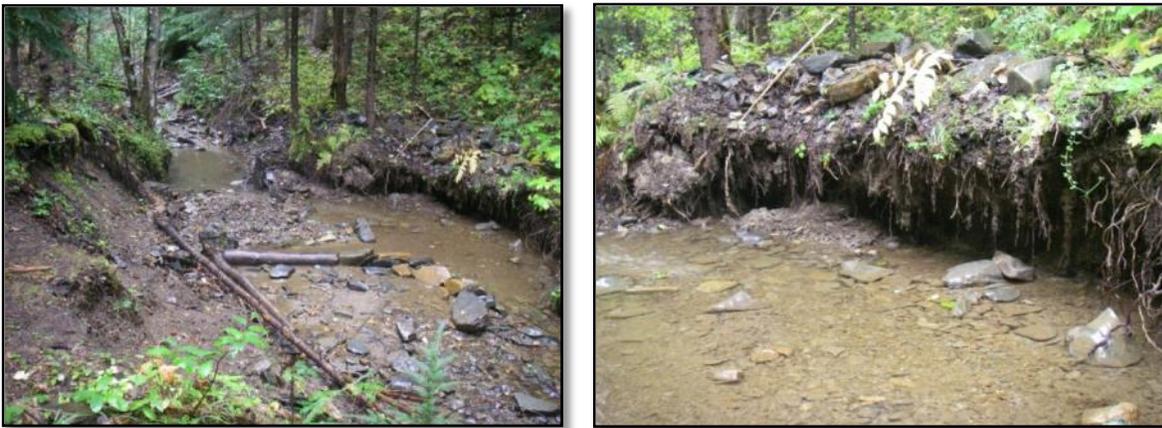
Figure 12. Bank excavation and channel alteration associated with improper small dredge mining operation in Potosi Gulch during 2010

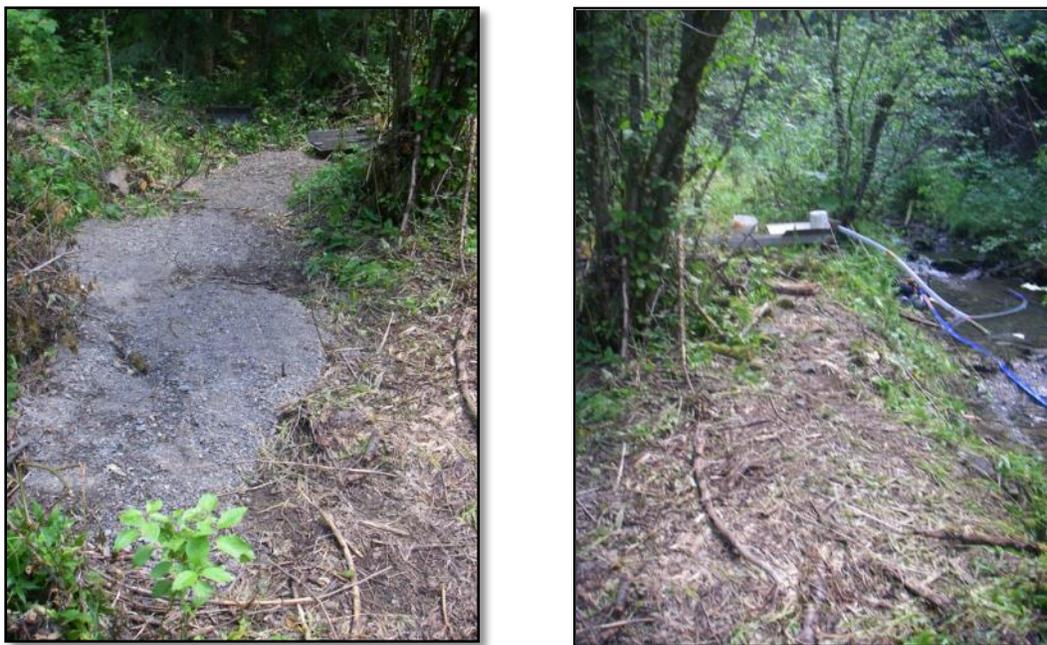
Figure 13. Removal of streambank vegetation, channel alteration and discharge of gravels upland associated with an improper small suction dredge mining operation in Pony Gulch during 2010

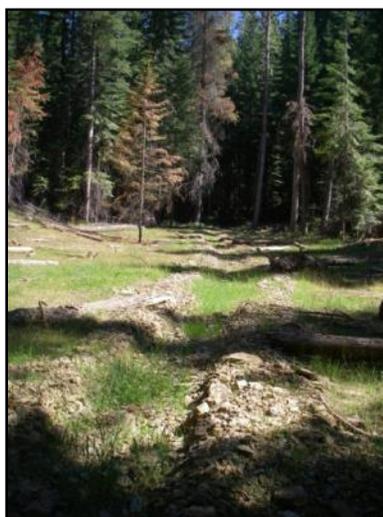
Figure 16. One of the difficulties in reclaiming placer dredge mining operations includes subterranean stream channels due to channel alteration and changes in alluvial soils composition

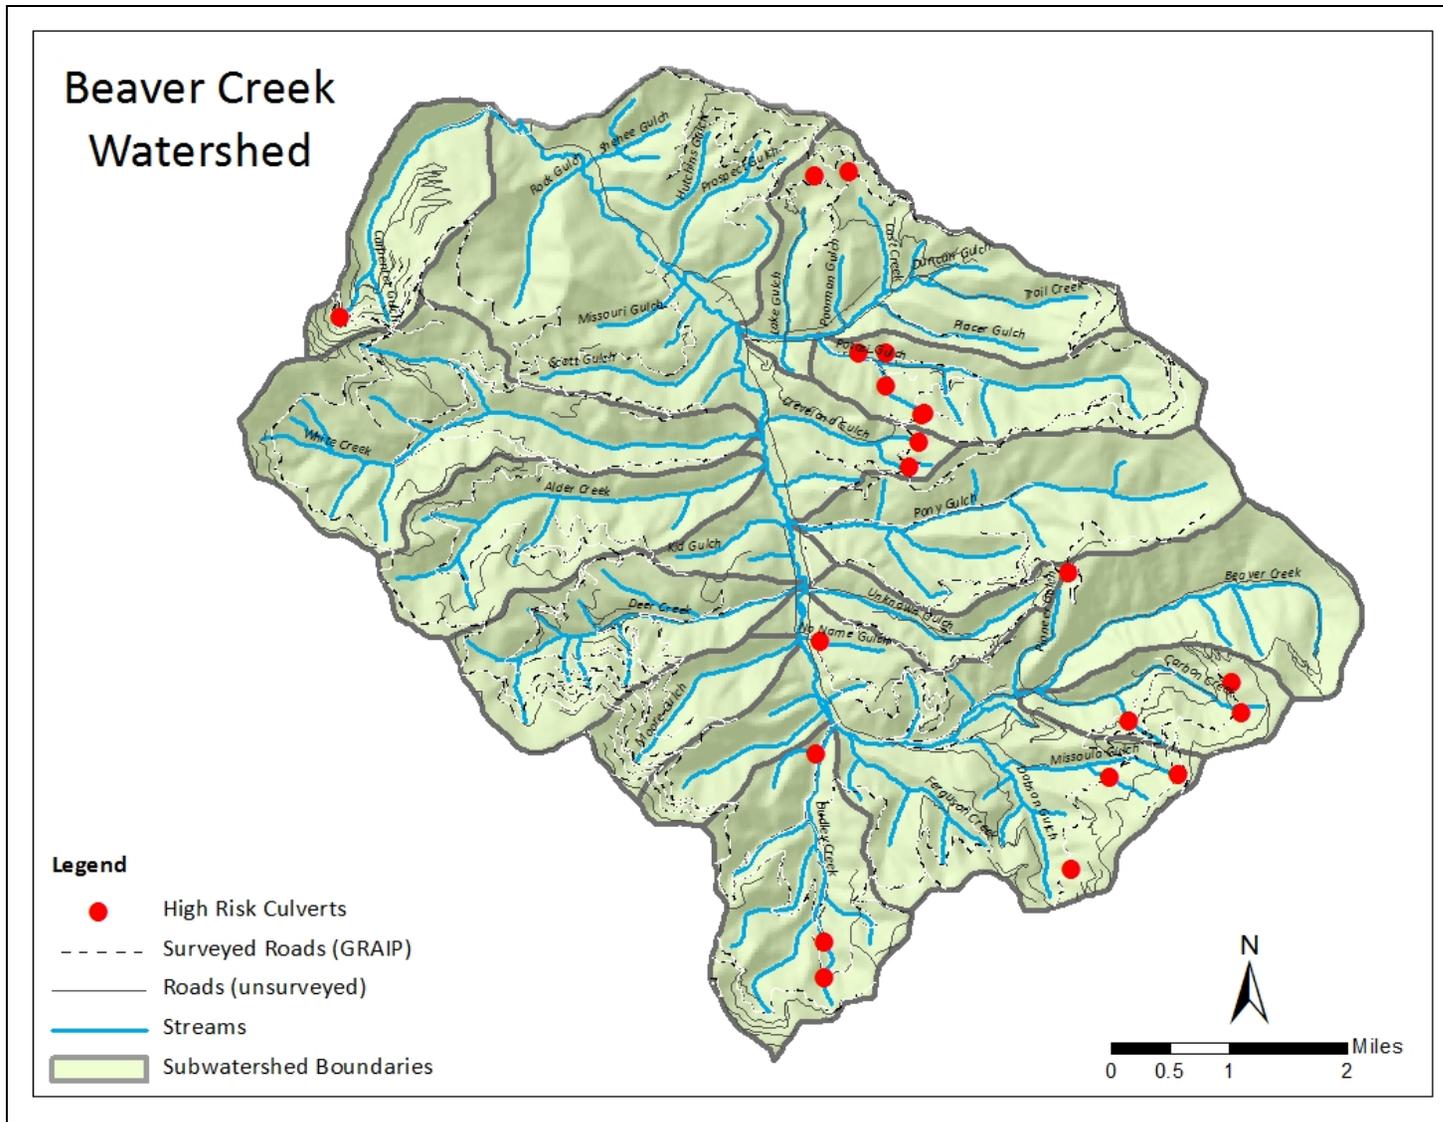
Figure 27. High risk culverts in the Beaver Creek Watershed that are at risk of failing

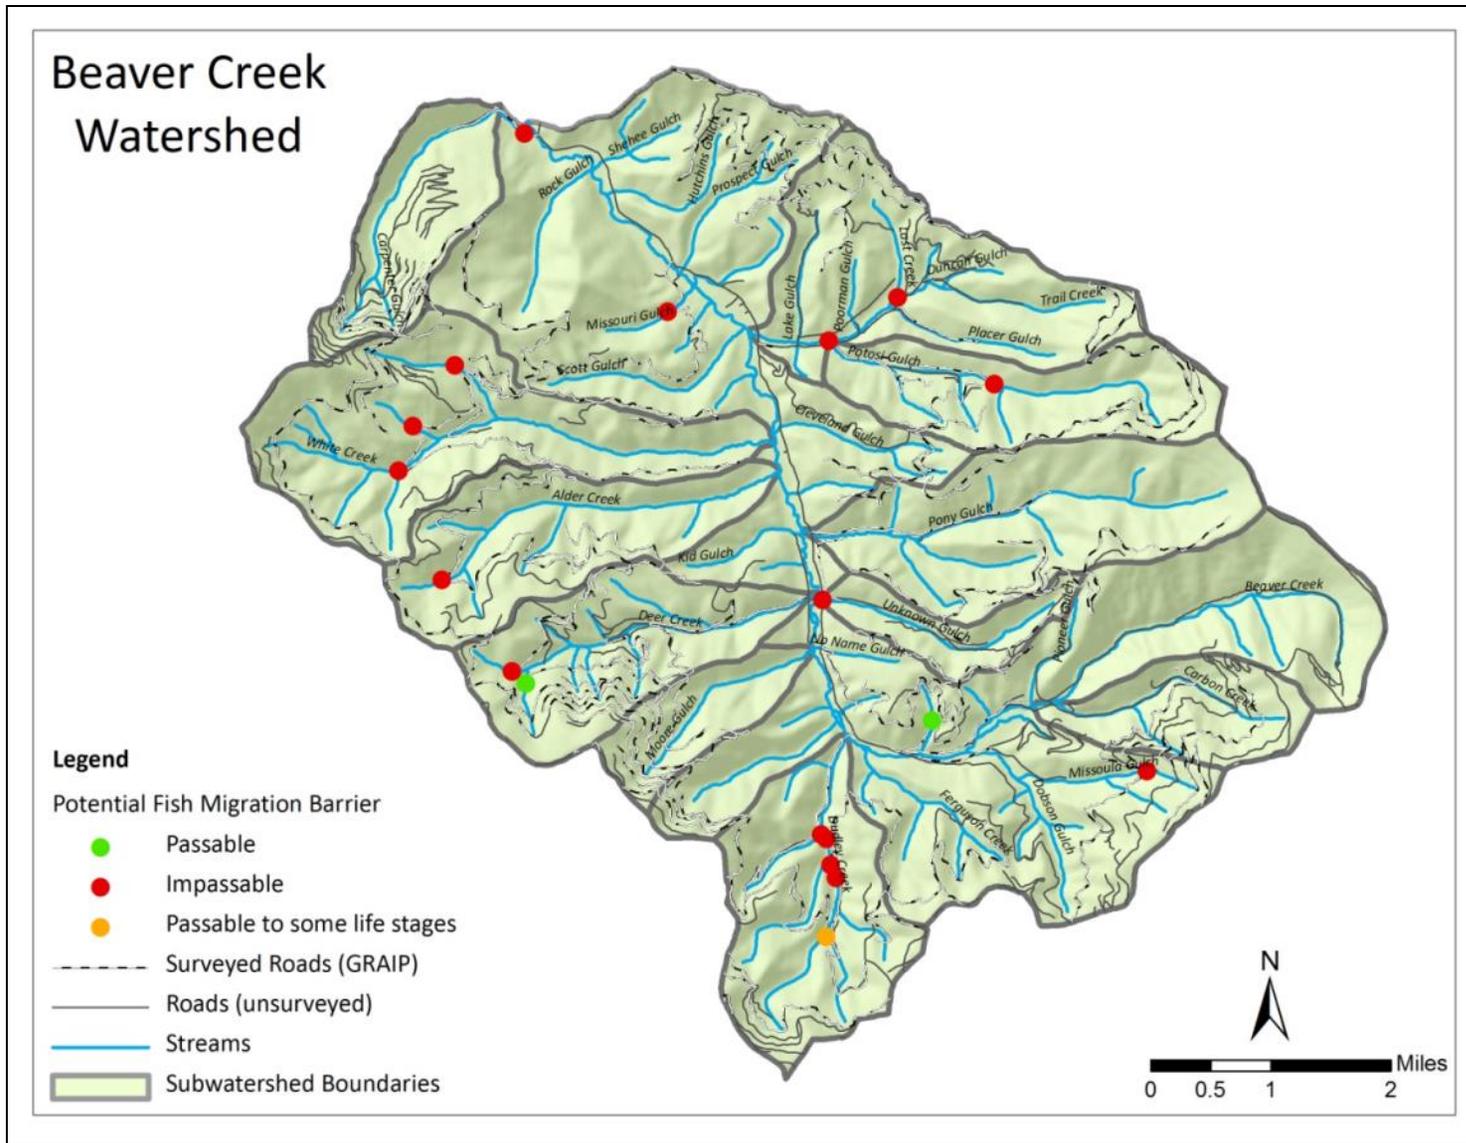
Figure 28. Surveied culverts that are potential migration barriers to fish in the Beaver Creek Watershed

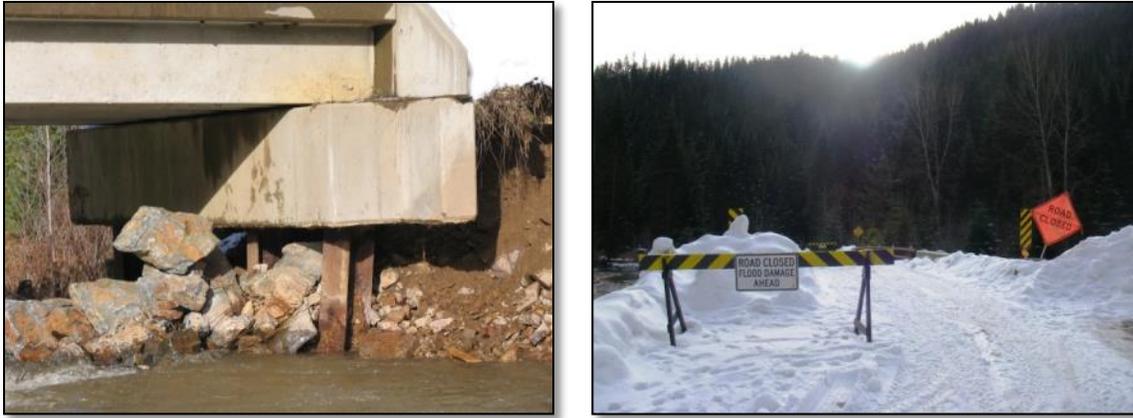
Figure C.1. Before—A combination of factors led to flood damage of the bridge and road closure during 2011.

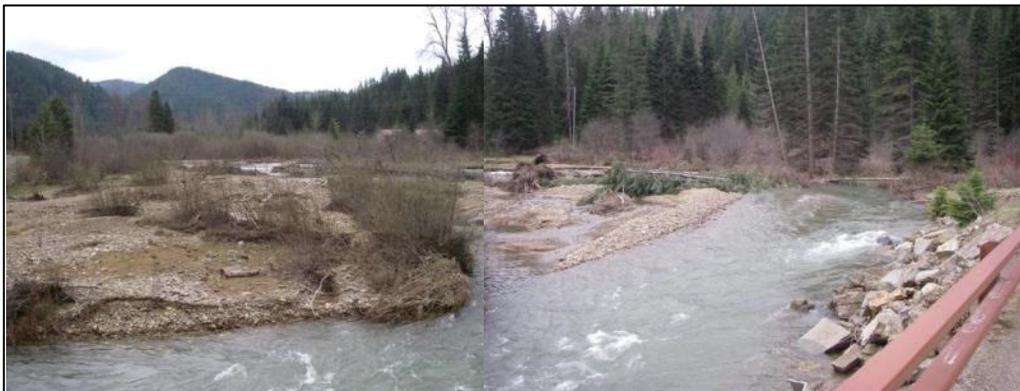
Figure C.2. Before—Aggradation of sediment in the Beaver Creek stream channel just upstream of the bridge (FR 933) contributed to channel migration and a 90 angle of entry at the bridge, May 10, 2011.

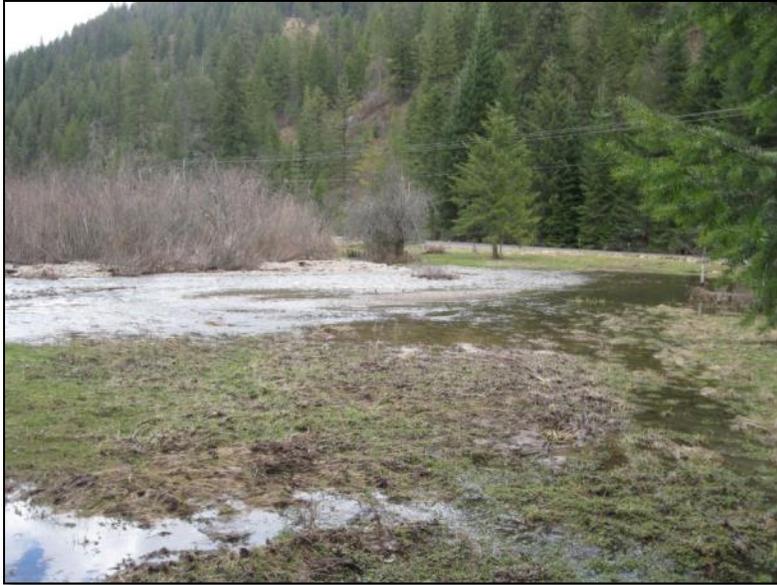
Figure C.4. Before—Aggradation and channel instability across a flat valley posed flood risks to this part of the Beaver Creek Road, April 2011.

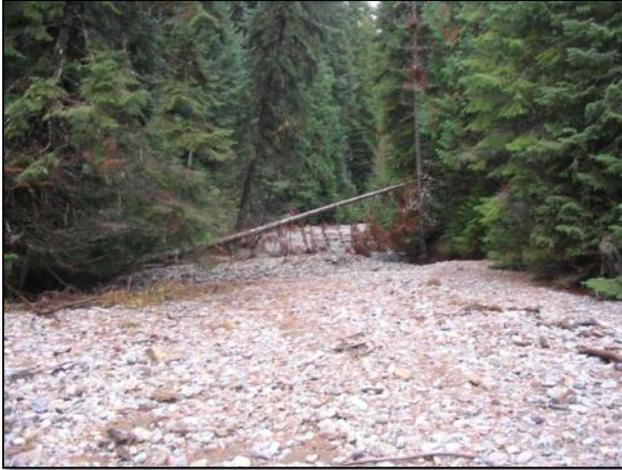
Figure C.5. Before—Beaver Creek aggraded channel (Oct 2007).

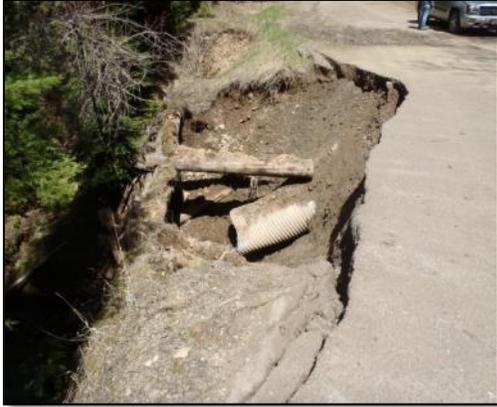
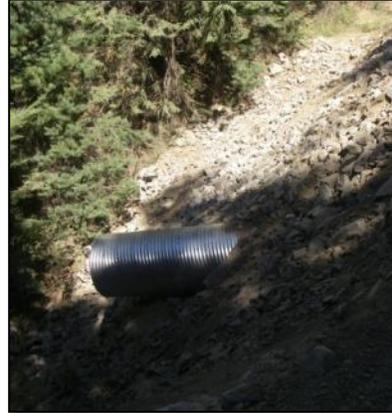
Figure C. 7. (Left) Before—Failure of Placer Creek culvert at Kings Pass Road, (Right) Placer Creek culvert following replacement

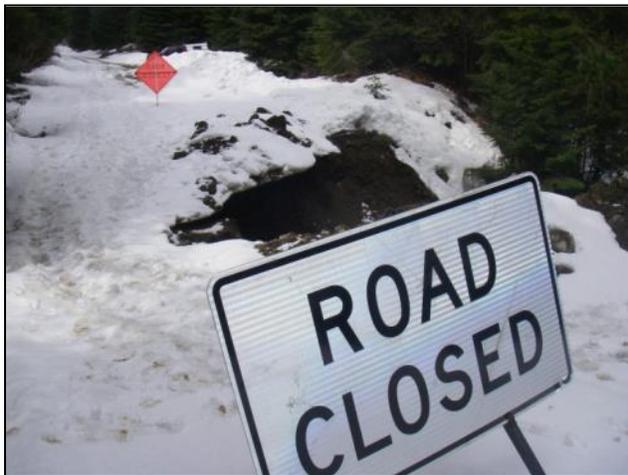
Figure C. 8. Before—Potosi Gulch culvert failure site before maintenance opened up a lane for traffic.

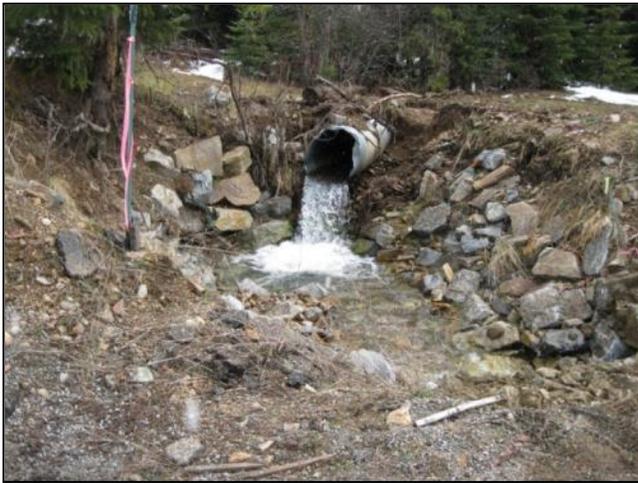
Figure C. 9. Before—Unknown Gulch failing culvert (April 2011).
