Hem Creek 2009 Field Investigations

**State of Idaho
Department of Environmental Quality**

June 2012

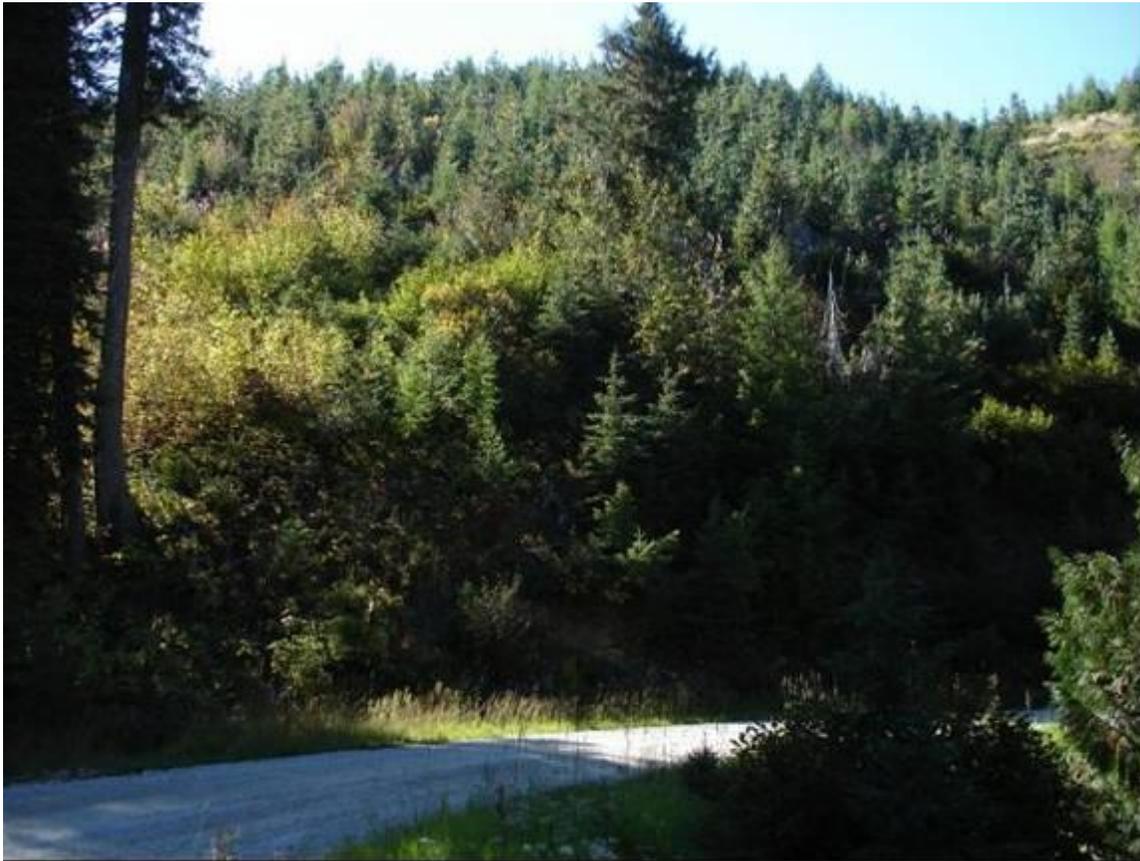
Photo A-1. Cut 1 as viewed from Forest Service Road 5216 (foreground). Hem Creek crossing is just out of view at bottom of picture.

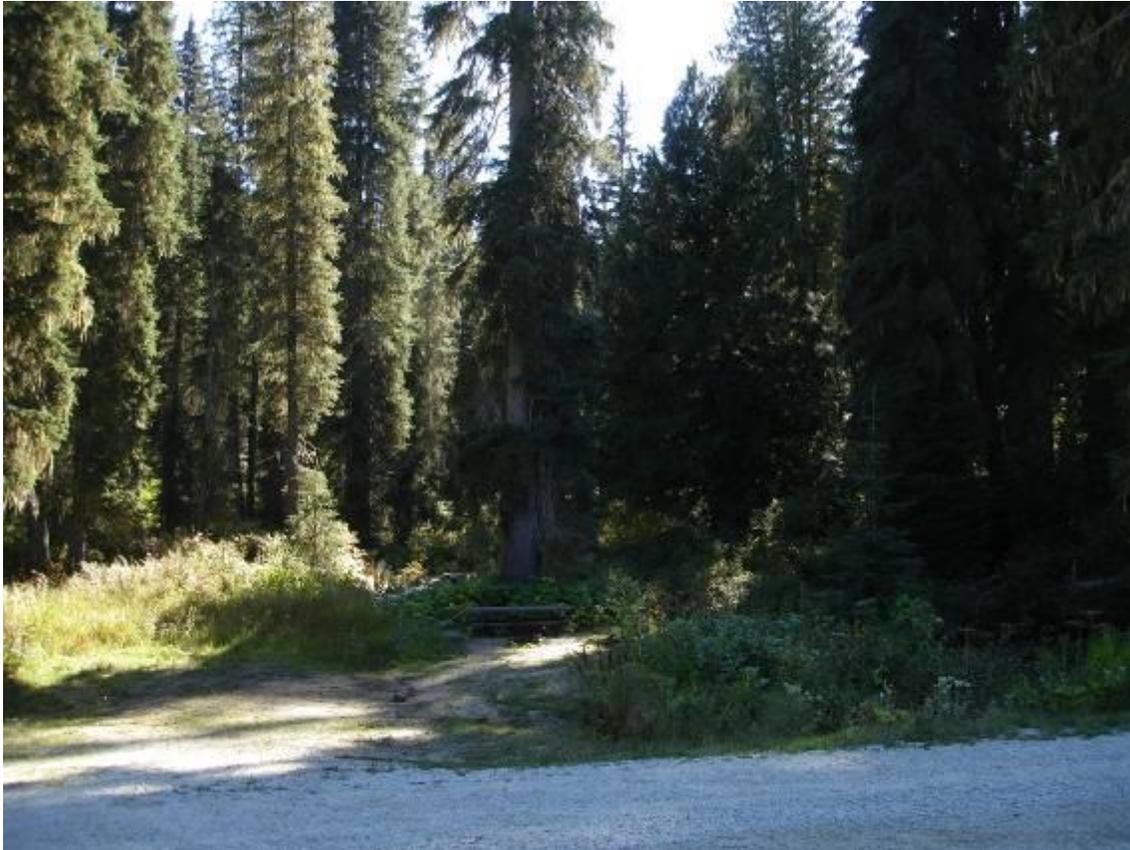
Neither a road nor any evidence of a road constructed was seen in the riparian area of the lower 2.9 km of Hem Creek. A small, primitive one-unit camping site was found adjacent to Hem Creek on the south bank just upstream of Forest Service Road 5216. We do not know the source of misinformation regarding a riparian road along Hem Creek, but it may have been an inaccurate roads layer or misinterpretation of aerial photos or imagery.

Photo A-2. View up Hem Creek from Forest Service Road 5216 showing campsite. Creek flows from middle to lower right corner.

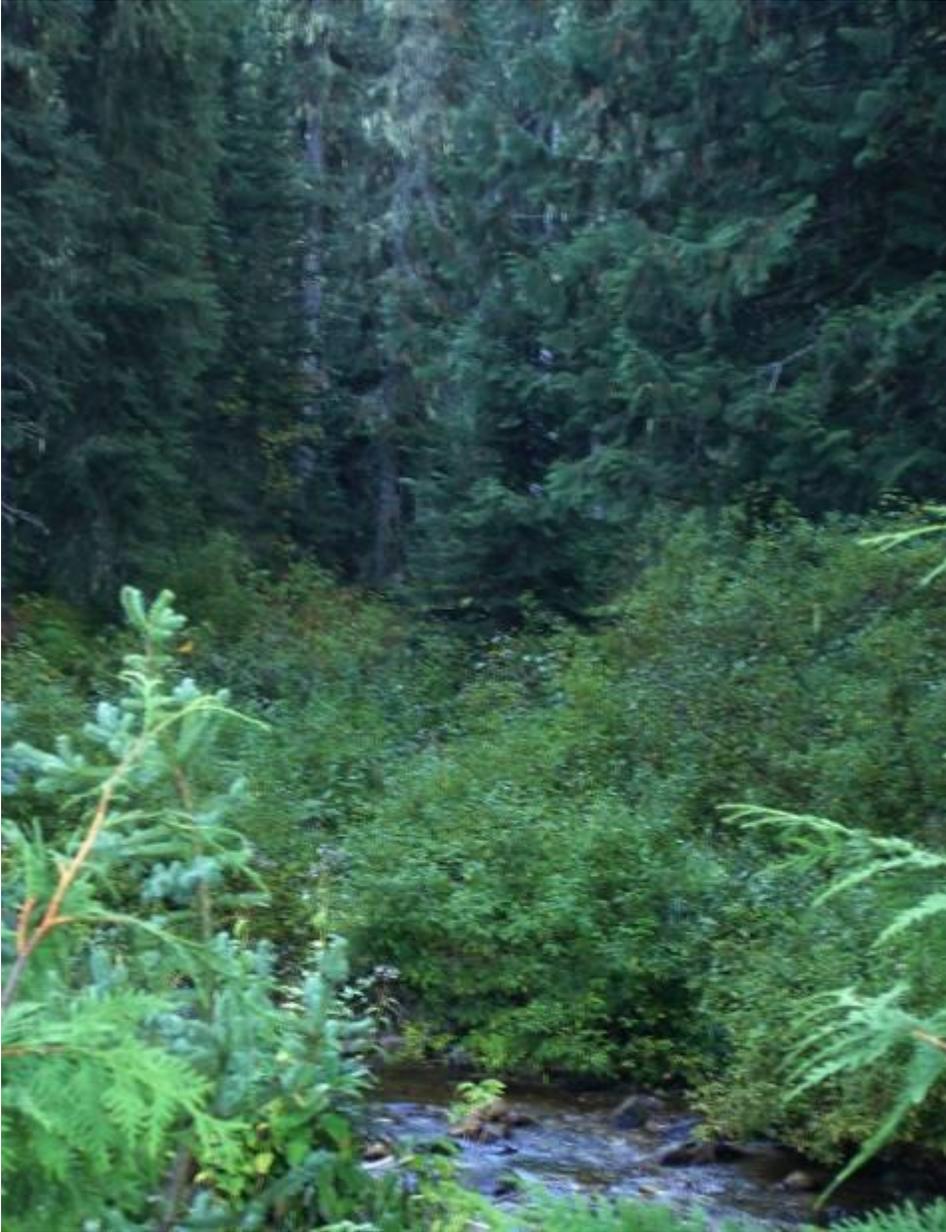
Photo A-3. View of Hem Creek looking upstream from transect 1. The creek in this area has some floodplain. Temperature logger 4 was located near this area.

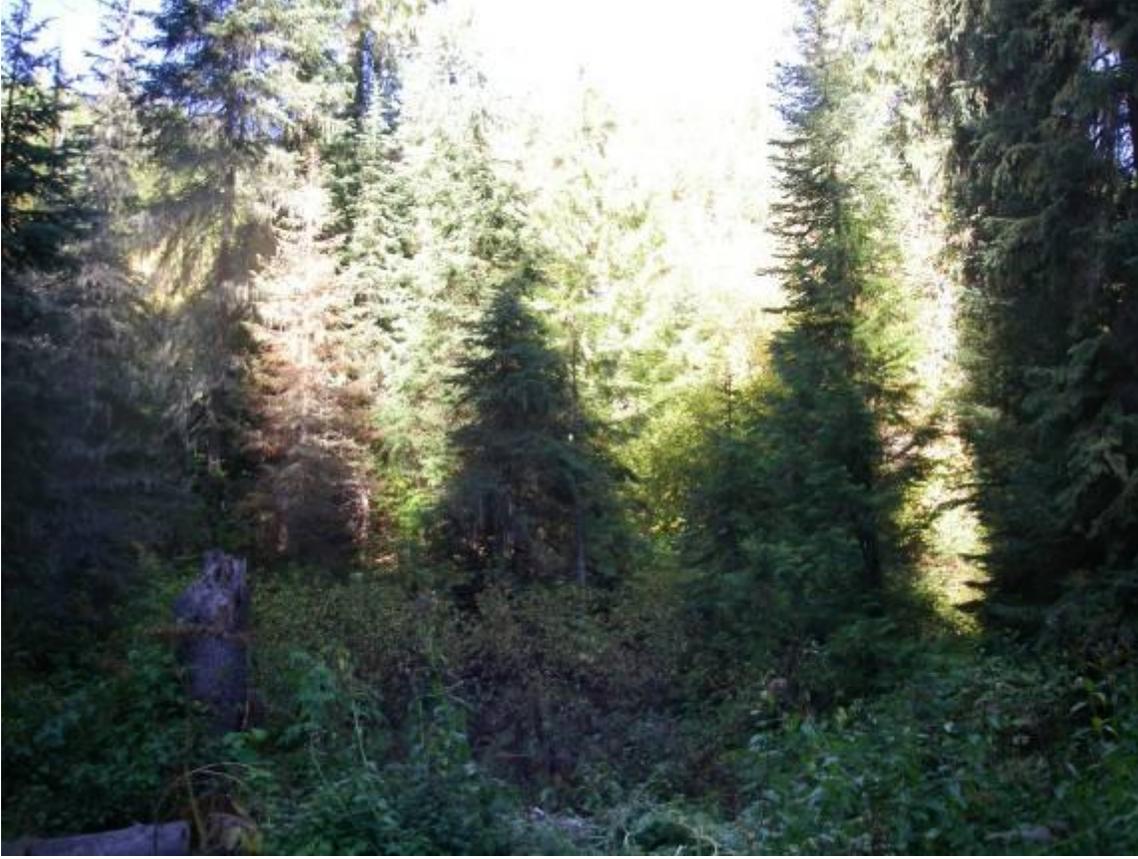
Photo A-4. View toward cut 1 from Hem Creek just above transect 1.

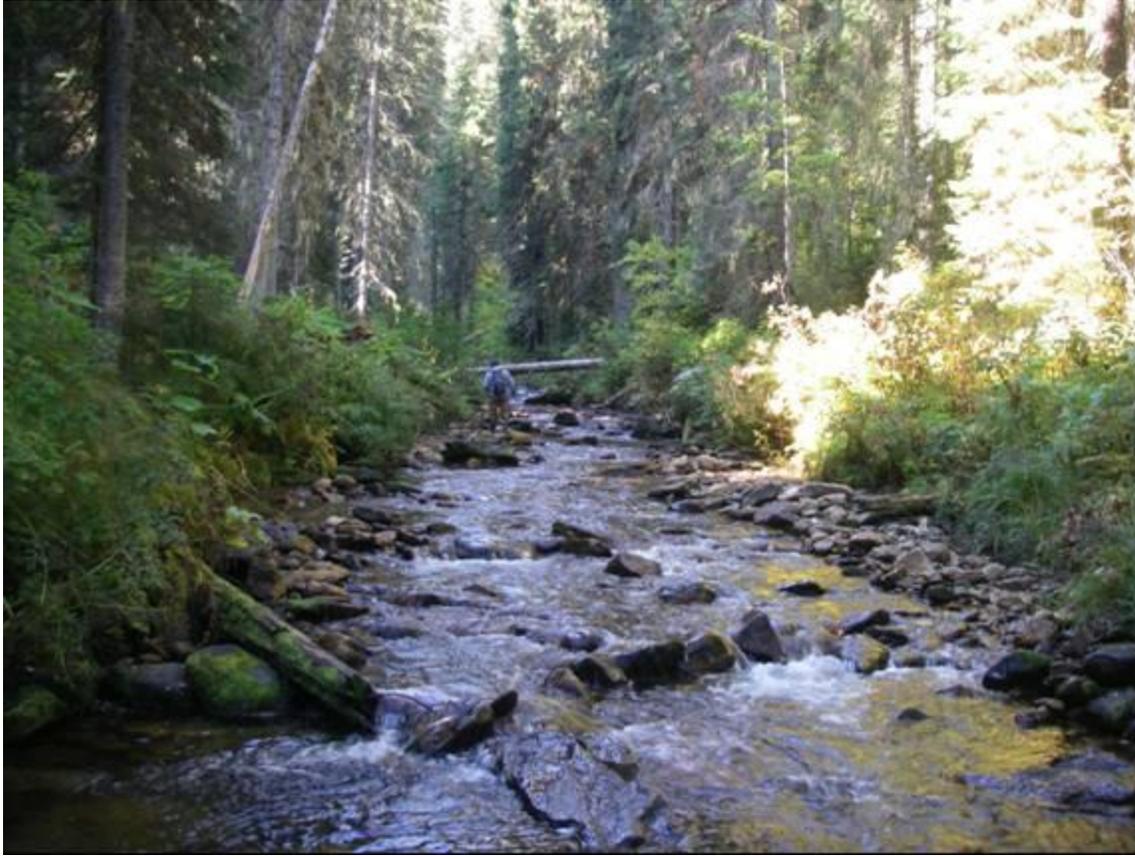
Photo A-5. Hem Creek between transects 1 and 2.

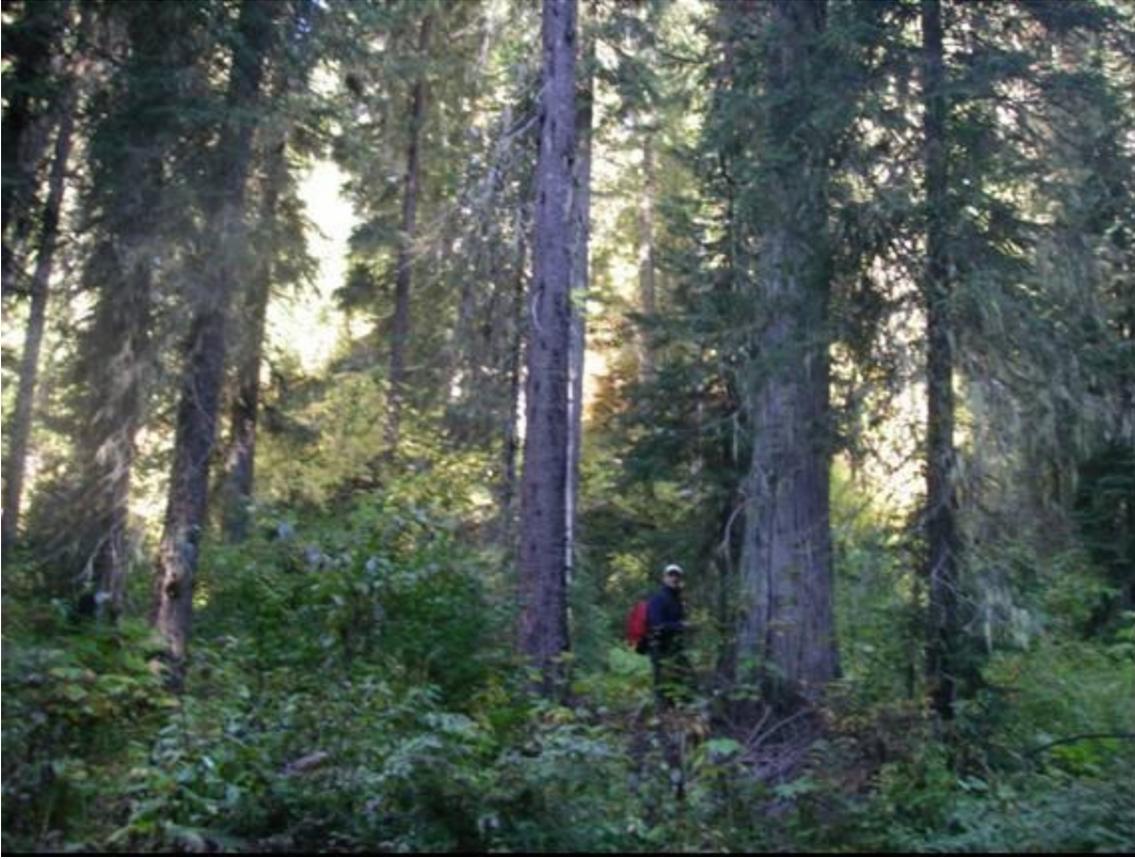
Photo A-6. View upslope toward cut 1 from transect 2.

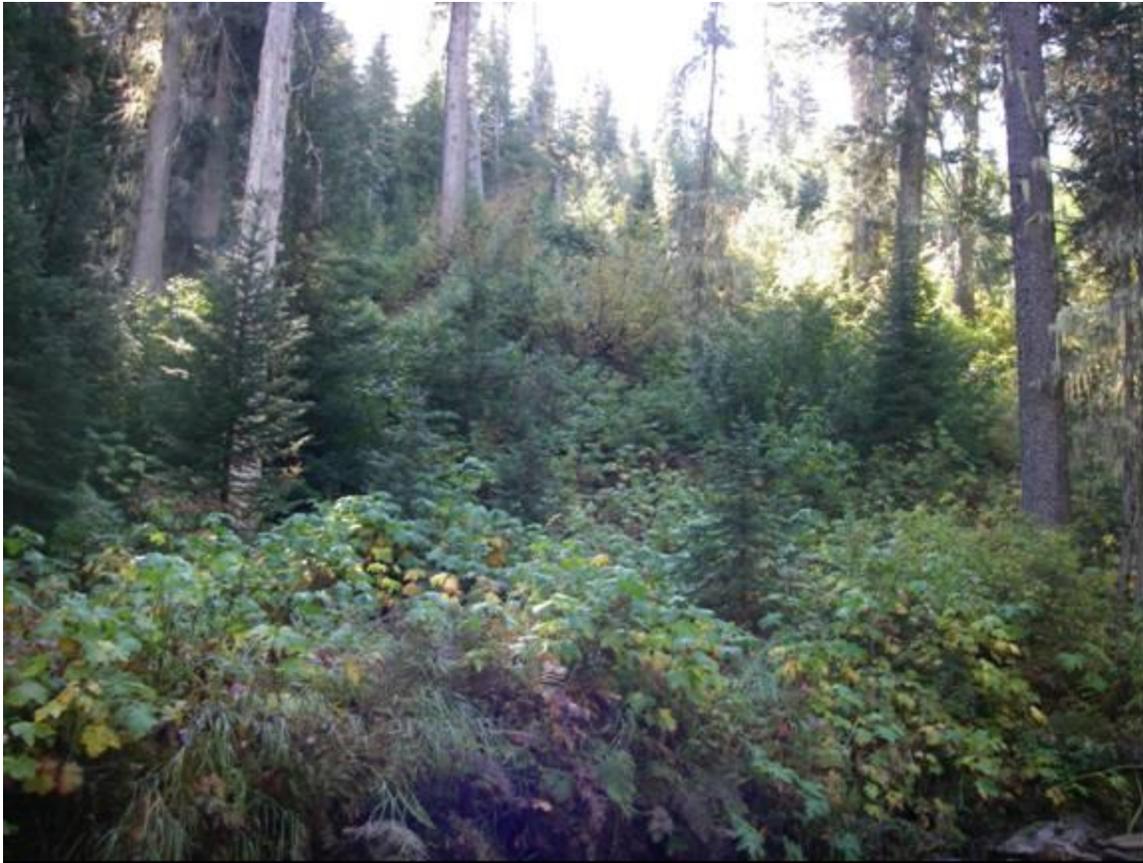
Photo A-7. Natural gap in forest canopy (no stumps) on south bank between transects 2 and 3.

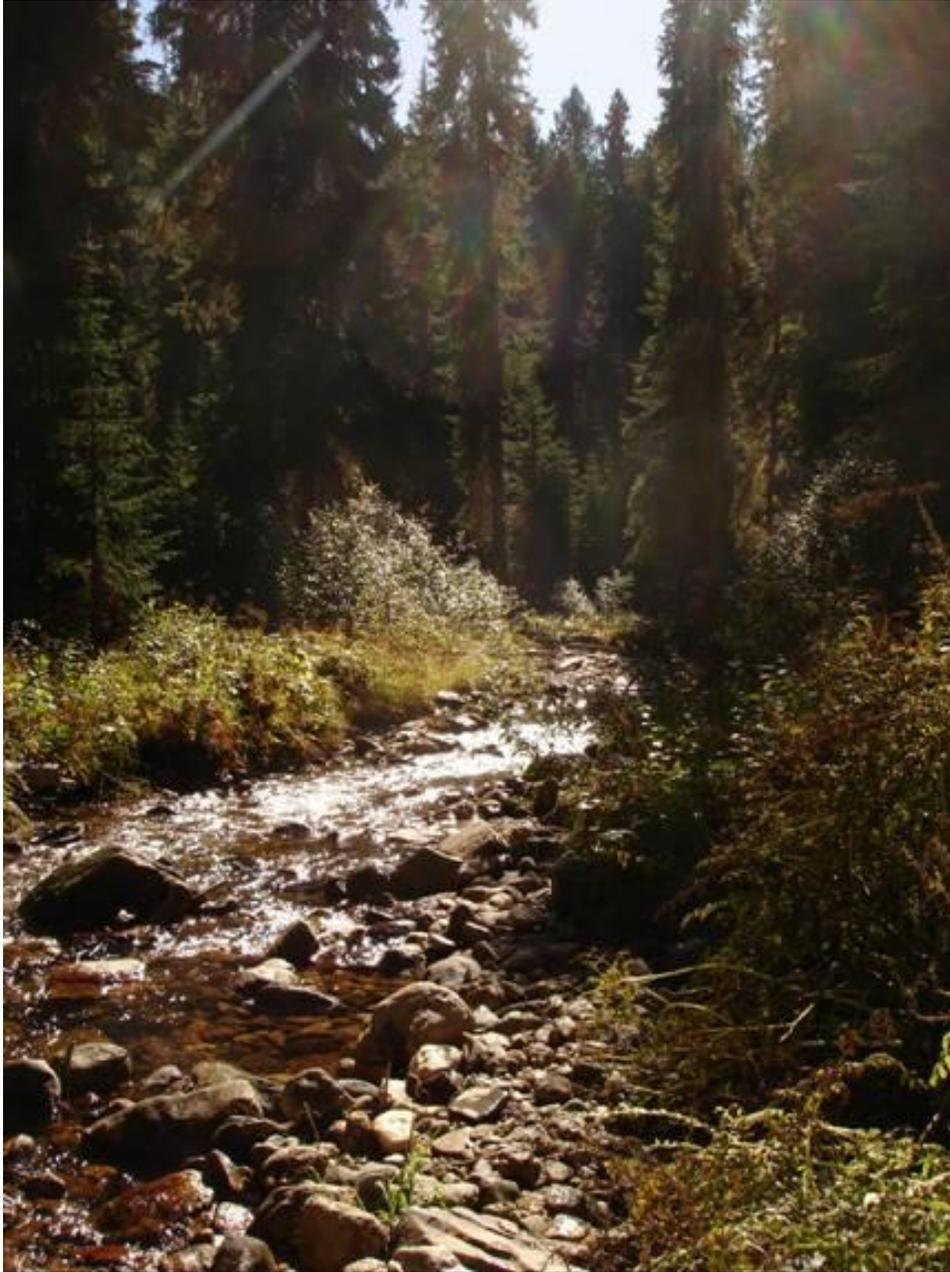
Photo A-8. View up Joy Creek from confluence with Hem Creek. Joy Creek is an un-entered, roadless watershed. Temperature logger 3 was located in this area.

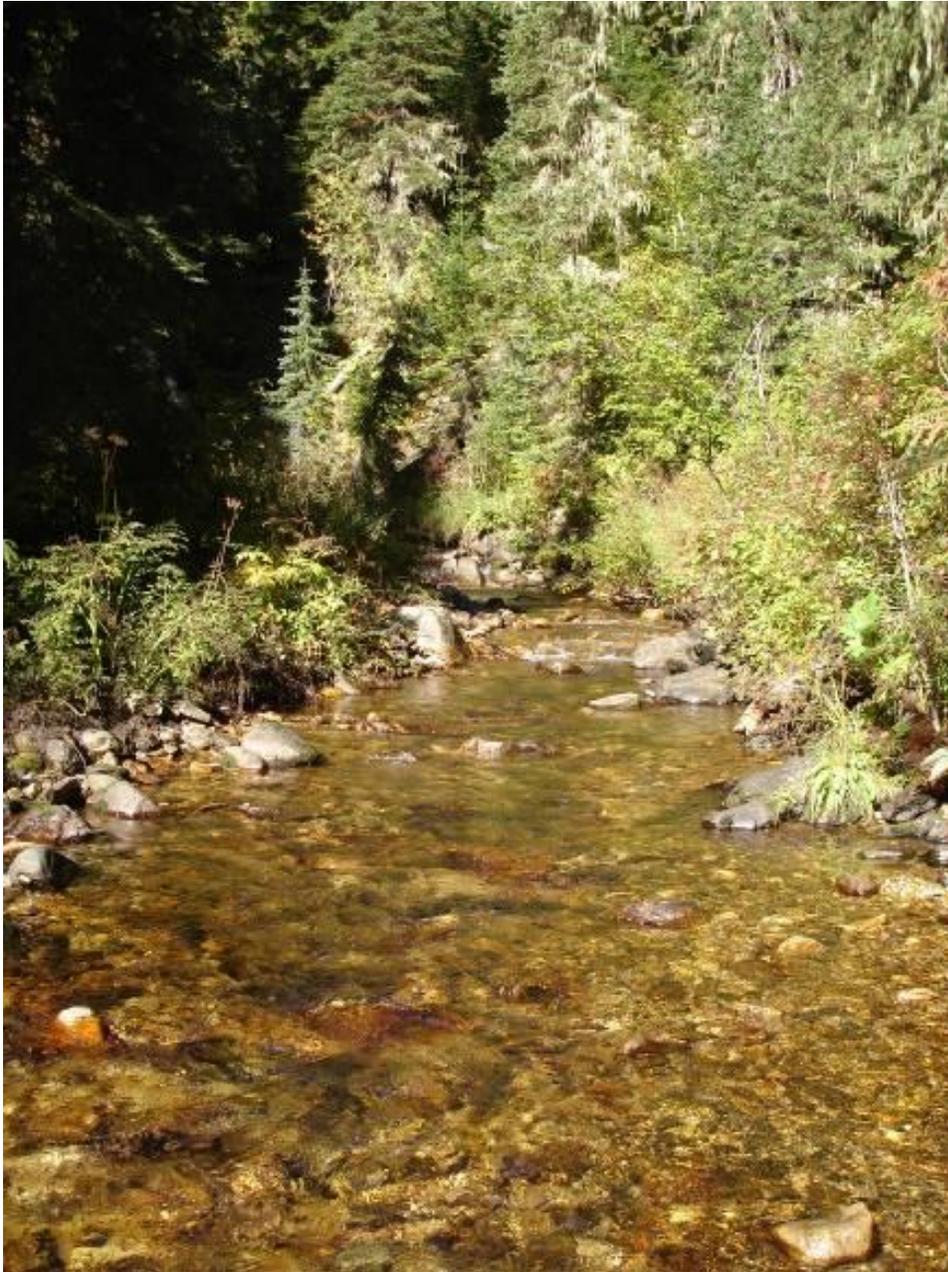
Photo A-9. Hem Creek view upstream above Joy Creek confluence. Temperature logger 2 was located in the area. No cutting units are located in area. Sun was shining through gap in forest formed by Joy Creek.

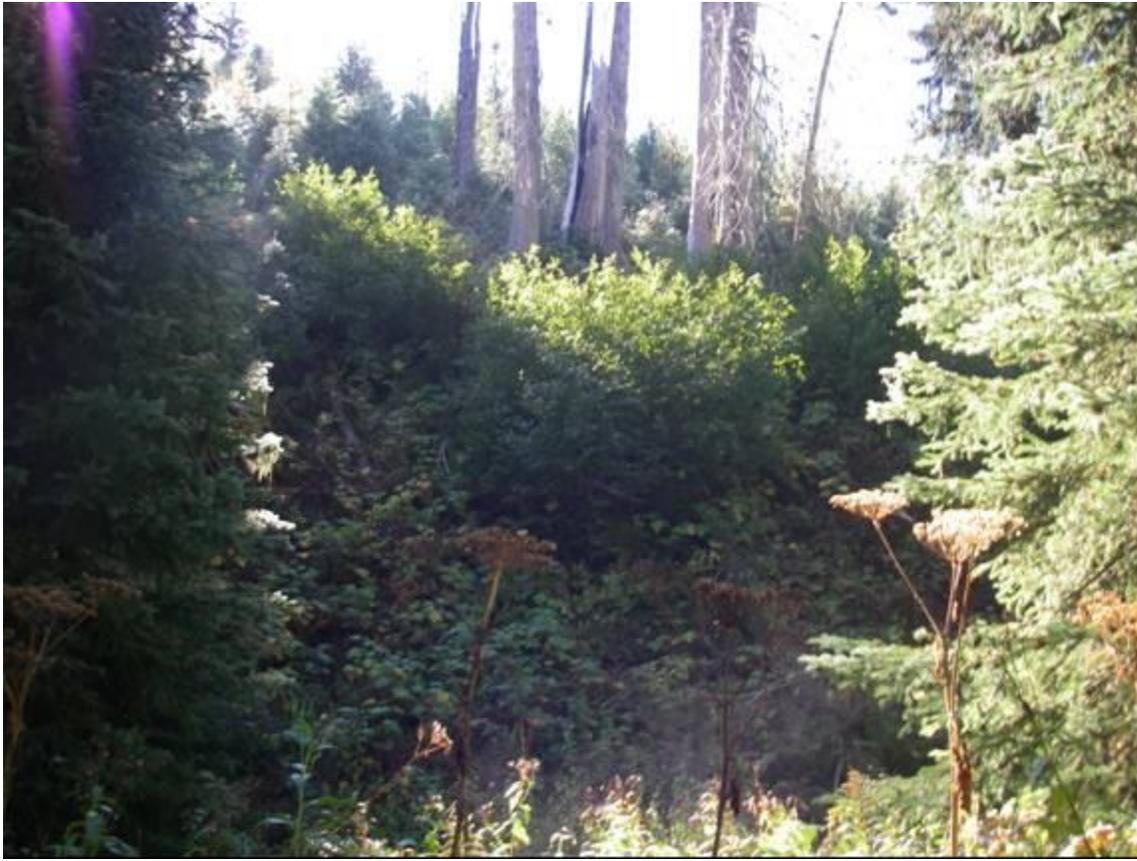
Photo A-10. View up to cut 3 taken at transect 3. One of two natural gaps encountered, approximately 30 yards wide. No stumps were present.

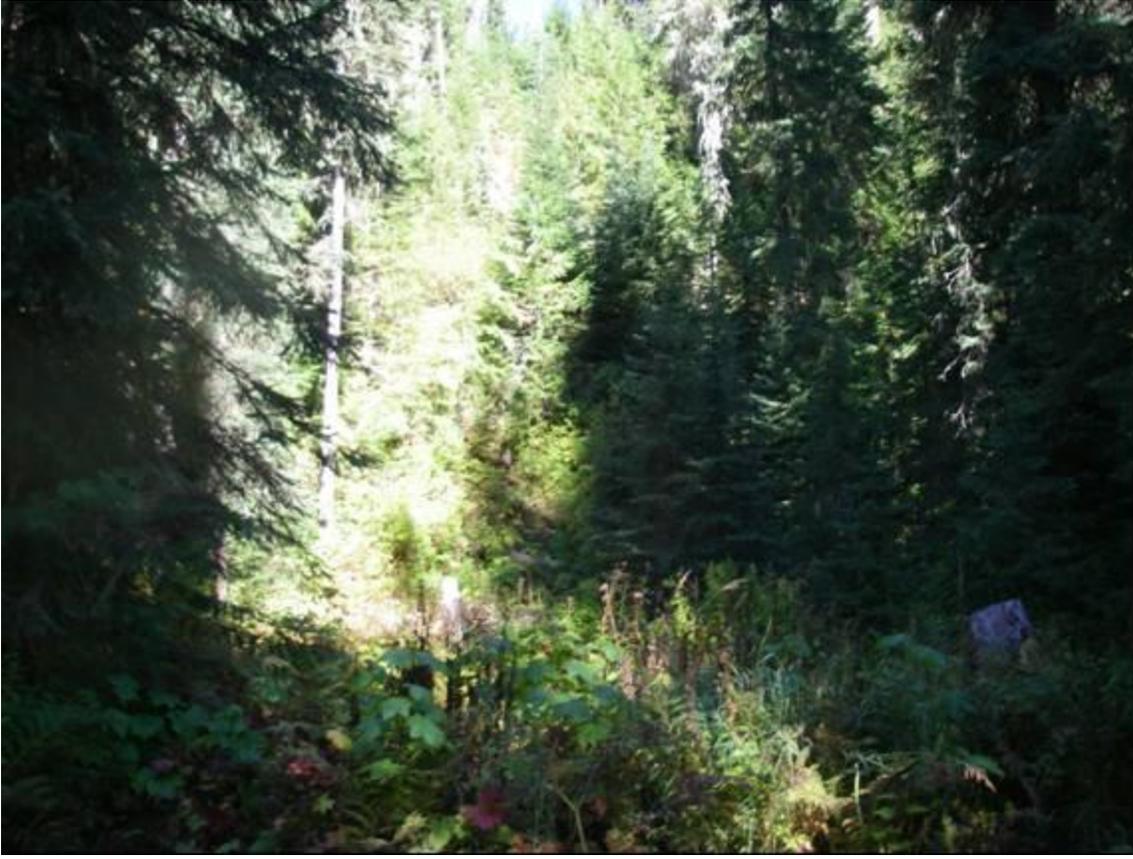
Photo A-11. View up north bank taken from transect 3 toward cut 1, which was not visible from stream.

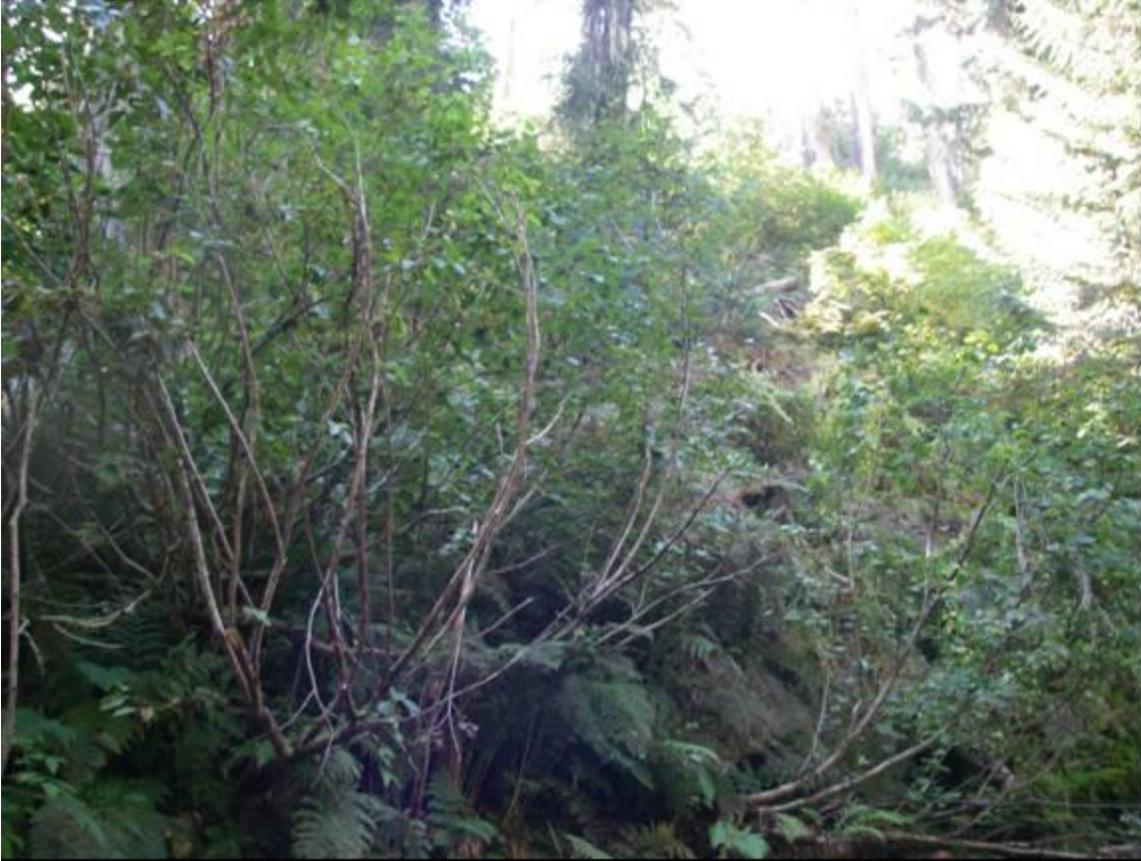
Photo A-12. View of south bank of Hem Creek at transect 4, looking toward cut 4.

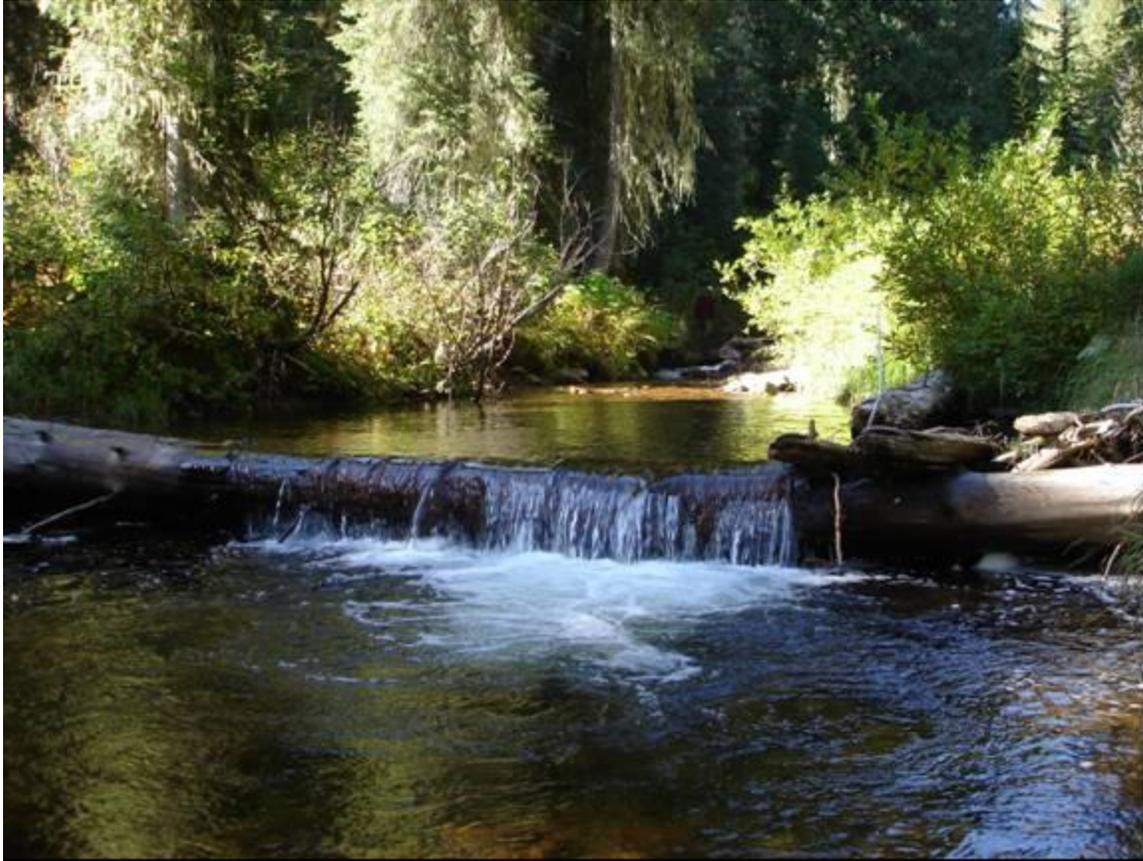
Photo A-13. Pool formed by log just above transect 4. Abundant large woody debris created structure and habitat in the channel.

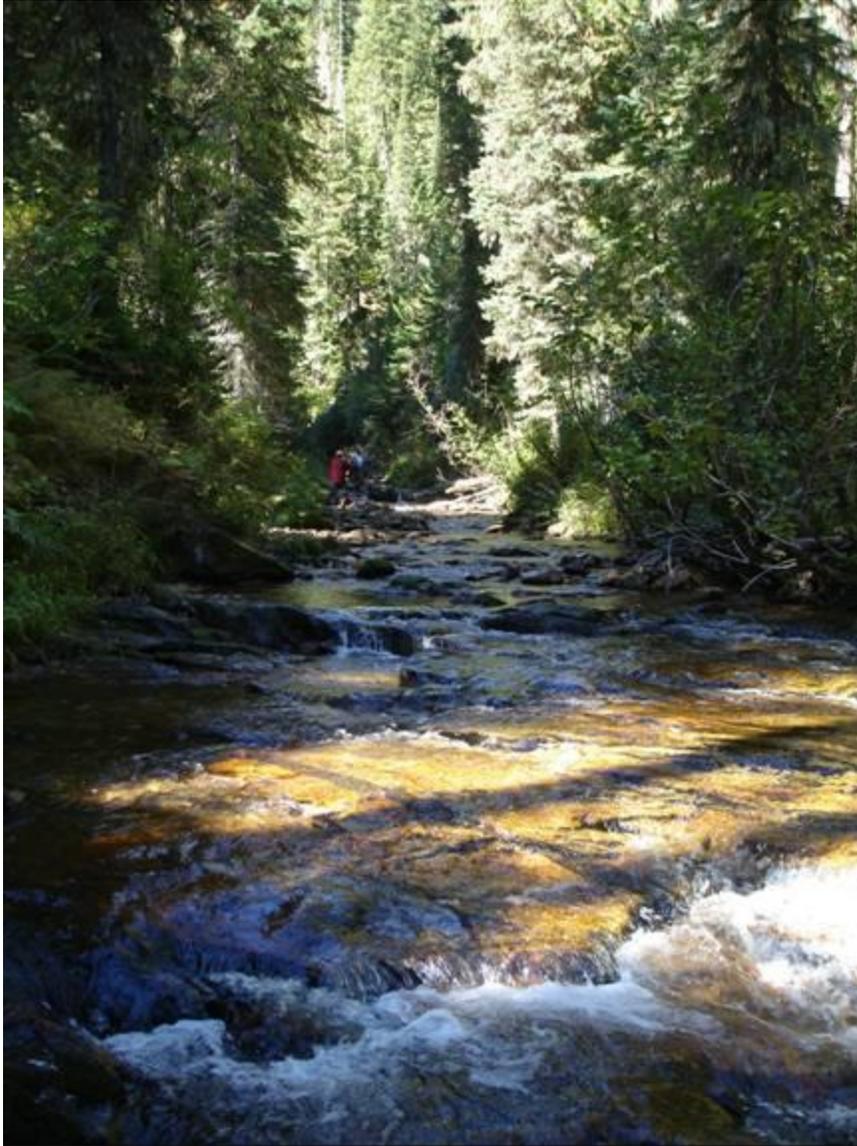
Photo A-14. Bedrock stream channel between transects 4 and 5; cut 4 is to the left but was not visible from stream.

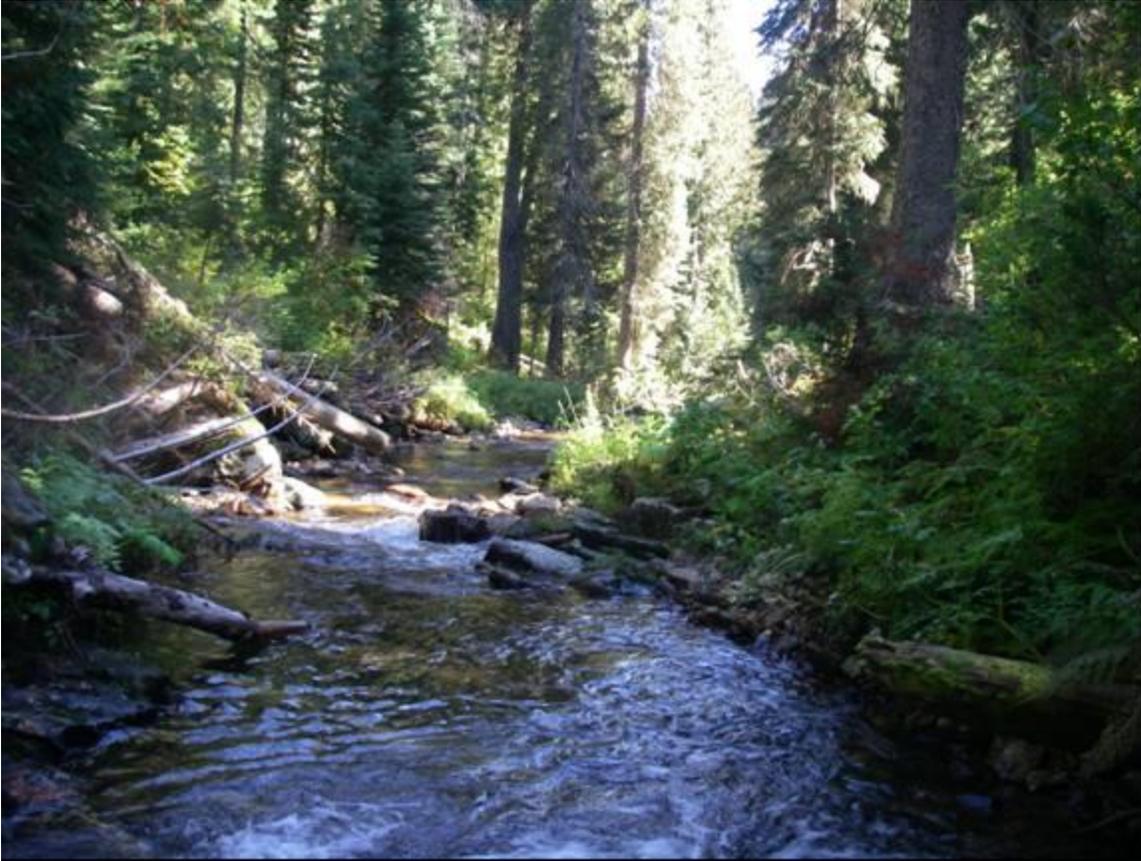
Photo A-15. View down Hem Creek at transect 5. Cut 4 is to the right. No floodplain is present.

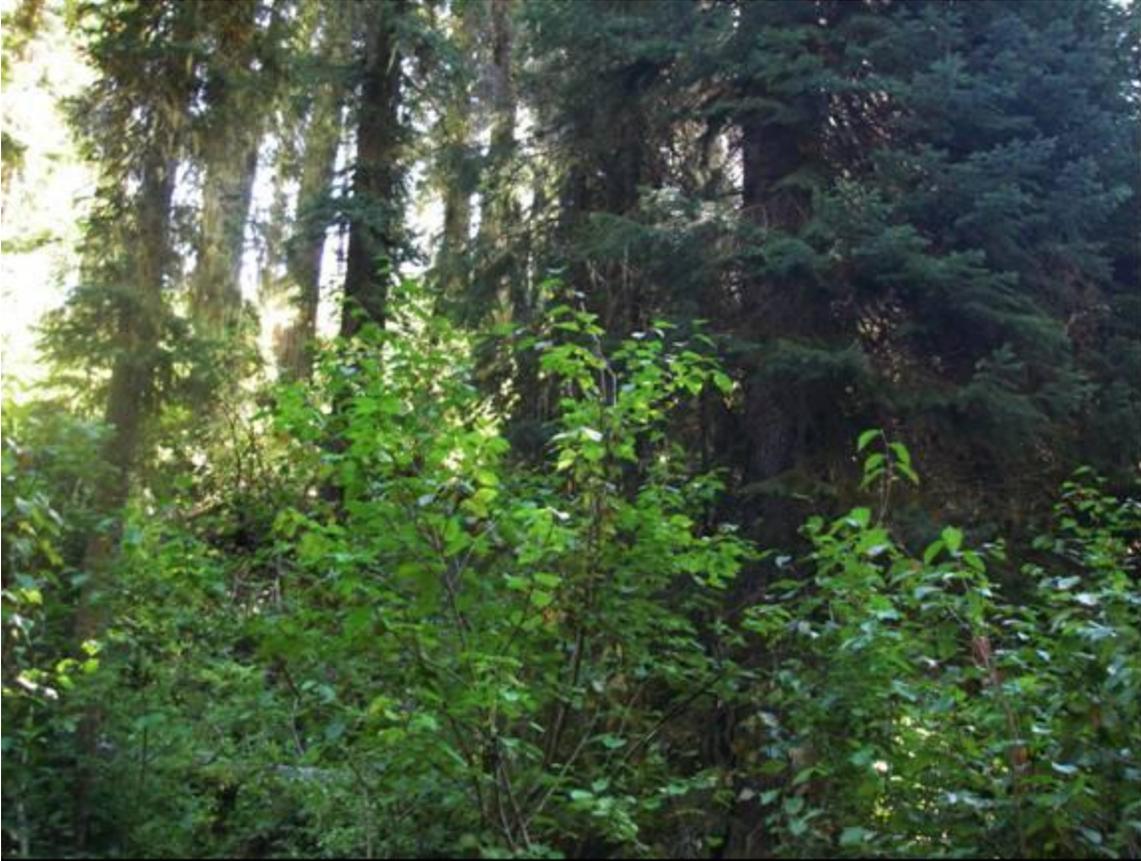
Photo A-16. View of south bank at transect 5, looking toward cut 4.

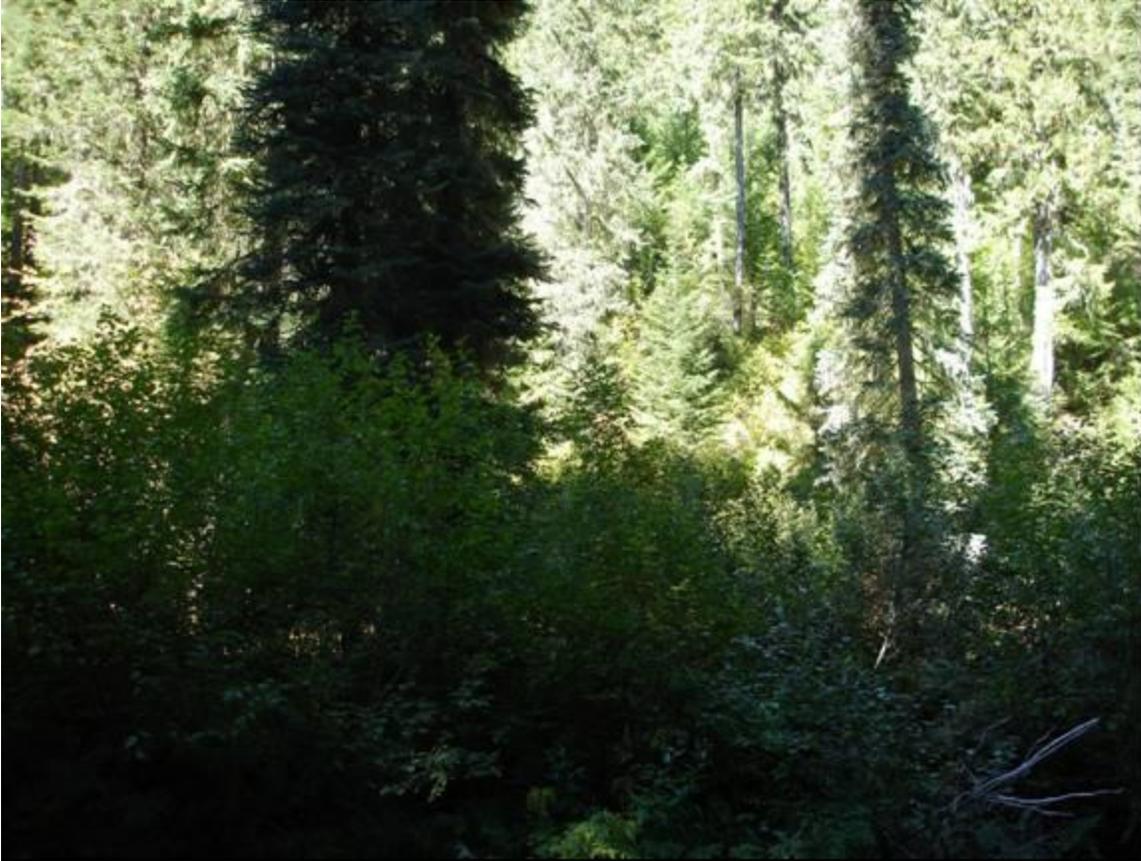
Photo A-17. View toward cut 2 from mouth of small tributary between transects 5 and 6. Cut was not visible.

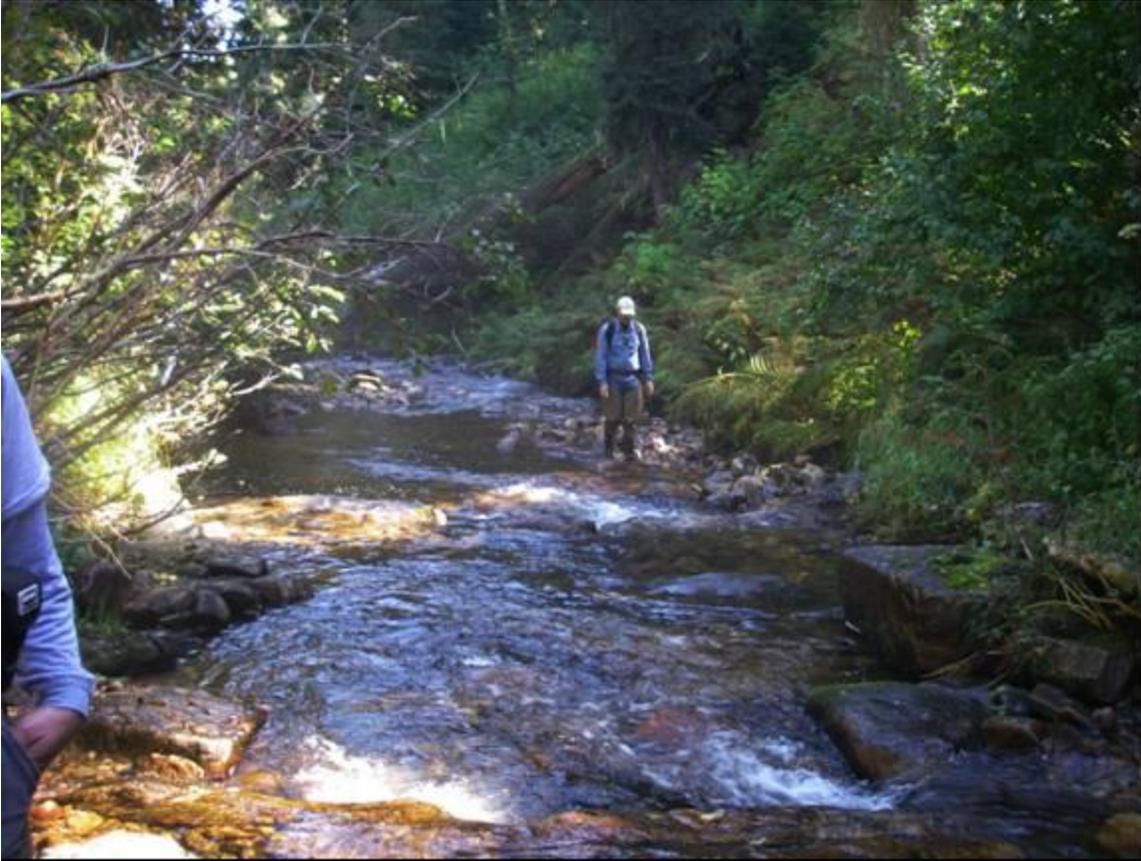
Photo A-18. View downstream at transect 6, cut 5 on right. No floodplain is present. Hill slopes plunge down into stream.

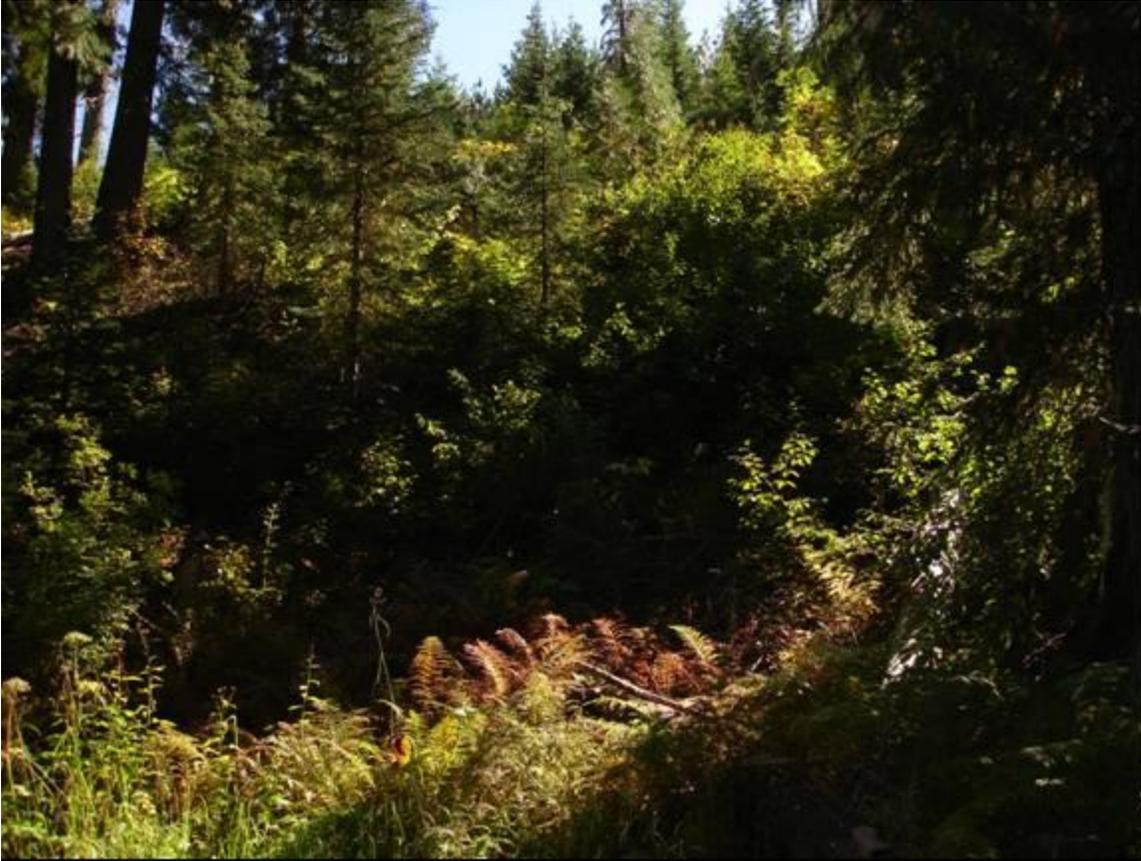
Photo A-19. View of cut 5 through natural gap near transect 6.

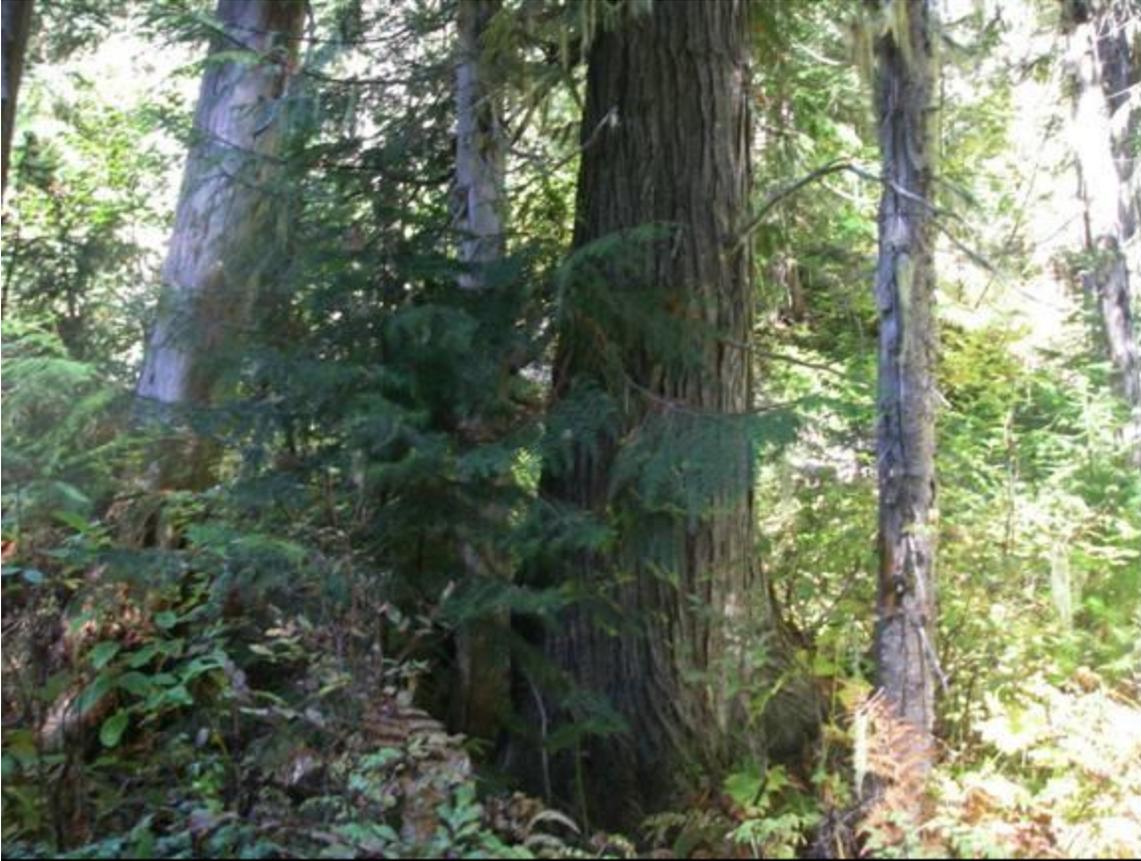
Photo A-20. View of north bank at transect 6, looking toward cut 2.

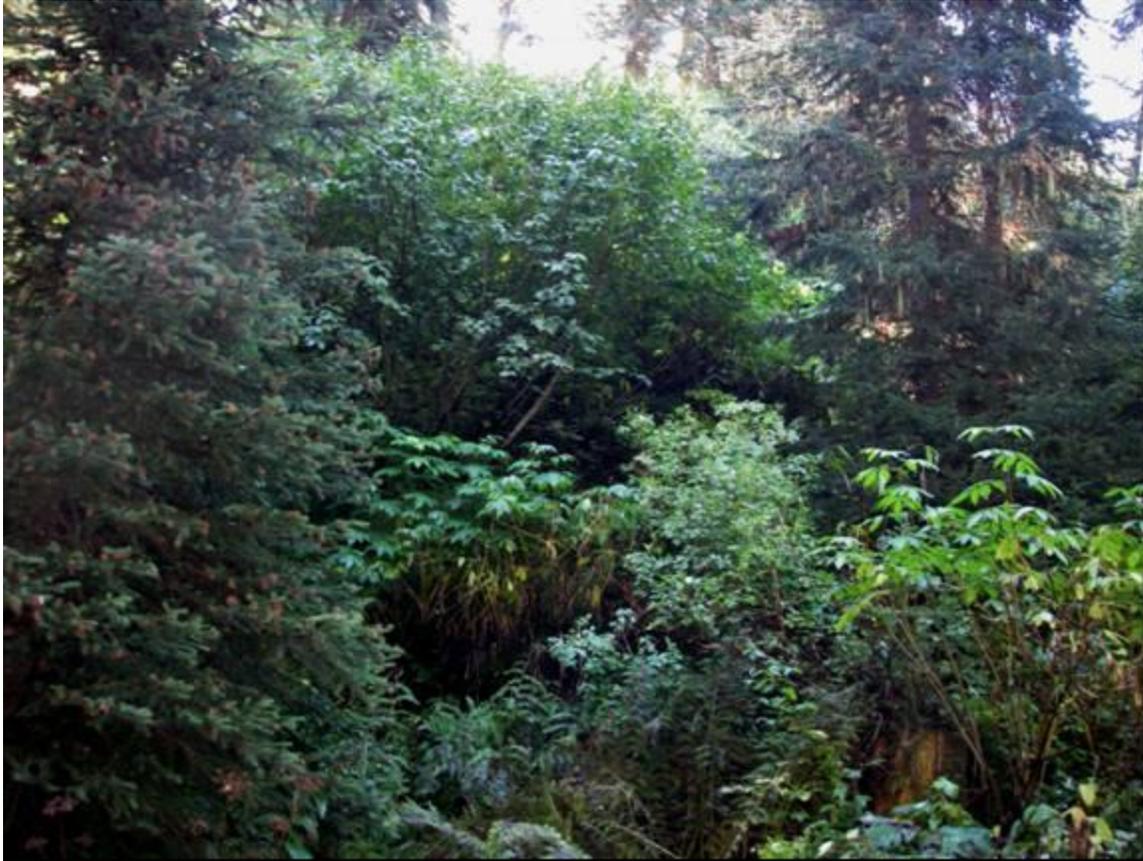
Photo A-21. View of south bank, looking toward cut 5 at transect 6.

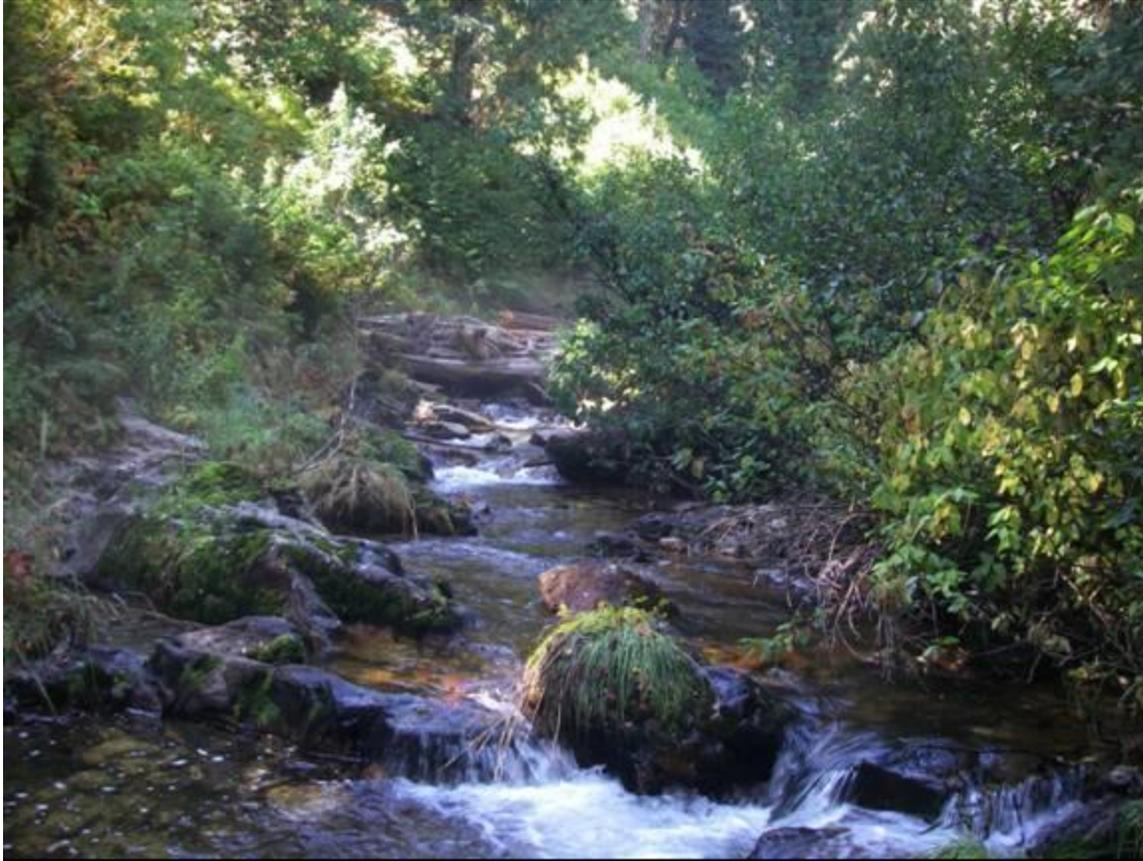
Photo A-22. View upstream at transect 6.
