Hem Creek 2009 Field Investigations

**State of Idaho
Department of Environmental Quality**

June 2012

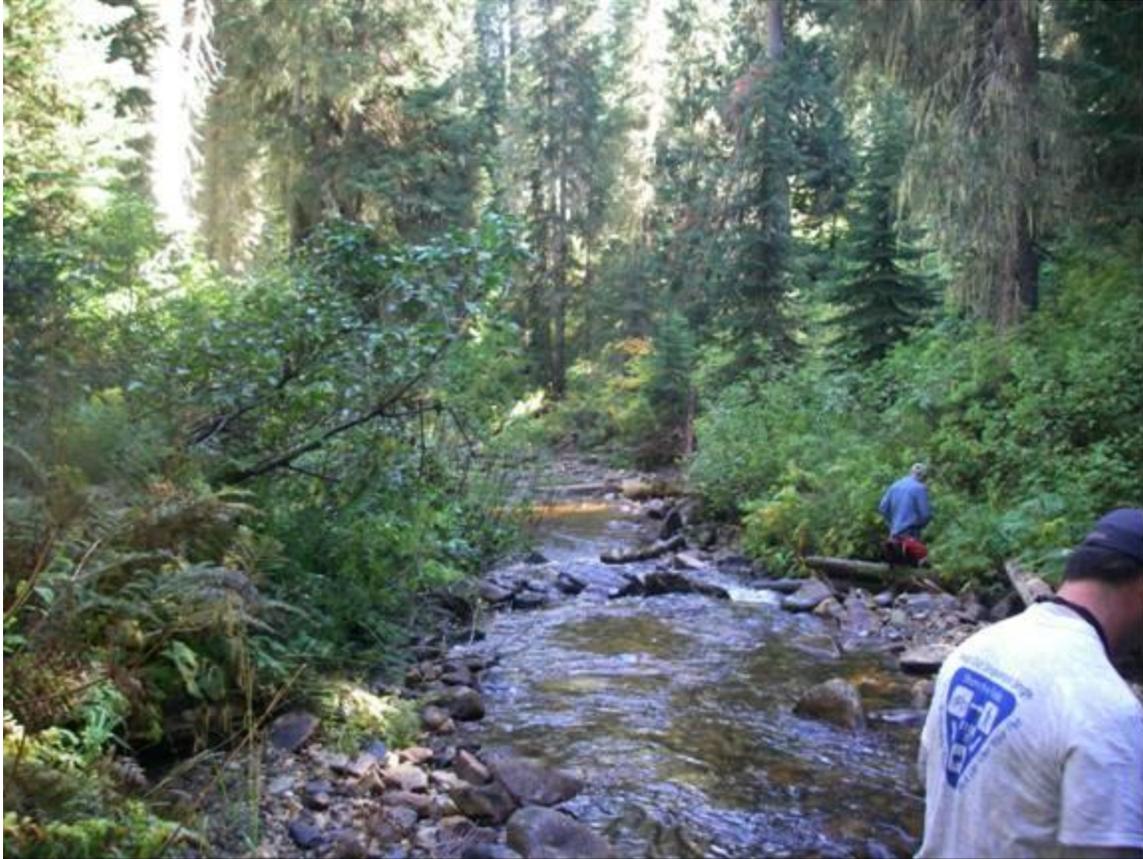
Photo A-23. View down Hem Creek at transect 7. Stream has a small floodplain. Cut 2 is to the left, and cut 5 is to the right; neither are visible from stream.

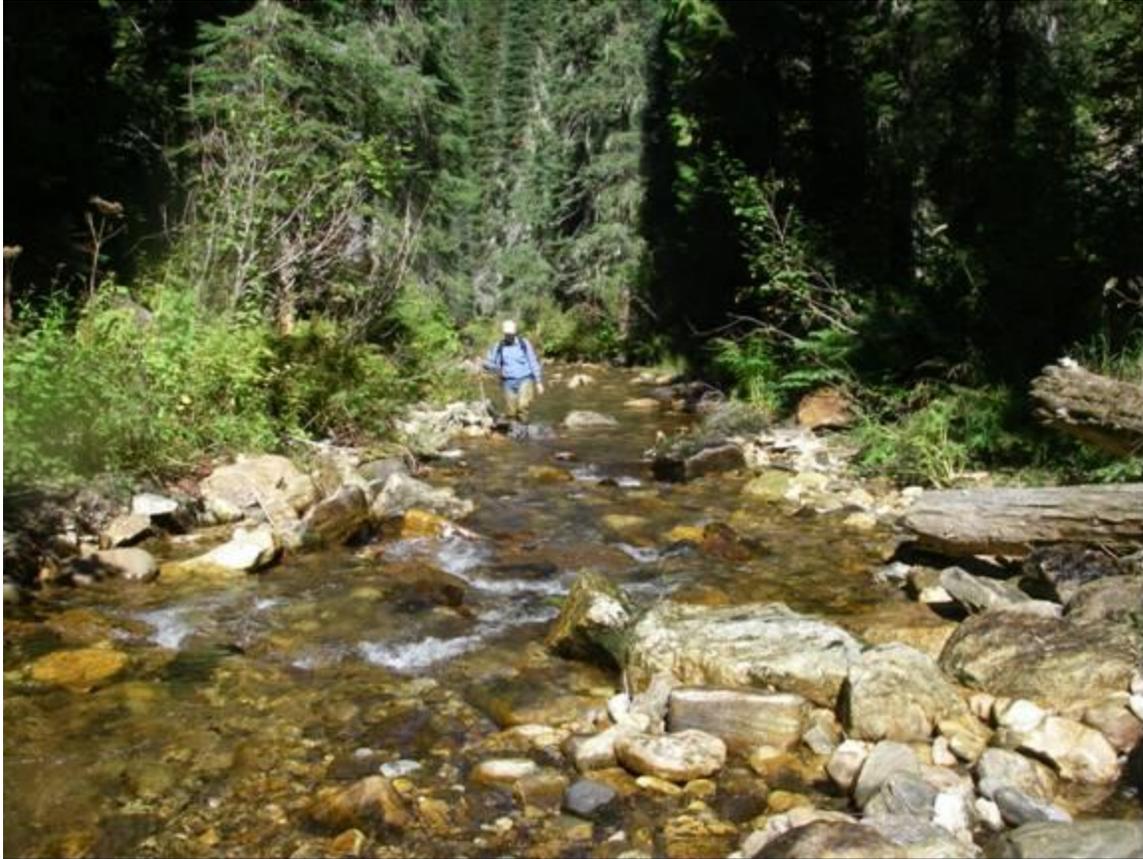
Photo A-24. View downstream at transect 8. No cuts are nearby. Sunshine is due to stream aspect and time of day.

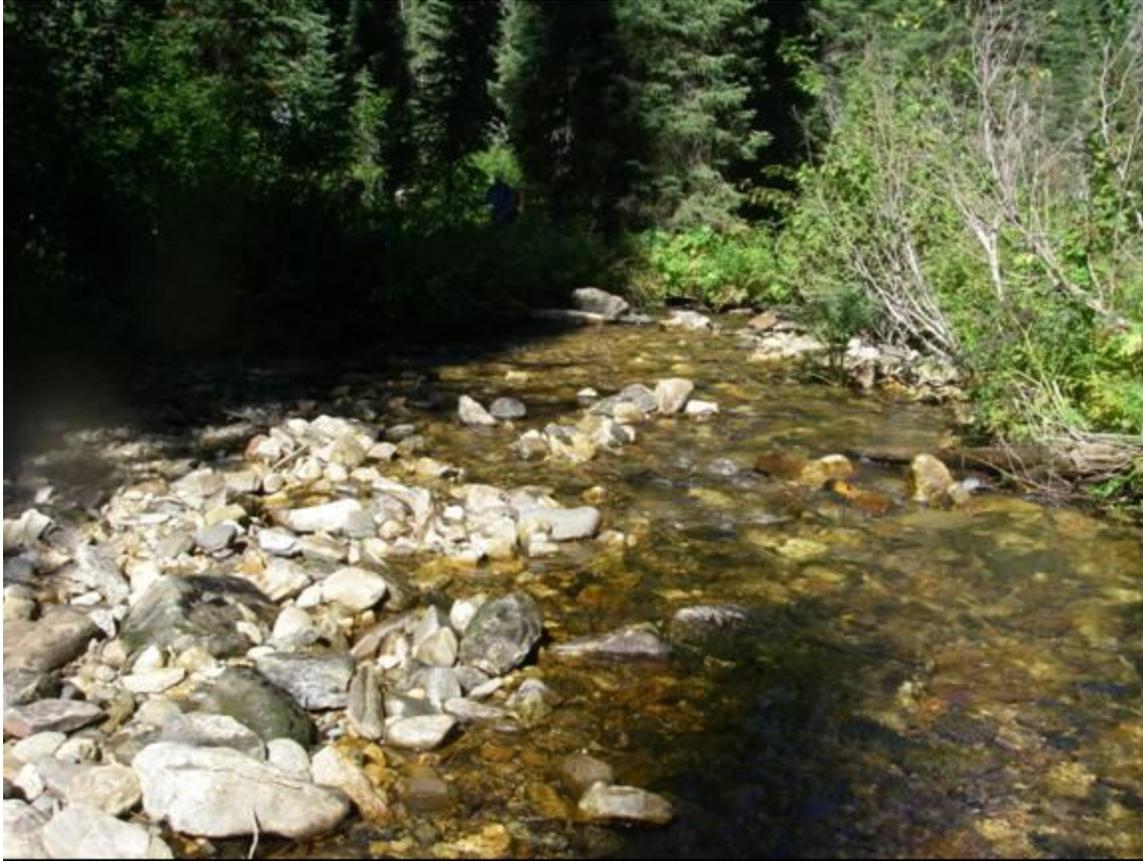
Photo A-25. View downstream at transect 9. Uppermost cut on south side of stream is off to the right but not visible from stream. Sunshine is due to stream aspect aligning with sun.

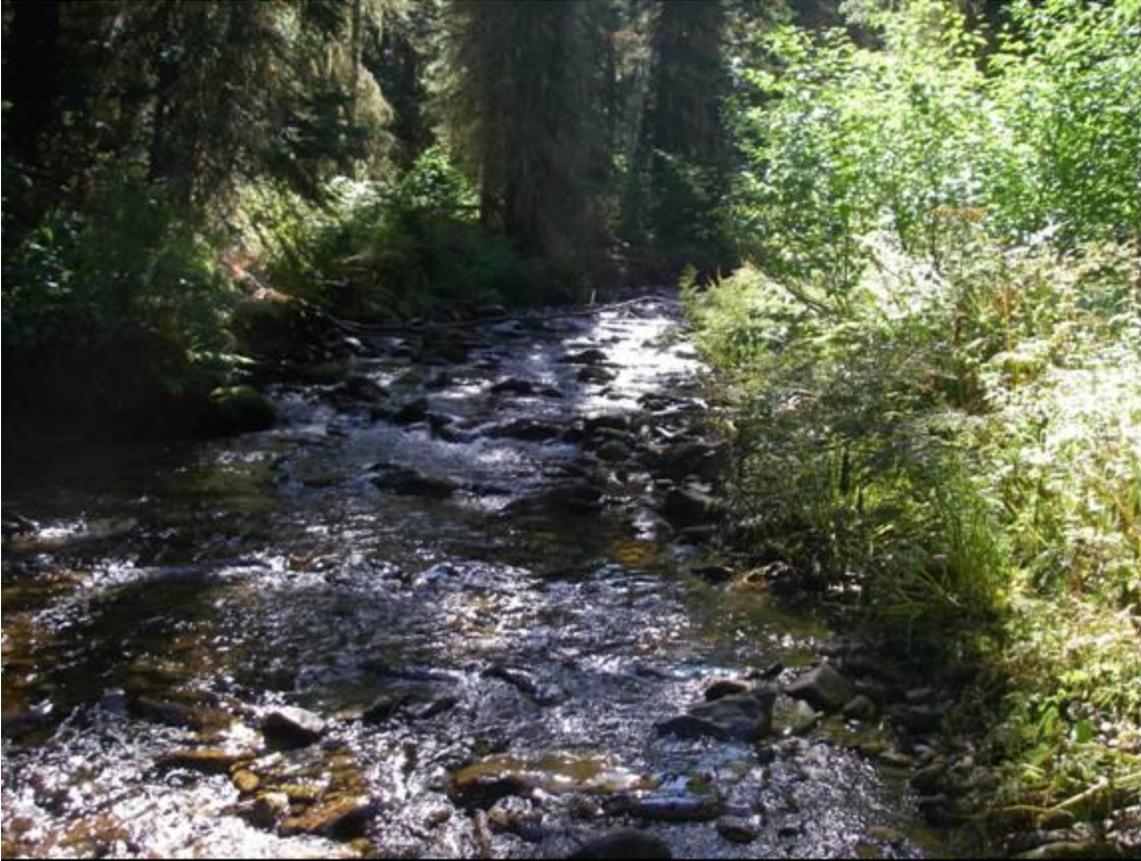
Photo A-26. View upstream at transect 9.

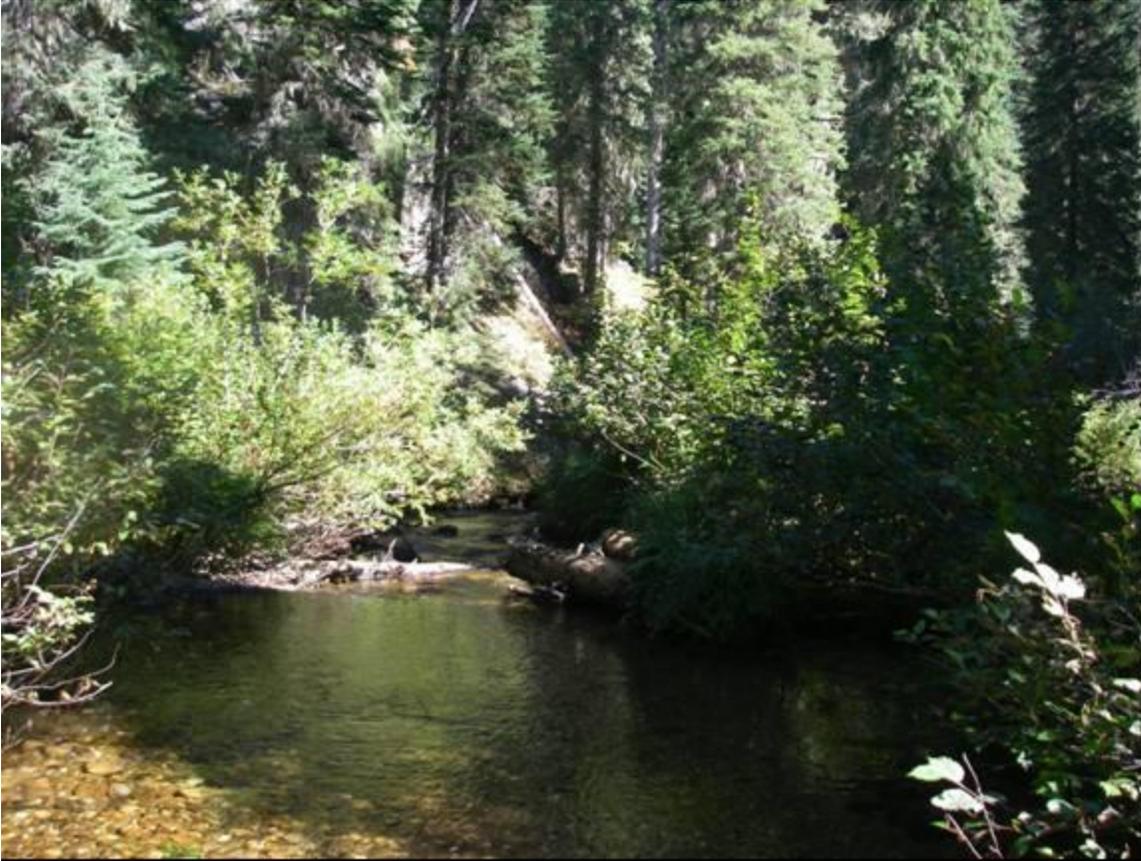
Photo A-27. View downstream from transect 10.

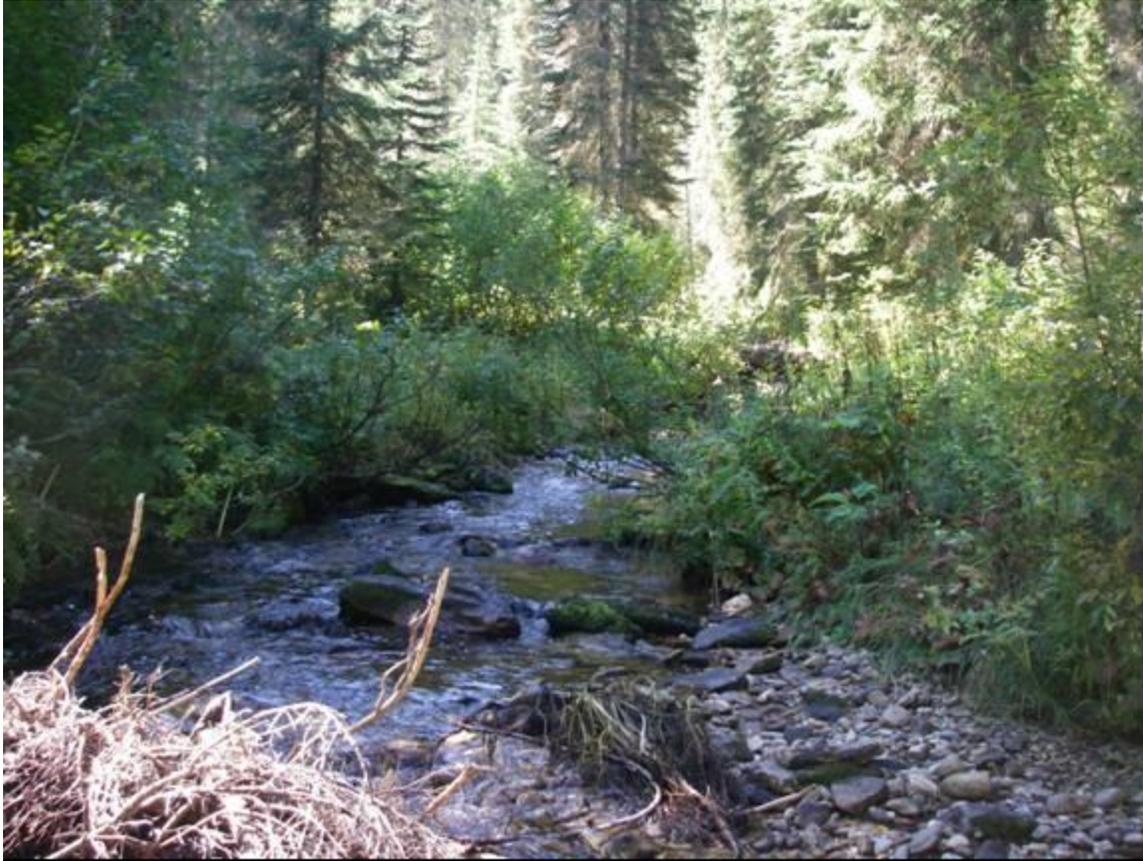
Photo A-28. View upstream at transect 10. Temperature monitoring location 1 (Hem Creek above cuts) was a short distance upstream. At this point, the channel gradient has slackened; valley has opened up a bit; and a floodplain is again present. All past timber harvest activity is downstream from this location.
