Teton River Subbasin Assessment And Total Maximum Daily Load

Teton River Subbasin Assessment and Total Maximum Daily Load

January 10, 2003

**Prepared by:
Idaho Falls Regional Office
Department of Environmental Quality
900 N. Skyline Ave., Suite B
Idaho Falls, Idaho 83402**

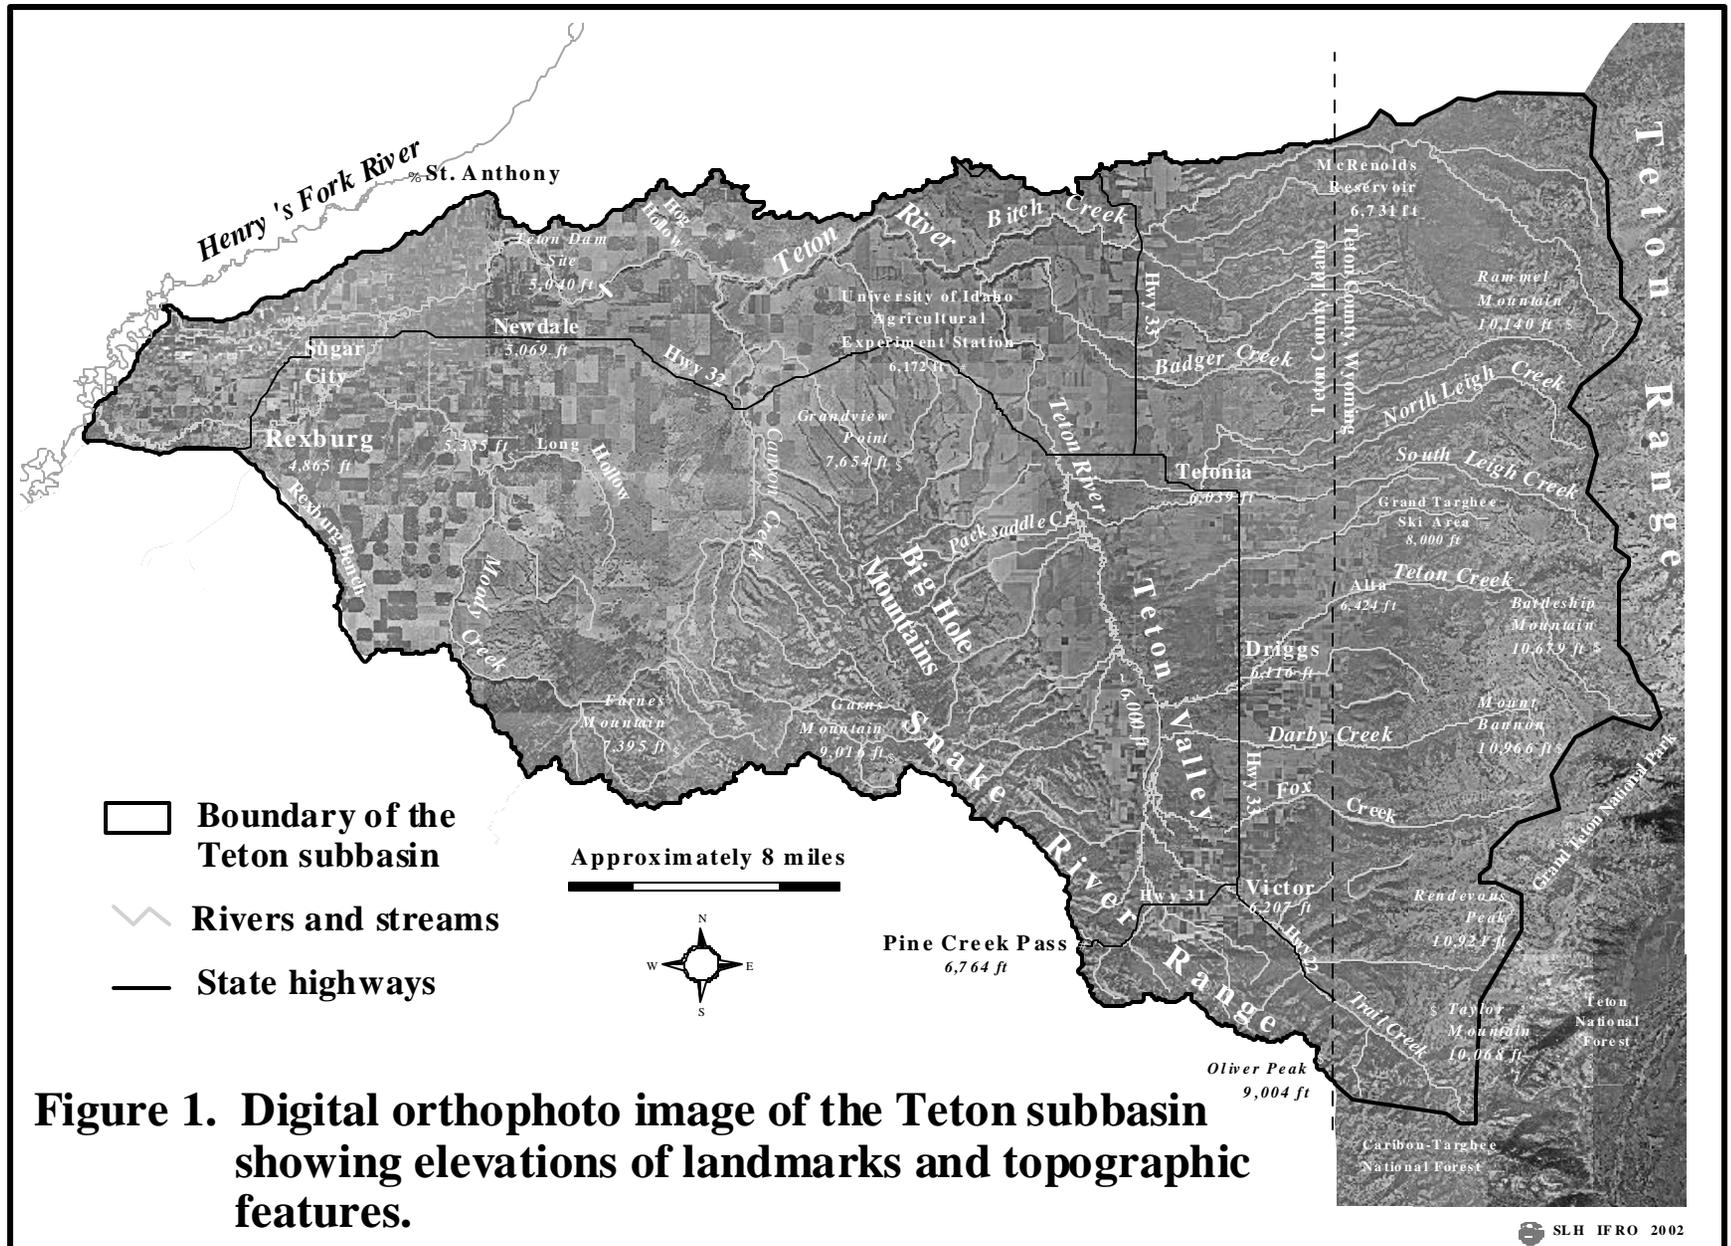
Figure 1. Digital orthophoto image of the Teton subbasin showing elevations of landmarks and topographic features.

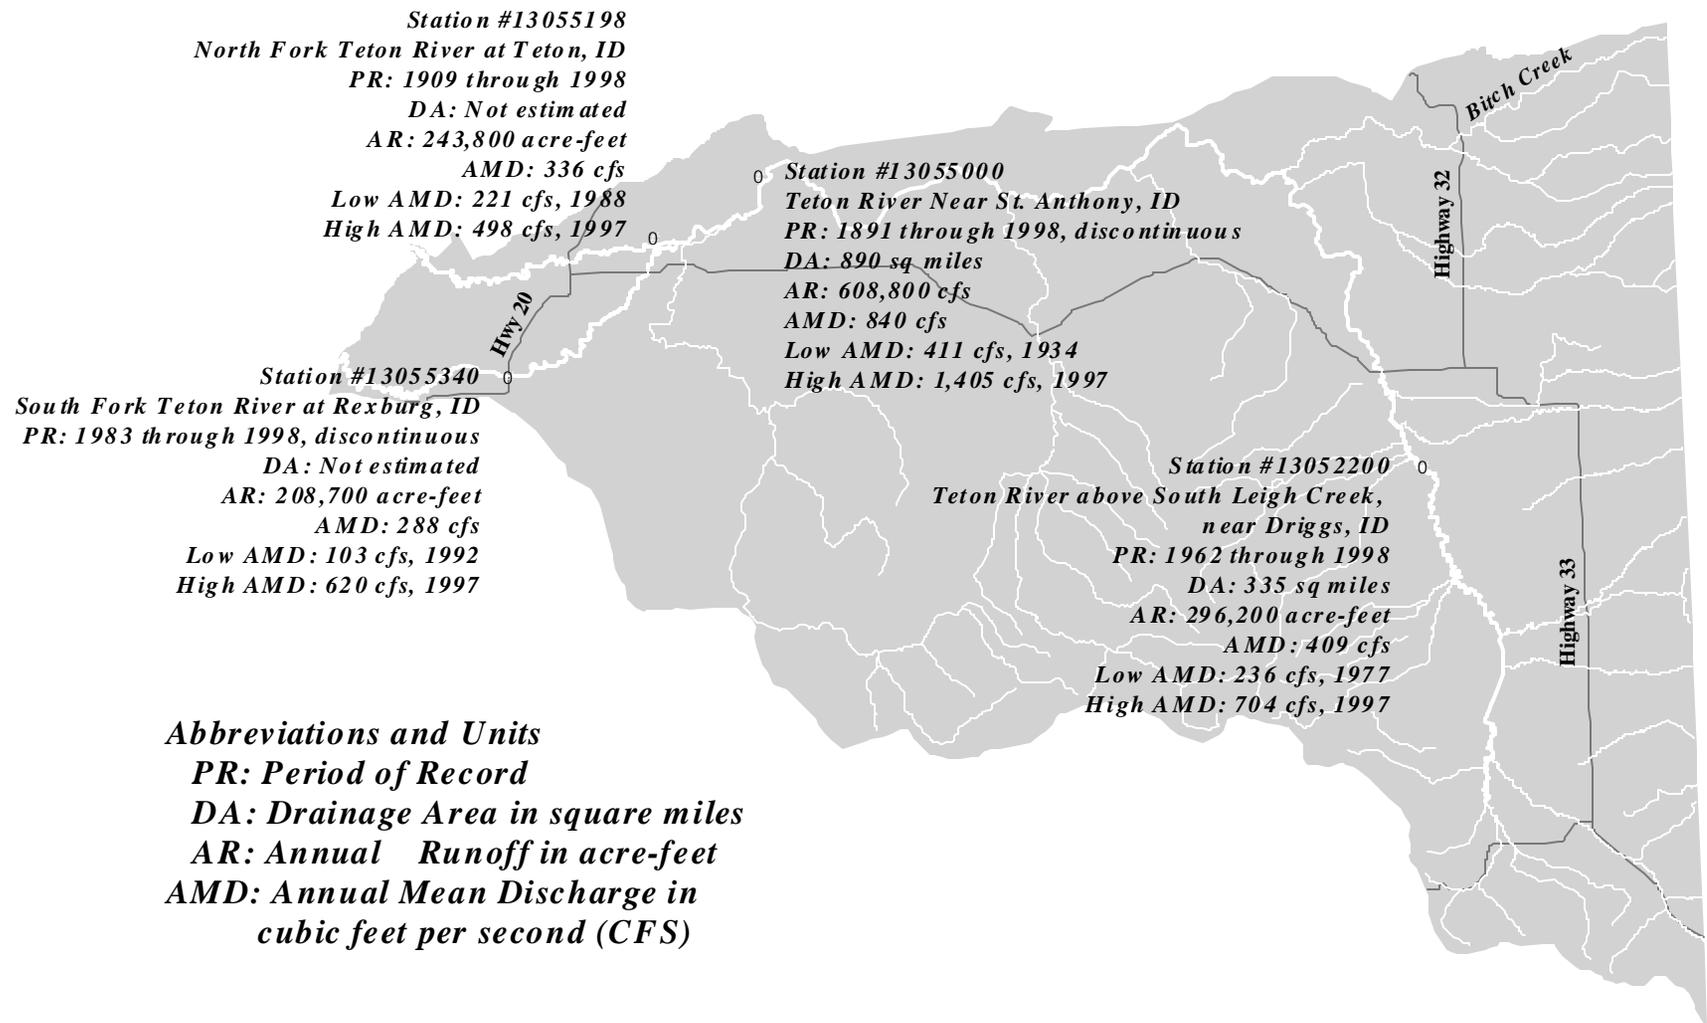
Figure 4. Locations of U.S. Geological Survey surface-water stations currently operating in the Teton subbasin, and summaries of discharge data for the period of record through 1998. Source: U.S. Geological Survey Water-Data Report ID-98-1.

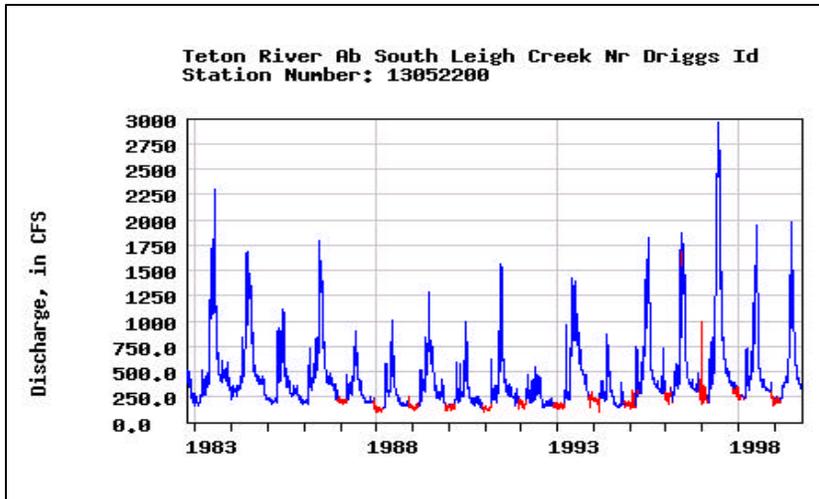
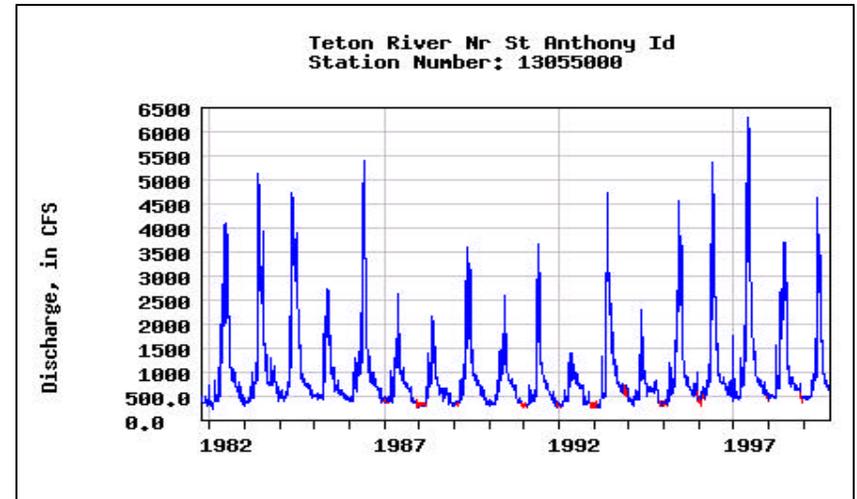
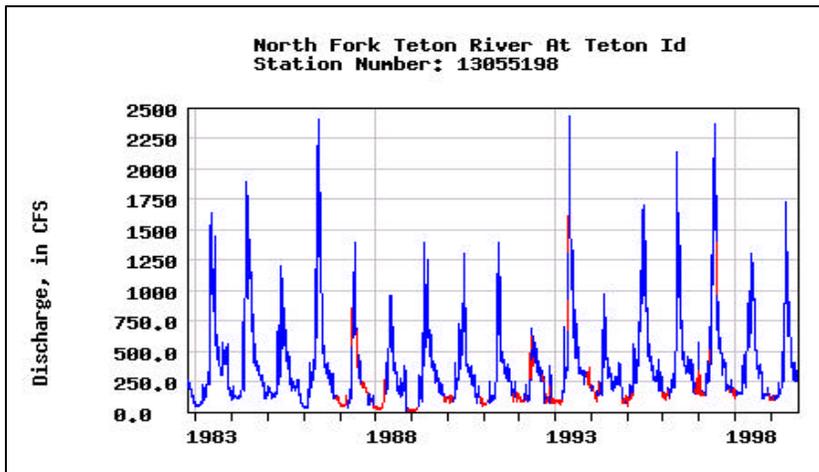
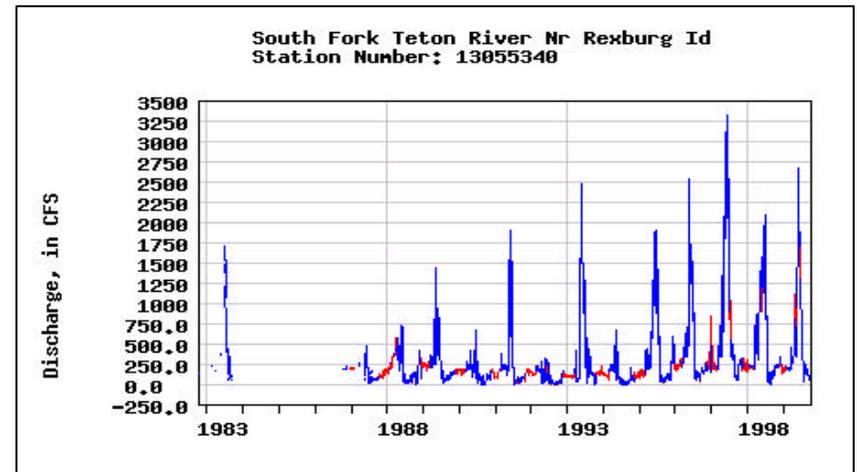
Figure 5. Discharge data recorded or estimated since 1982 at active USGS gage stations in the Teton subbasin. Graphs were taken directly from the USGS data retrieval site at <http://waterdata.usgs.gov/nwis-w/ID>.

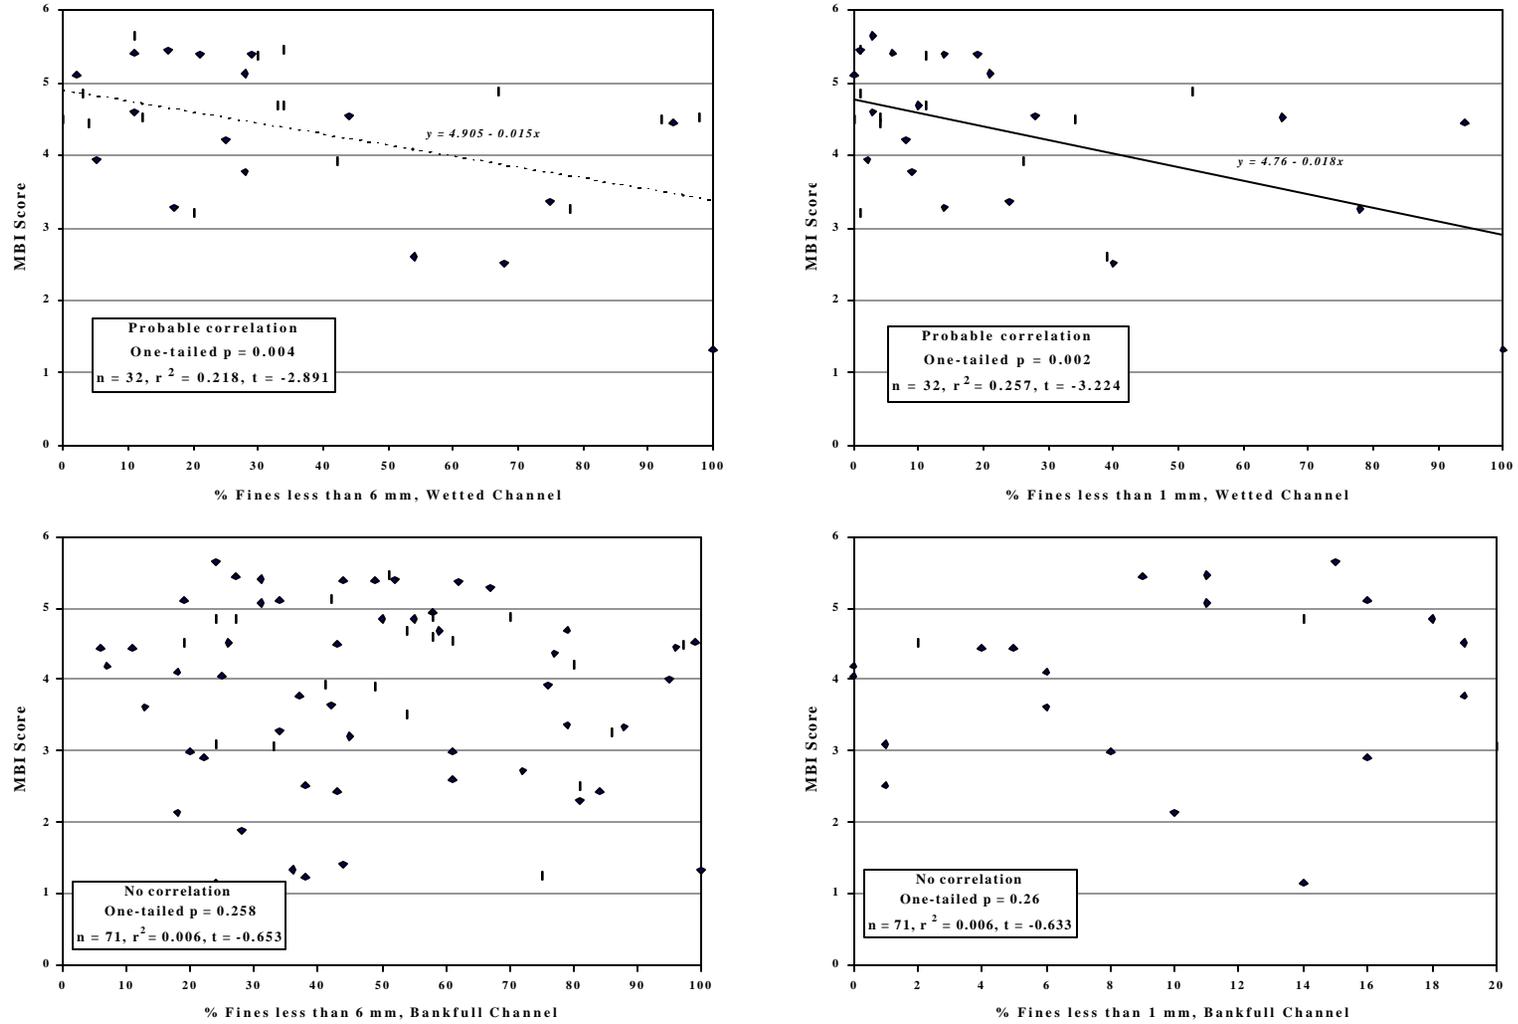
Figure 15. Macroinvertebrate biotic index (MBI) scores plotted against the percentages of fine substrate sediment less than 6 mm or 1 mm in size, as measured in wetted and bankfull channels. The MBI scores are negatively correlated with percentages of fine sediment measured in wetted channels, but are not correlated with percentages of fine sediment measured in bankfull channels.

These analyses indicated that the percentage of fine sediment measured in the wetted width of the stream channel is a better predictor of desirable macroinvertebrate communities in the Teton Subbasin than the percentage of fine sediment measured in the bankfull width of the channel. Both MBI scores and percentages of EPT were negatively correlated with percentages of surface fines less than 6 mm and less than 1 mm when surface fines were measured in wetted channels, but statistically significant relationships were not observed between the same parameters when surface fines were measured in bankfull channels (Figures 15 and 16). Future measurements of surface fines in the Teton Subbasin, whether conducted as part of the BURP protocol or any other assessment procedure, should be performed in the wetted width of the stream channel.

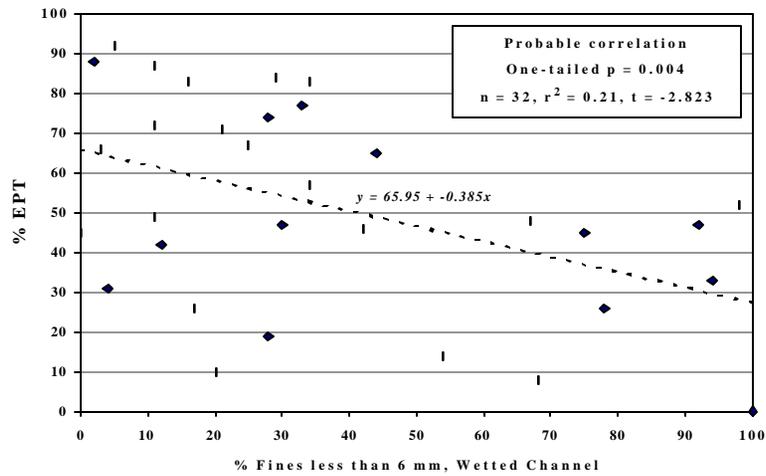
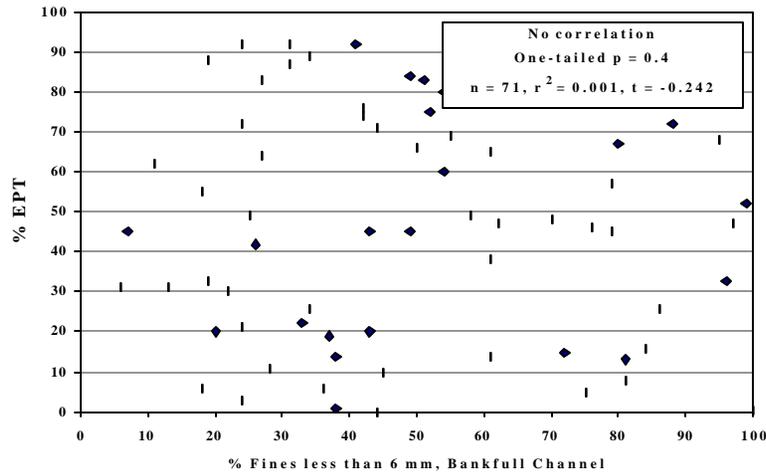
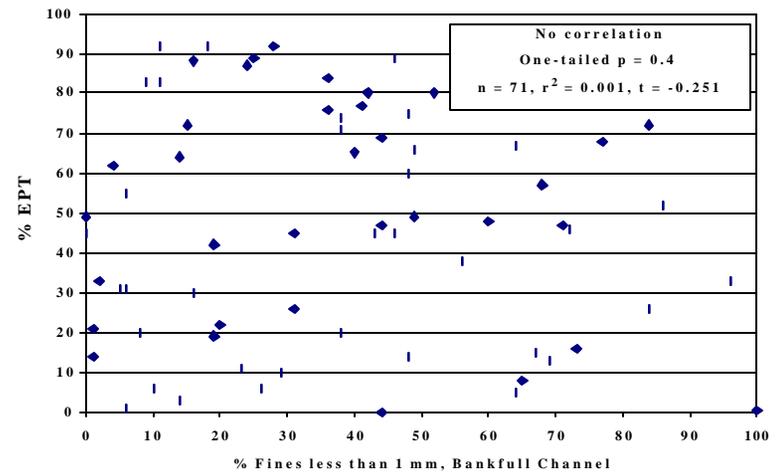
Figure 16. Percentages of insects belonging to the orders Ephemeroptera, Plecoptera, and Trichoptera (EPT) plotted against the percentages of fine substrate sediment less than 6 mm or 1 mm in size, as measured in wetted and bankfull channels. The percentages of EPT are negatively correlated with percentages of fine sediment measured in wetted channels, but are not correlated with percentages of fine sediment measured in bankfull channels.

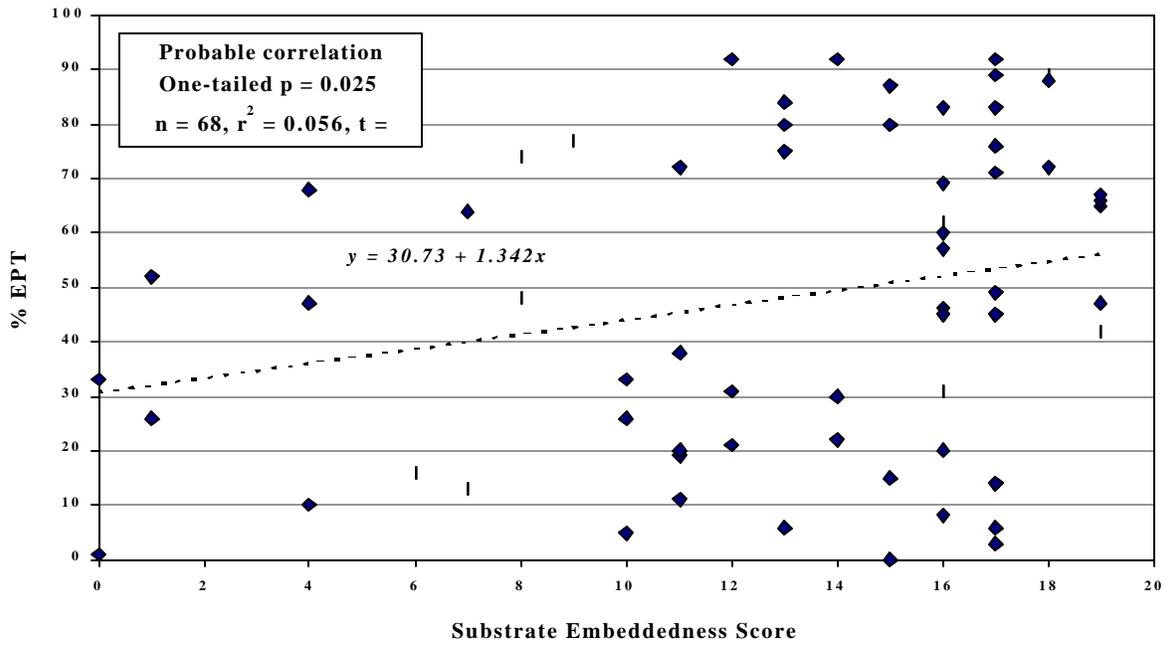
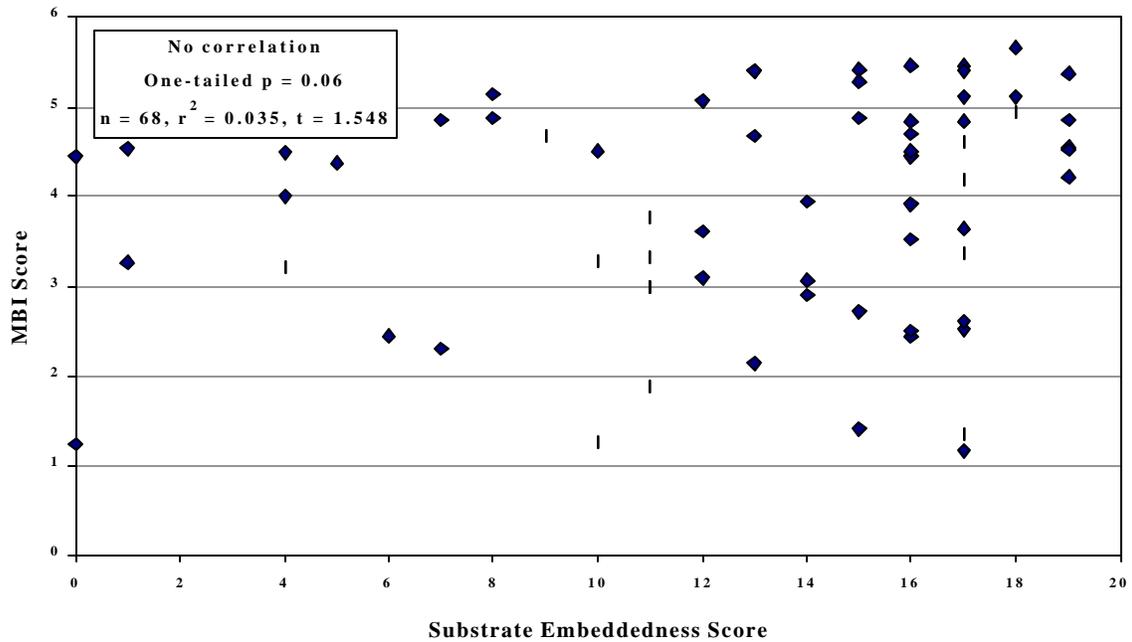
Figure 17. The relationships between percentages of insects belonging to the orders Ephemeroptera, Plecoptera, and Trichoptera (EPT) and embeddedness, and macroinvertebrate biotic index (MBI) scores and embeddedness. Embeddedness is scored qualitatively with 0 indicating the most-embedded substrate and 20 indicating the least-embedded substrate.

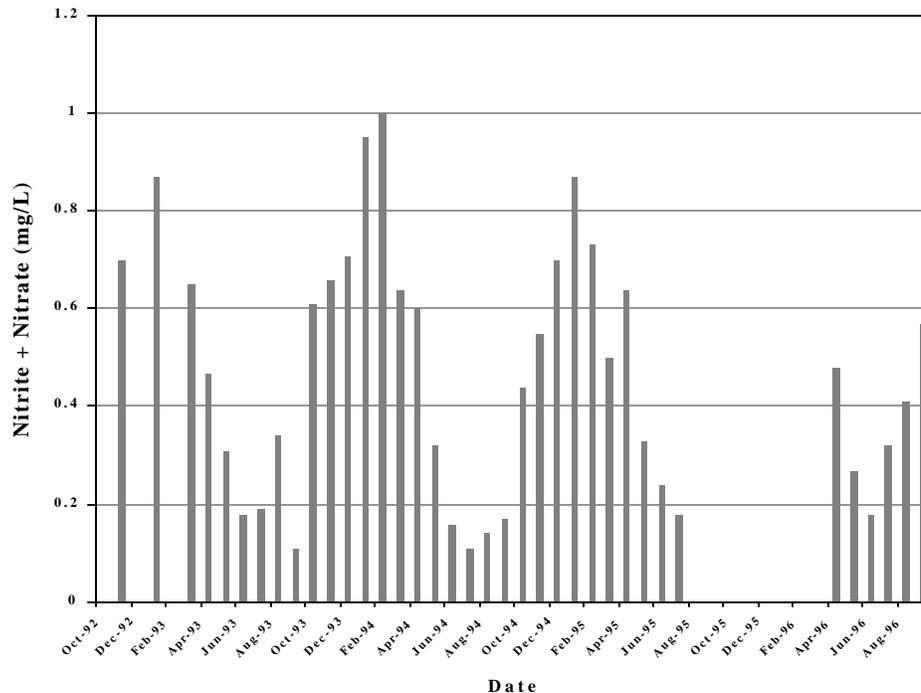
Figure 19. Concentrations of NO₂ + NO₃ in samples of water collected from December 1992 through September 1996 by the U.S. Geological Survey at the Teton River near St. Anthony gage station.

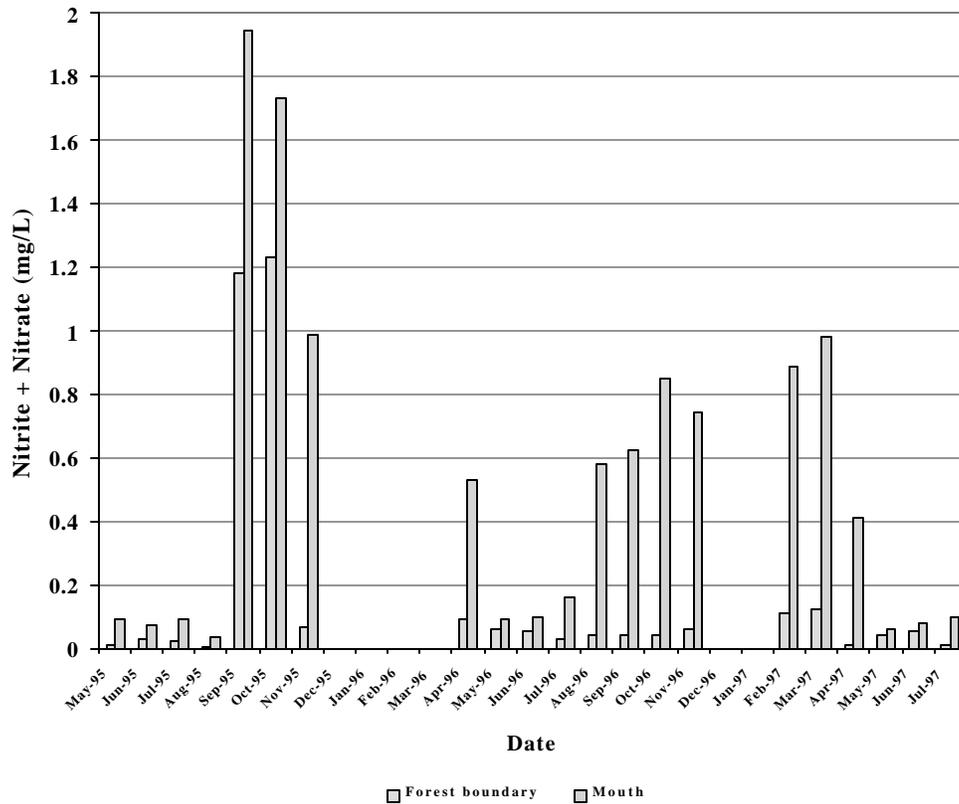
Figure 20. Concentrations of NO₂ + NO₃ in samples of water collected from Bitch Creek at the National Forest boundary and mouth from May 1995 through May 1998.

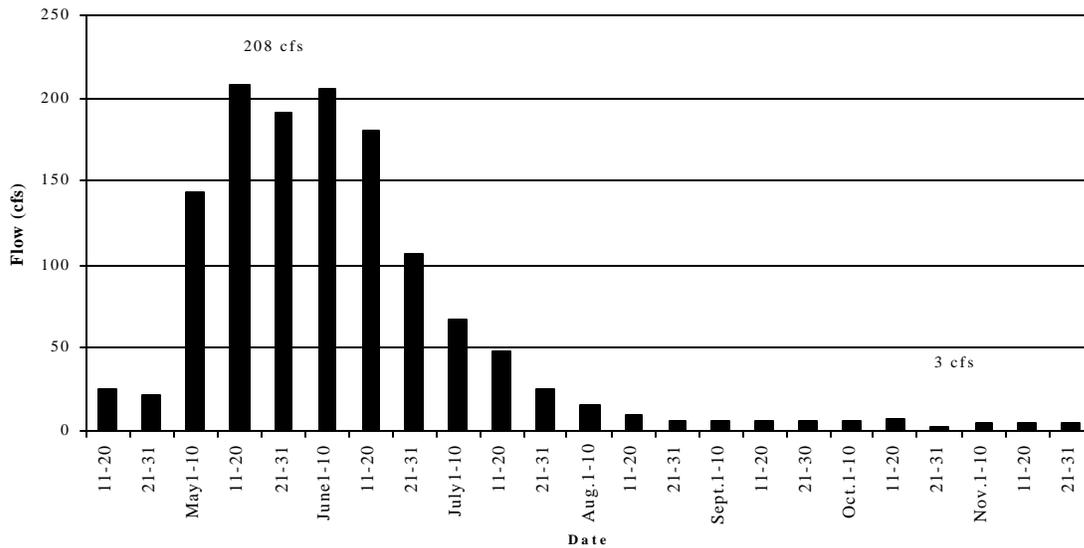
Figure 26. Eighteen-year average flows measured on Badger Creek at Rammel road.

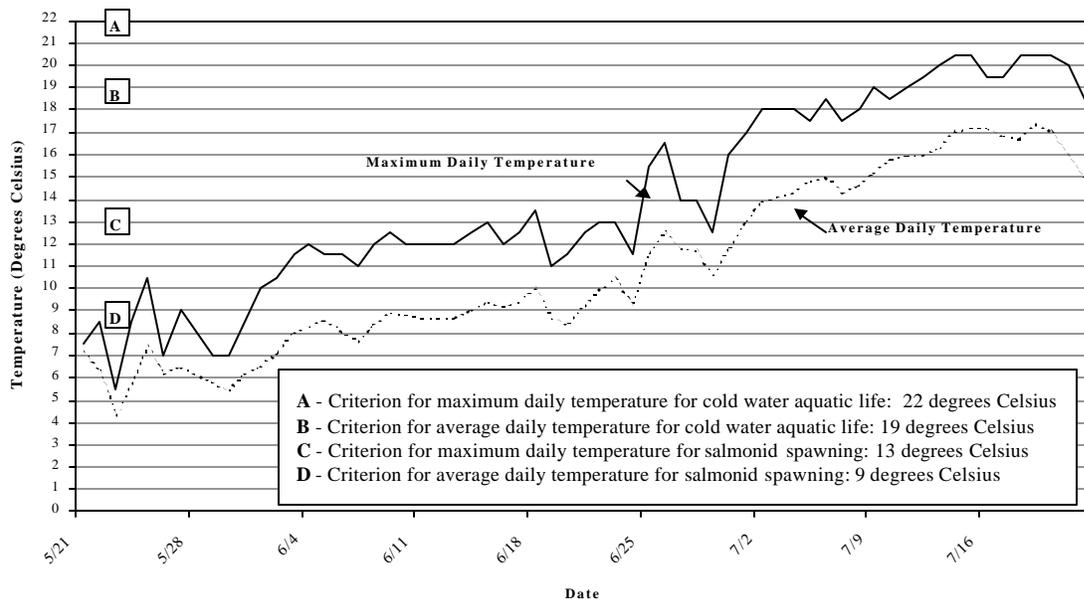
Figure 27. Water temperatures in Badger Creek from May 21 through July 22, 1996 (Schrader 2000).

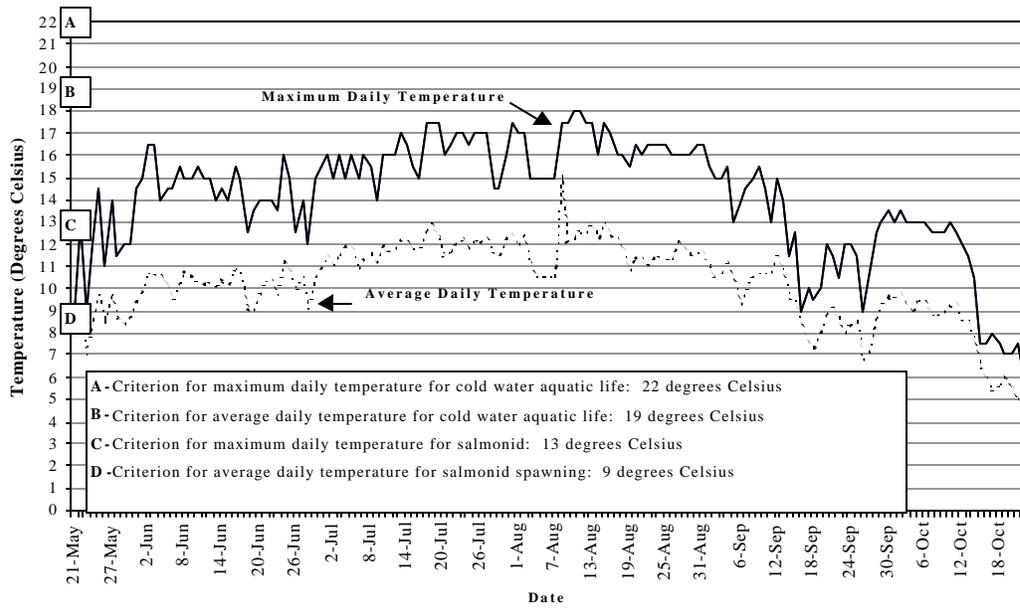
Figure 33. Fox Creek water temperatures from March 20 through October 21, 1996 (Schrader 2000).

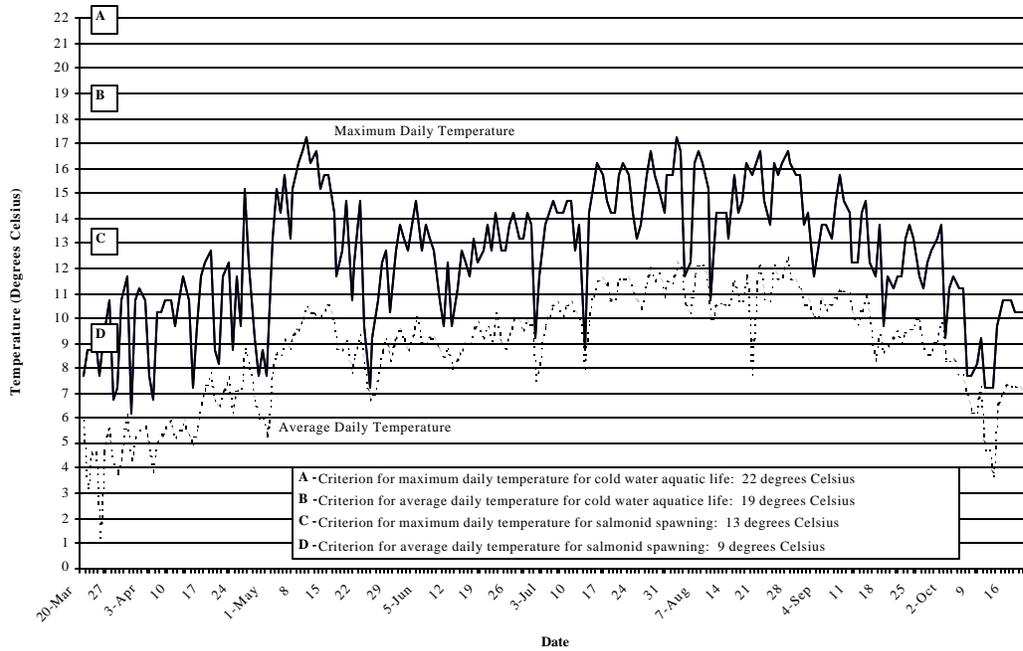
Figure 34. Fox Creek water temperatures from March 20 through October 21, 1997 (Schrader 2000).

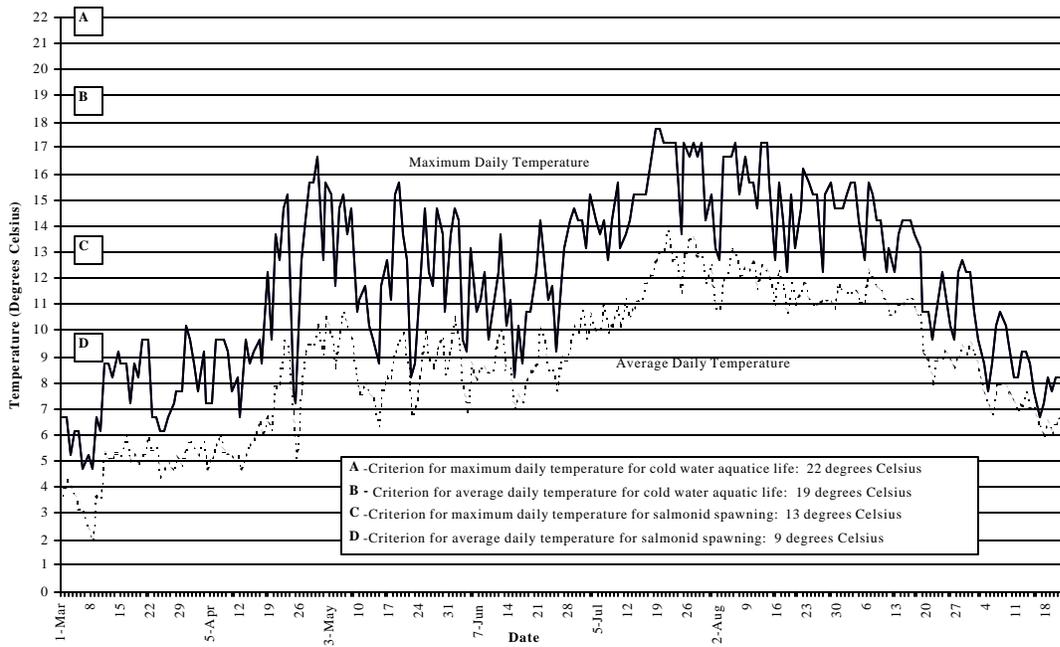
Figure 35. Fox Creek water temperatures from March 1 through October 21, 1998 (Schrader 2000)

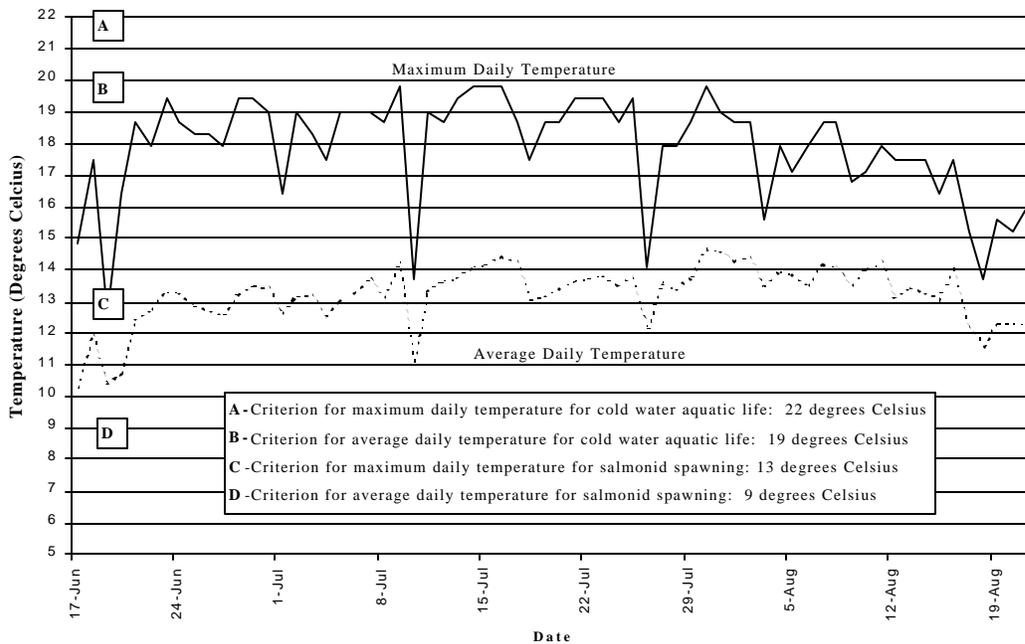
Figure 36. Fox Creek temperatures from June 18 through August 21, 2000.

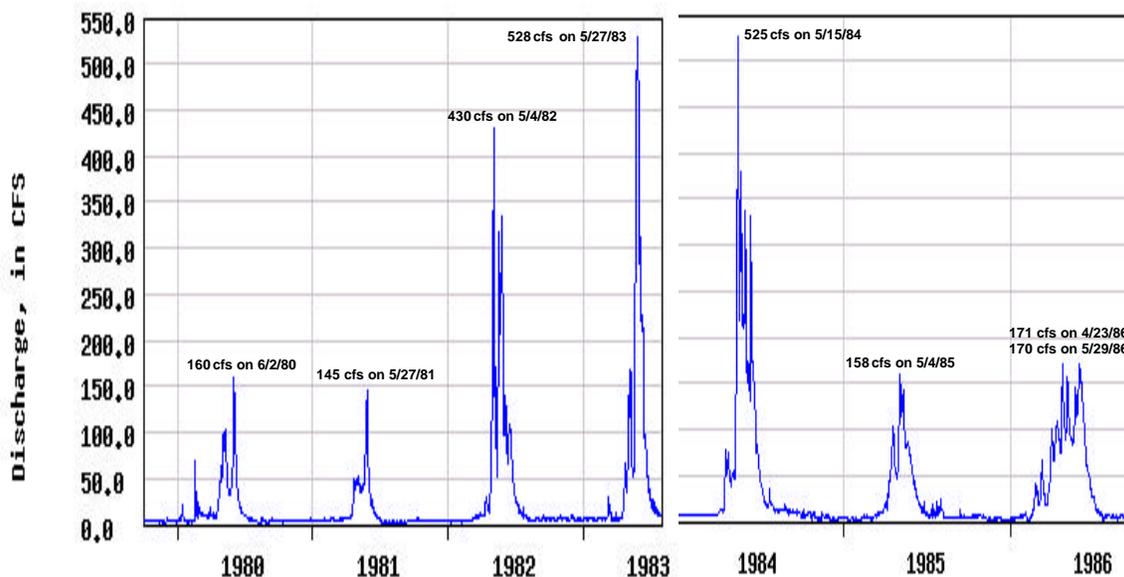
Figure 37. Daily mean discharges recorded from 10/1/79 to 7/31/83 and 1/1/83 to 9/30/86 at U.S. Geological Survey gage station 13055319, Moody Creek near Rexburg Id. Graphs were downloaded from the Idaho NWIS-W Data Retrieval page at <http://waterdata.usgs.gov/nwis-w/id>.

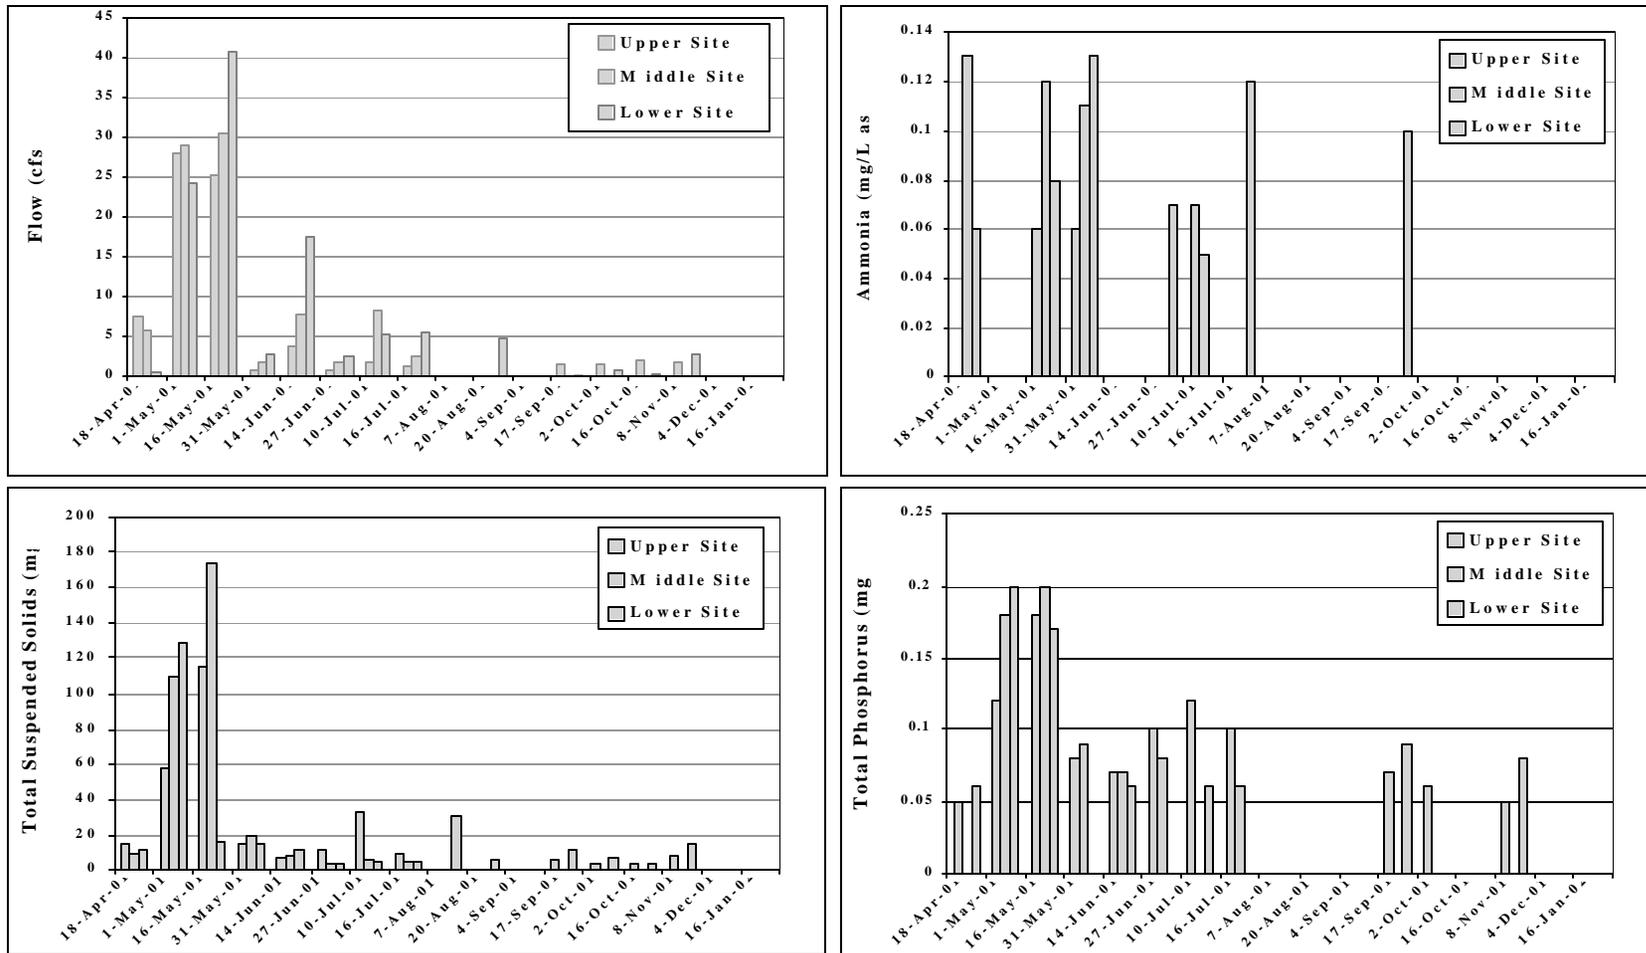
Figure 40b. Results of selected water quality analyses performed on samples collected at three locations on Moody Creek in 2001 (Fischer 2002). Samples were not collected at the middle site from 7 August through 8 November because the stream had been dammed by beavers.

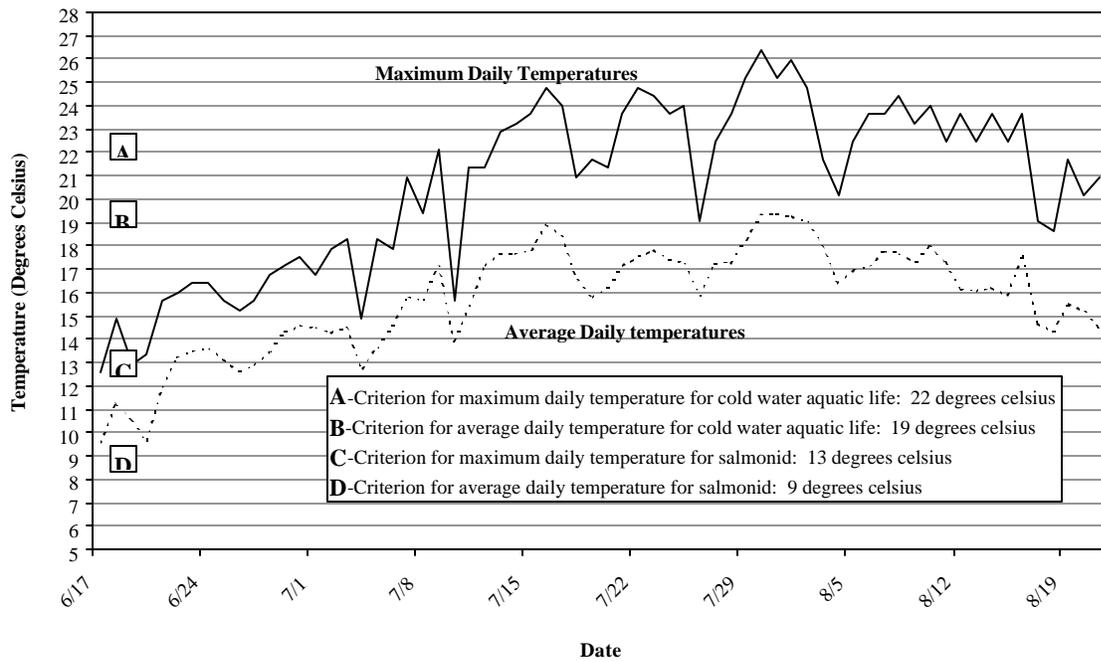
Figure 50. Water temperatures collected in Spring Creek from June 17 through August 21, 2000.

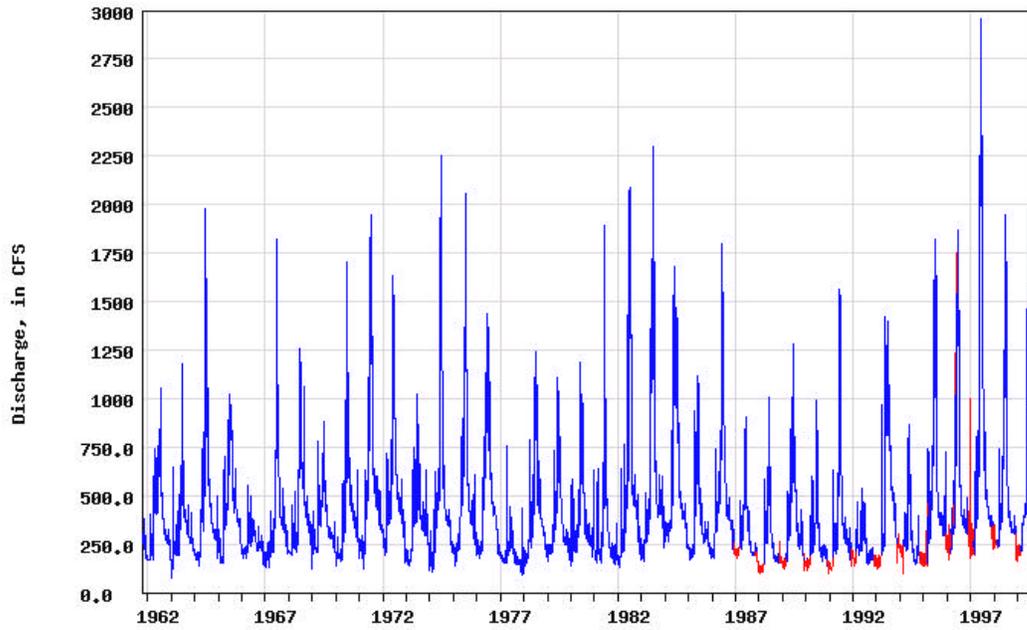
Figure 53. Discharge data recorded from 1961 through 1999 at USGS gage 13052200, Teton River above South Leigh Creek near Driggs, ID.
Source: USGS data retrieval site at <http://waterdata.usgs.gov/nwis-w/ID>

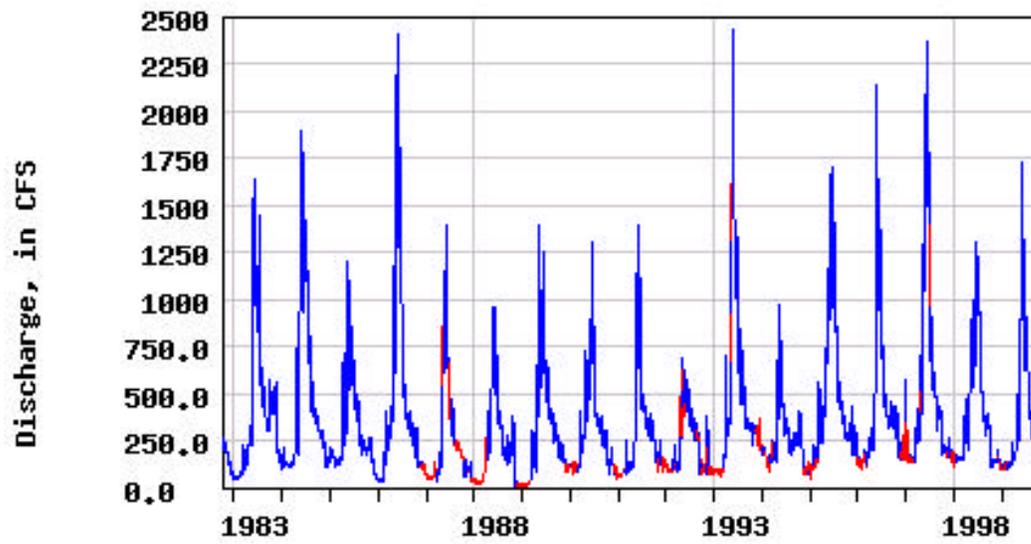
Figure 55. Discharge data recorded or estimated since 1982 at USGS gage 13055198, *North Fork Teton River at Teton, ID*. Source: USGS data retrieval site at <http://waterdata.usgs.gov/nwis-w/ID>.

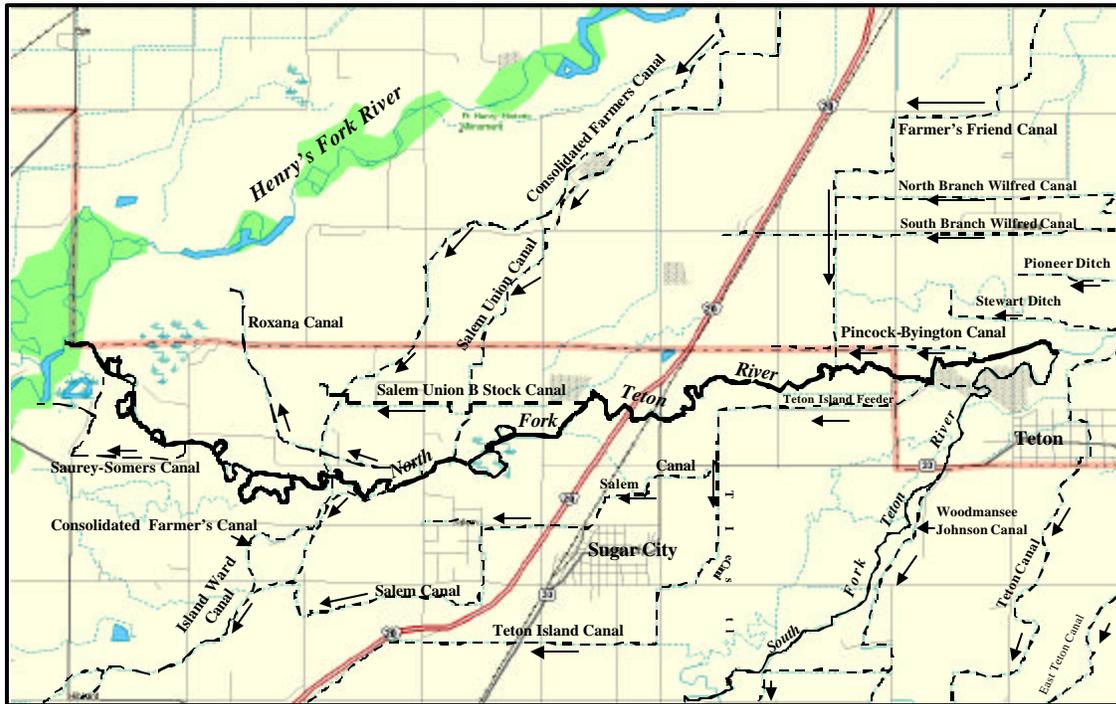
Figure 56. North Fork of the Teton River showing irrigation diversions and irrigation return flows.
