Pahsimeroi River Subbasin Assessment and Total Maximum Daily Load

August 2001

Mark L. Shumar and Dinah Reaney
State Office of Technical Services
Thomas Herron
Idaho Falls Regional Office
Idaho Department of Environmental Quality
Boise, ID 83706

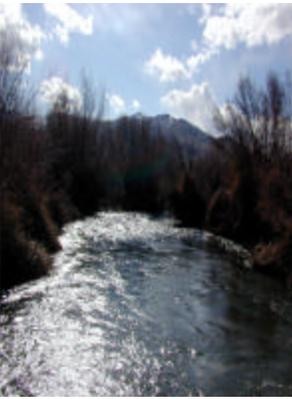
Looking Downstream from Hatchery Pond Diversion

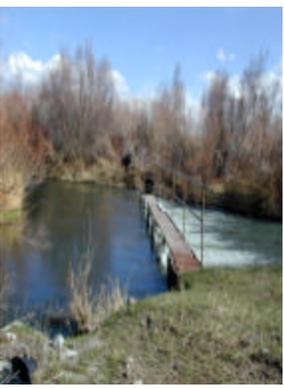
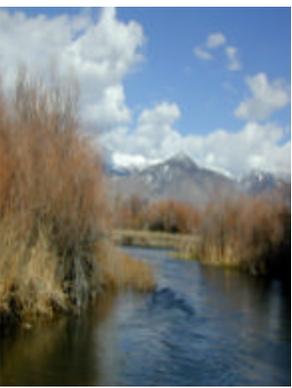
Looking Upstream from Hatchery Pond Diversion

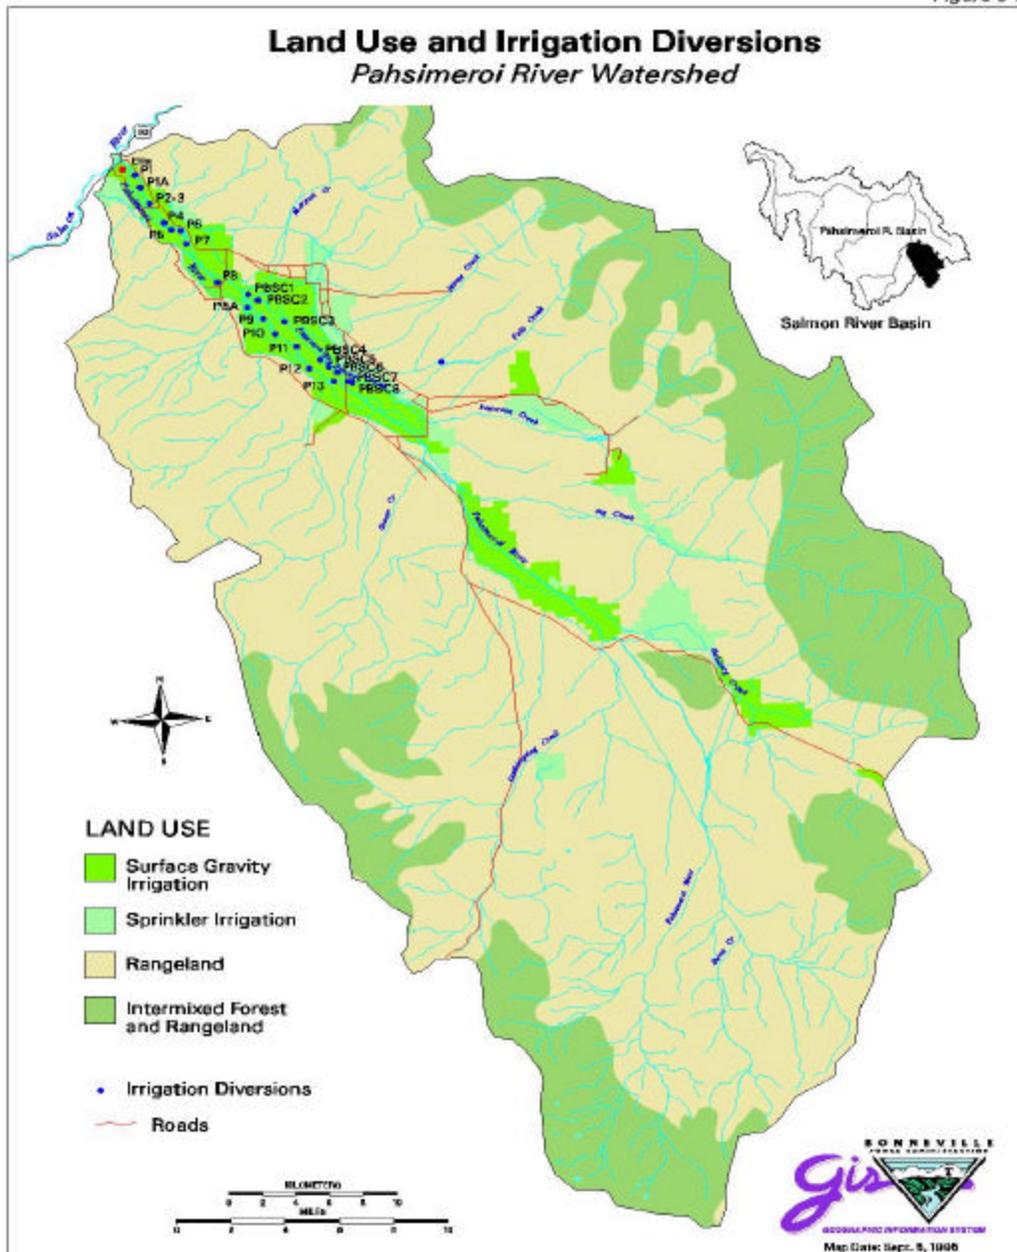
Figure 5-2

Appendix G
Bonneville Power Administration
Land Use and Irrigation Diversions Map for the Pahsimeroi Subbasin
