2010 Performance and Progress Report

**State of Idaho
Nonpoint Source Management Program
2010**

February 2011

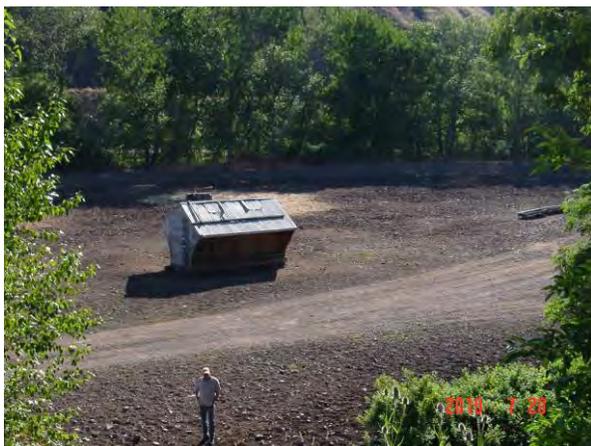
Figure 5. One of several AFO relocation subprojects for this 2001 subgrant. Lapwai Creek is just beyond the fence, a berm, and trees in the background.

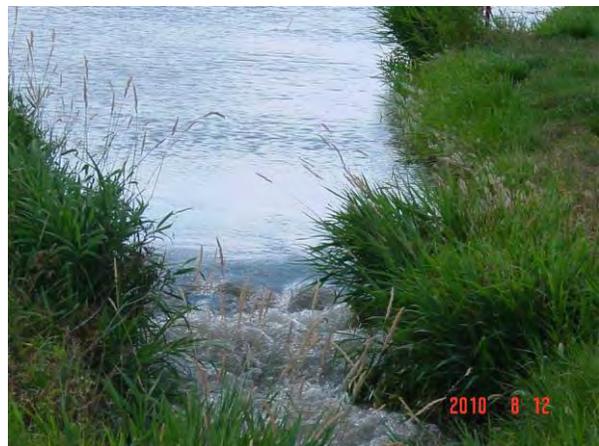
Figure 10. Outflow from the constructed wetlands and settling ponds is being discharged to the Snake River.

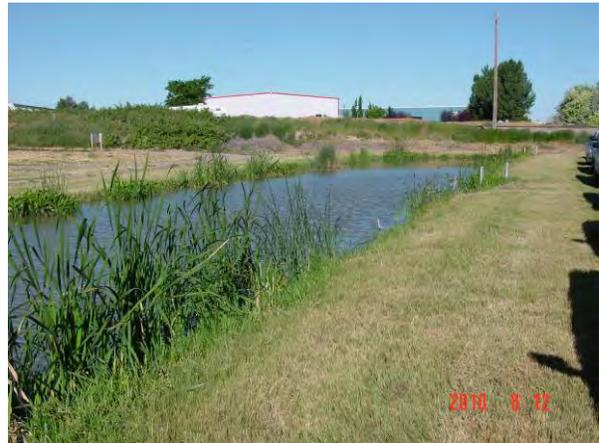
Figure 14. After approximately 90% of the pollutants settle, treated irrigation water is discharged from each of the 14 settling ponds.

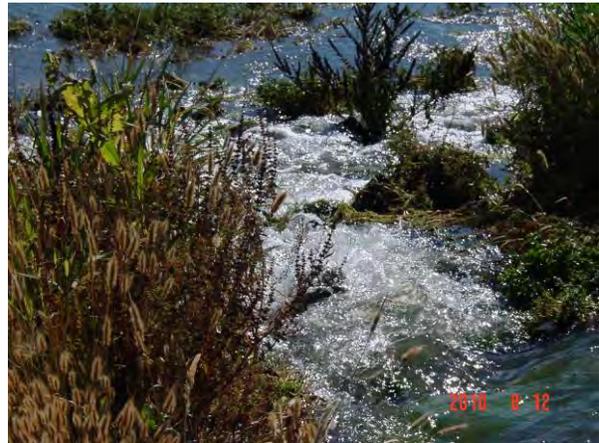
Figure 18. Prior to the installation of the settling pond, irrigation return flow discharged directly into Rock Creek and ultimately, into the Snake River.

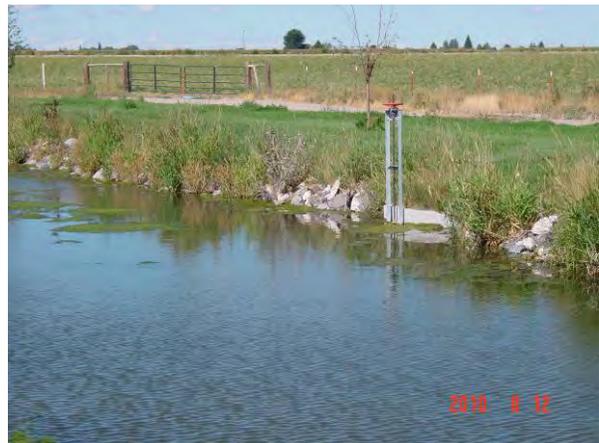
Figure 20. When needed, water from the settling pond can be reused to irrigate an adjacent farm field. The fencing in the background keeps cattle away from the treatment pond.

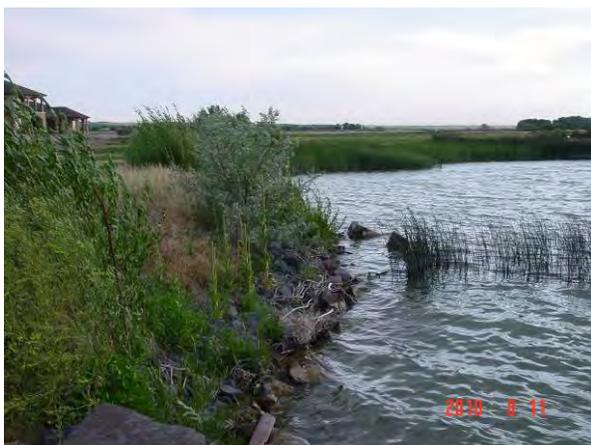
Figure 21. Shoreline along Milner Lake was eroding at the rate of tens of feet per year prior to this project. Rip-rap and vegetation have eliminated the problem.

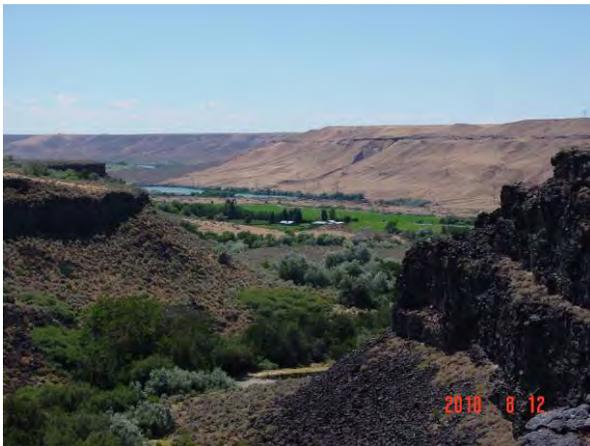
Figure 25. Most of the bottomland is now irrigated from the 99-acre settling pond, which treats irrigation return flow prior to releasing it.

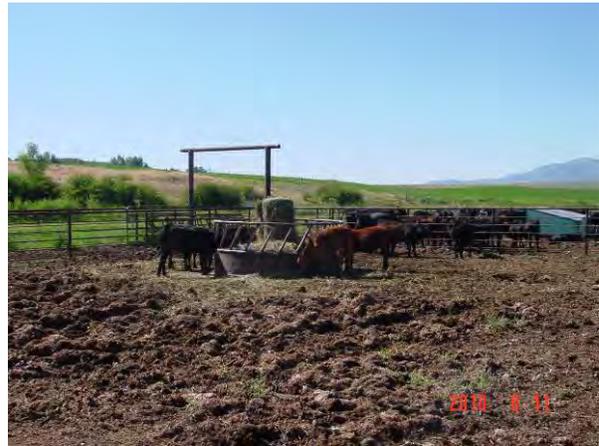
Figure 30. Prior to the construction of this new corral, livestock were watered directly in Marsh Creek.

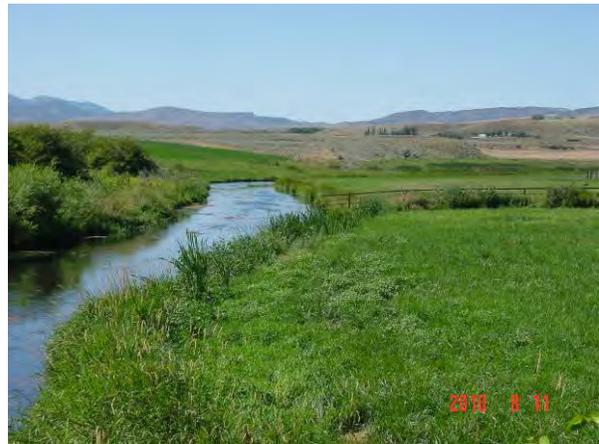
Figure 32. For many years, the corral was located at this site along Marsh Creek. The site was void of vegetation and piled high with manure. After one growing season, the abandoned corral site is a lush healthy stream bank.

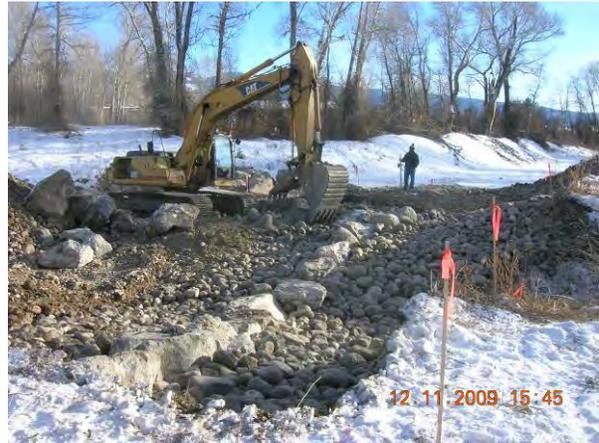
Figure 34. This trackhoe was used to place each boulder on its proper grade along the toe of the constructed bank.

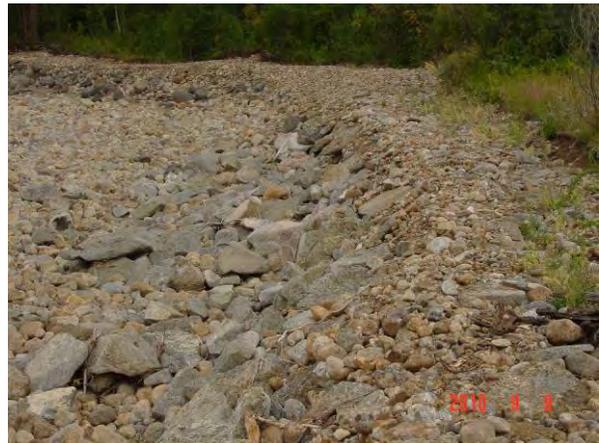
Figure 36. This V-weir was engineered and constructed last fall and after one spring runoff has already caused the streambed immediately up stream to rise by several feet.

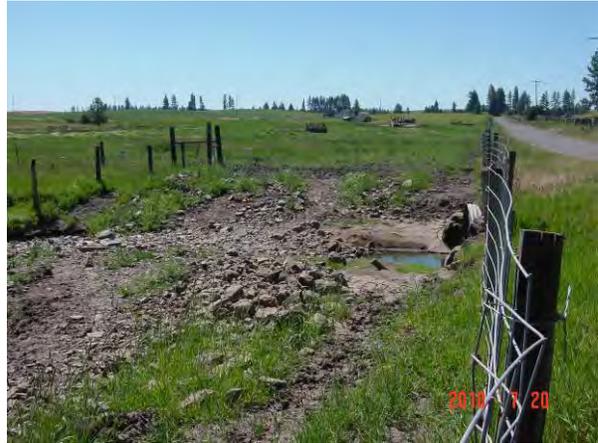
Figure 38. As part of the in-kind match work for this subgrant a rancher attempted to install a rock crossing but it did not turn out well. He will be asked to rebuild this BMP.

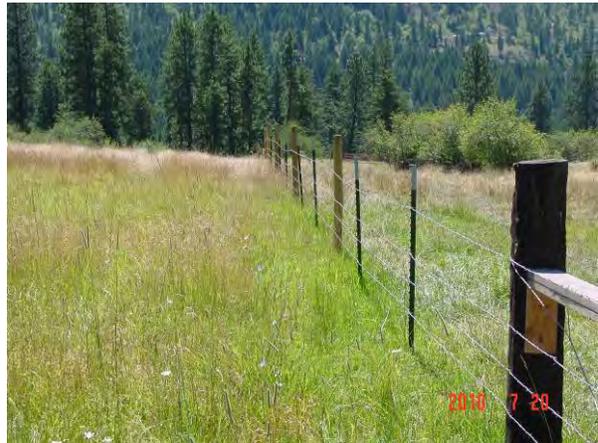
Figure 40. To date, 1,500 feet of fencing has been installed. Another 4,000 feet will soon be added to exclude cattle from surface water.

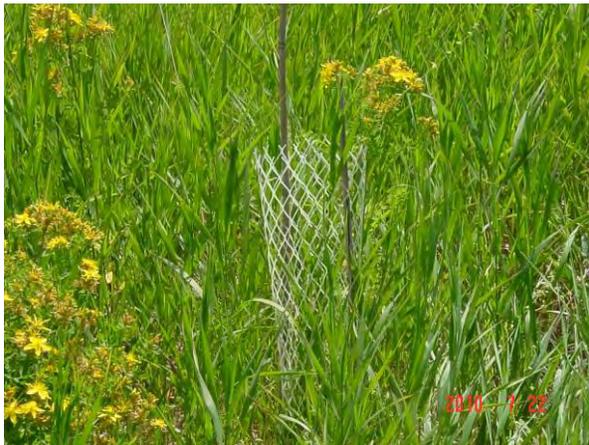
Figure 41. Plastic collars protect the hundreds of recently planted ponderosa pines from browsing deer and elk.

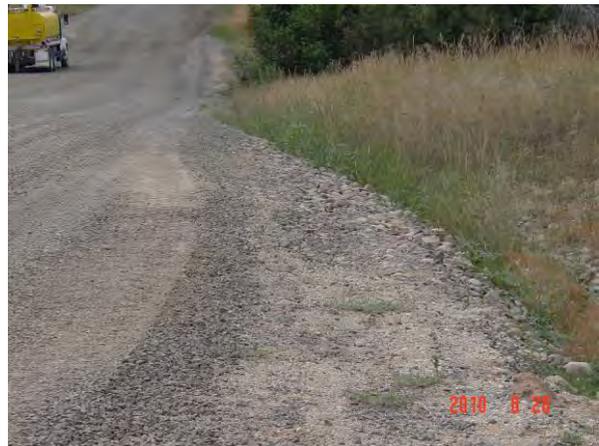
Figure 46. The roadbed was treated with calcium chloride to bind the very fine-grained material, resulting in a stable road with almost no sediment runoff.

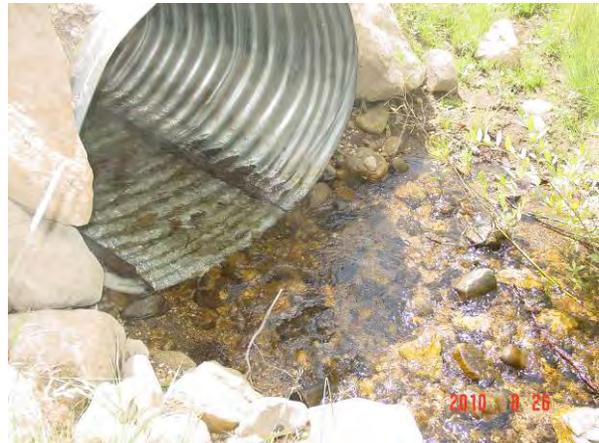
Figure 48. Prior to this roadwork, the old culvert at French Creek prevented fish from migrating up-stream. Now, fish have easy access.

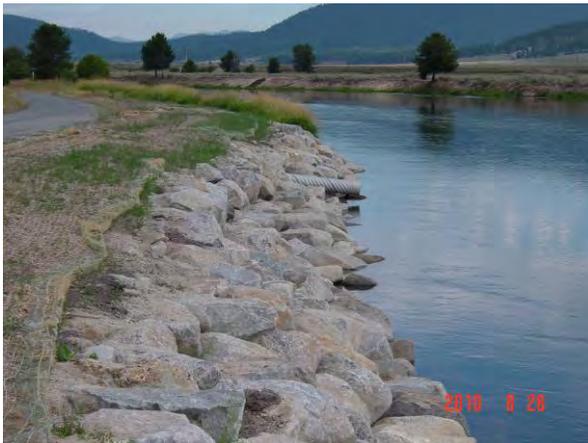
Figure 49. Rock left over from the kayak park up stream was used to reinforce a limited section of the stream.

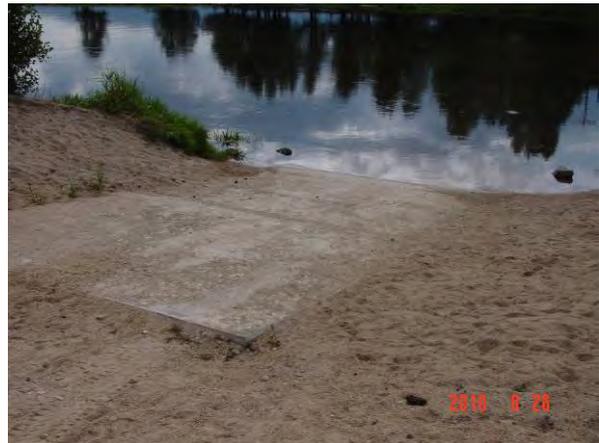
Figure 50. This boat ram installed for rafters prevents heavy foot and vehicle traffic from destroying the stream bank.

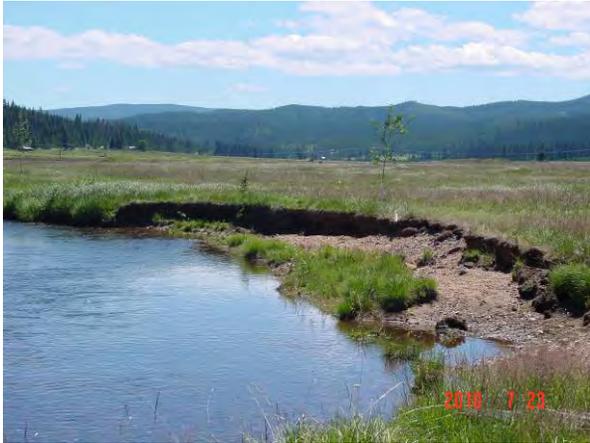
Figure 53. Uncontrolled grazing caused severe stream bank erosion. Stream banks will quickly stabilize themselves and allow the newly planted riparian vegetation to thrive now that cattle have been excluded.

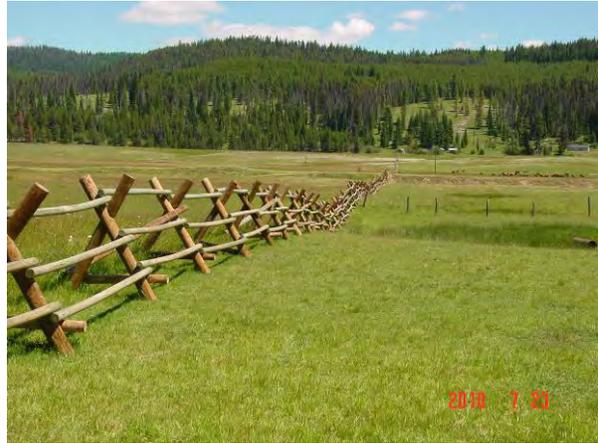
Figure 54. Cattle are being kept off the Red River by Jack pole fencing which stands up to harsh winter conditions, elk, and moose.

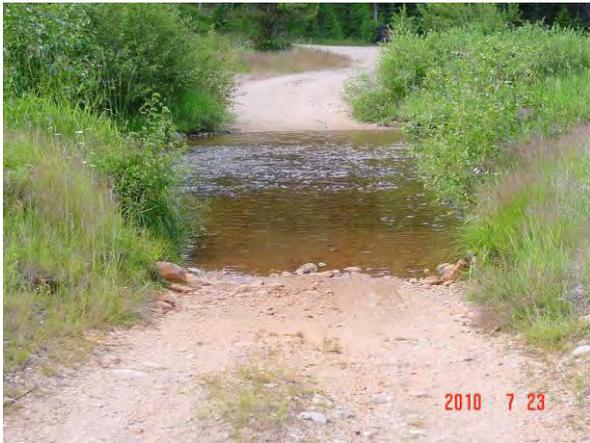
Figure 55. This heavily used crossing on Red River causes considerable sedimentation down stream.

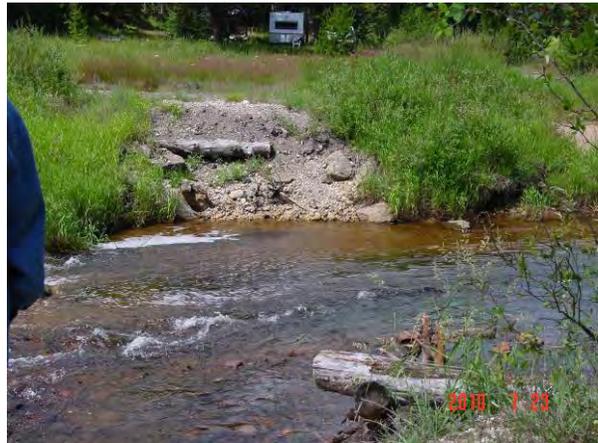
Figure 56. A bridge will be rebuilt at this location on Red River.

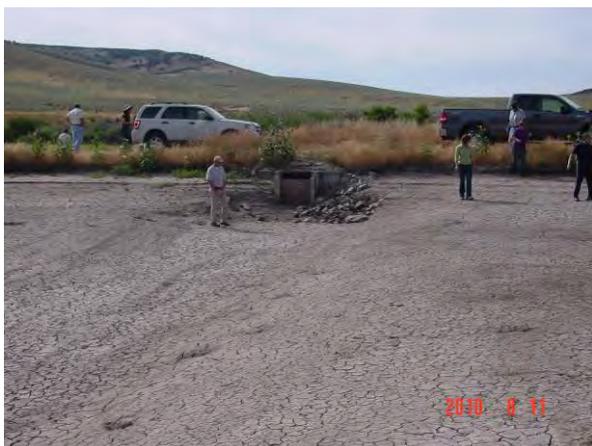
Figure 59. The second constructed wetland is flooded during nesting season but must be allowed to go dry during summer months, when the water is needed for irrigation downstream.

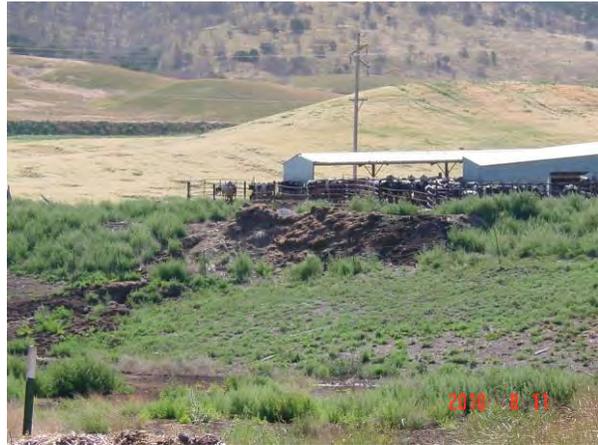
Figure 62. Stormwater and spring runoff are now conveyed beneath this manure storage area and feed lot via a subsurface pipe. Surface runoff was funneled right through this area prior to this project.

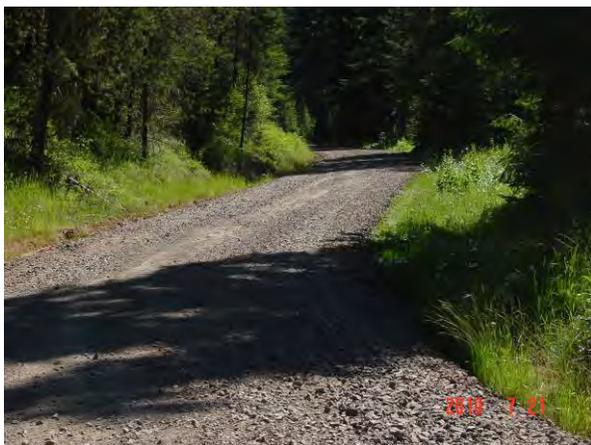
Figure 73. Road rocking is perhaps one of the least glamorous yet most effective BMPs. This 1.7-mile project will prevent tons of sediment from entering the Potlatch river.

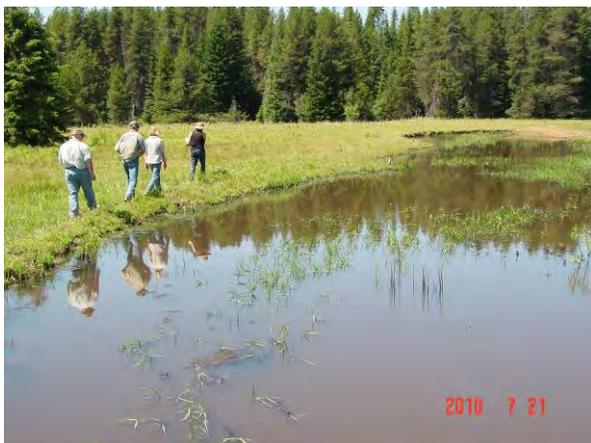
Figure 75. Wetlands will replace this portion of the new channel. The original channel, which is in the trees in the distance, will be reopened.

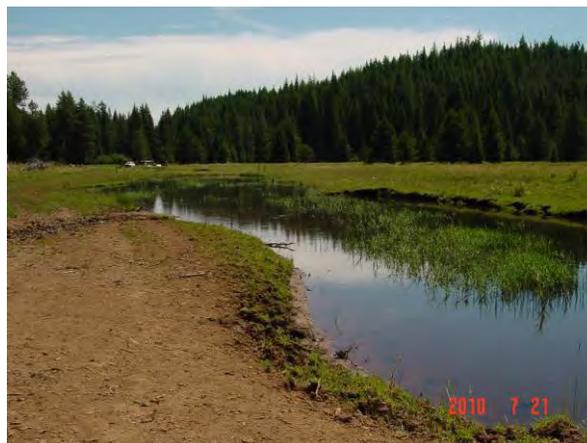
Figure 76. Free-roaming cattle have caused water pollution and made this portion of the new channel unstable.

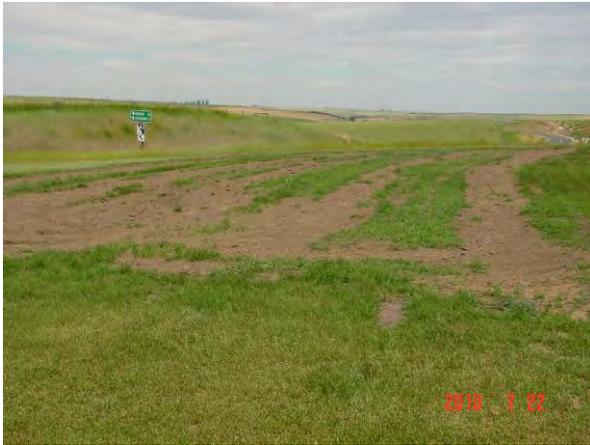
Figure 77. A new septic system was installed to replace an old leaky system that was polluting groundwater.

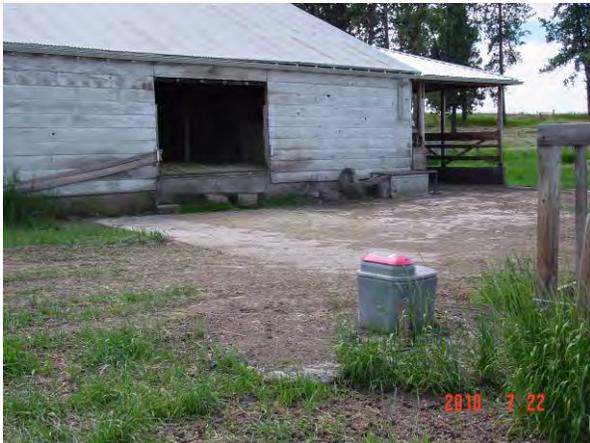
Figure 79. The concrete pad and frost-free ball-watering trough were installed to replace a corral situated in the nearby creek.

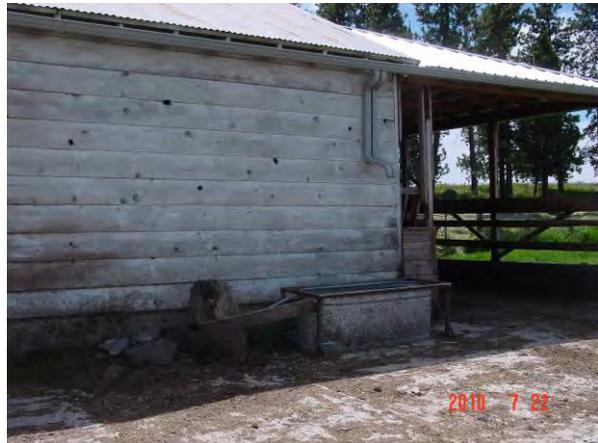
Figure 80. In addition to the concrete pad and watering trough, rain gutters were installed to collect stormwater for cattle consumption rather than allowing runoff to contact manure.

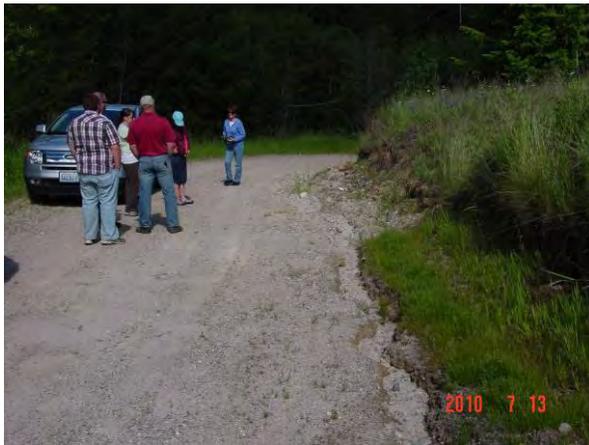
Figure 81. This last area to be worked on shows how the ditch looked prior to the work. BMPs here will include a cleaned out ditch, resloped bank, and grass.

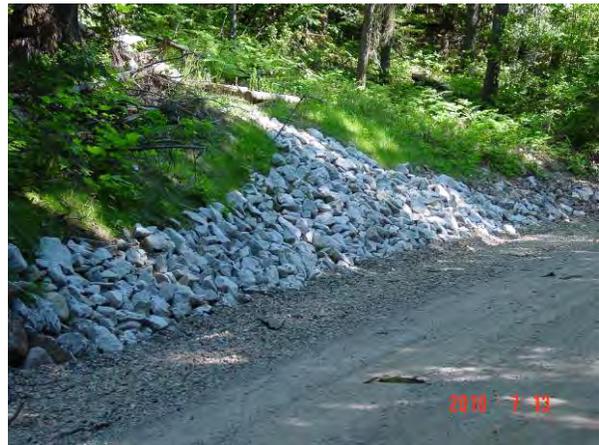
Figure 82. Some areas received heavy armor when sloping and grass alone would not work.

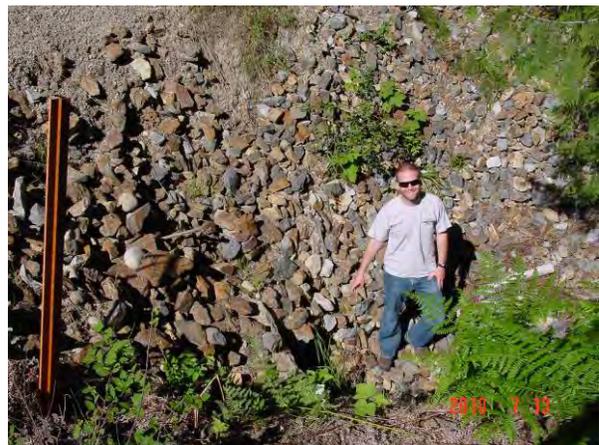
Figure 84. This culvert was installed where a major blow occurred last winter.

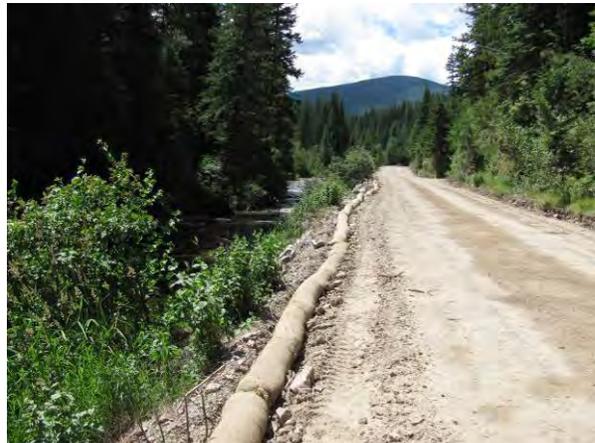
Figure 86. Stormwater BMPs minimize sediment runoff to the creek. A good road base, properly sloped road surface and next season's vegetative growth will minimize pollution to the creek.

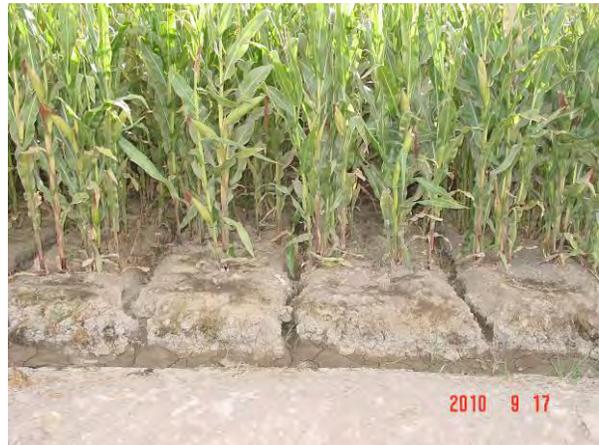
Figure 96. Even with drip irrigation, tons of valuable topsoil erodes from this field each growing season as a result of irrigation and storm events. This erosion is why settling ponds are necessary.

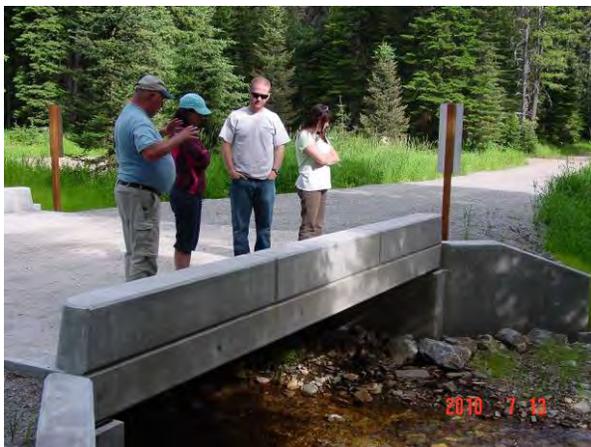
Figure 97. This new bridge replaces an undersized culvert that prevented fish from migrating upstream on Short Creek.

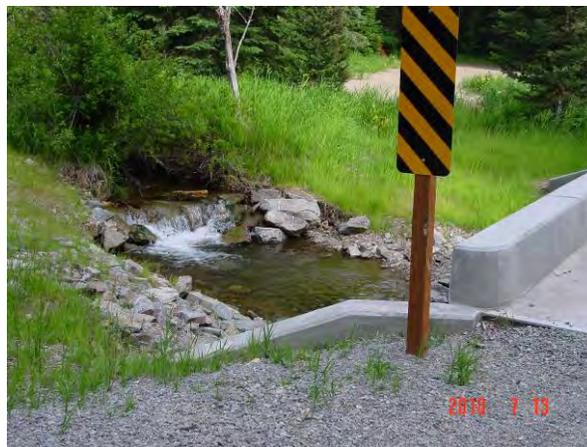
Figure 98. A new drop structure above the new bridge allows fish passage.

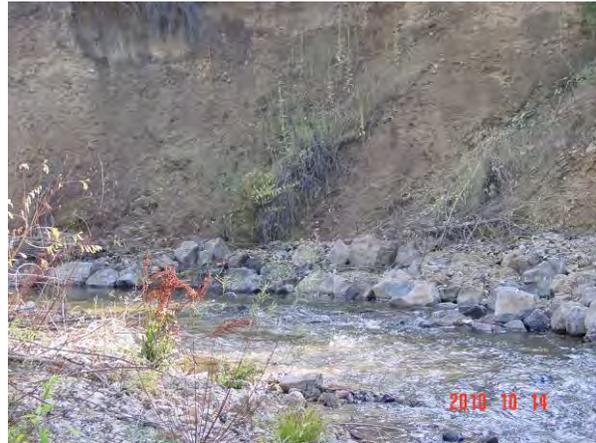
Figure 102. Carefully placed toe armor now stabilizes a 30-foot head cut that was badly eroding during each high water event.

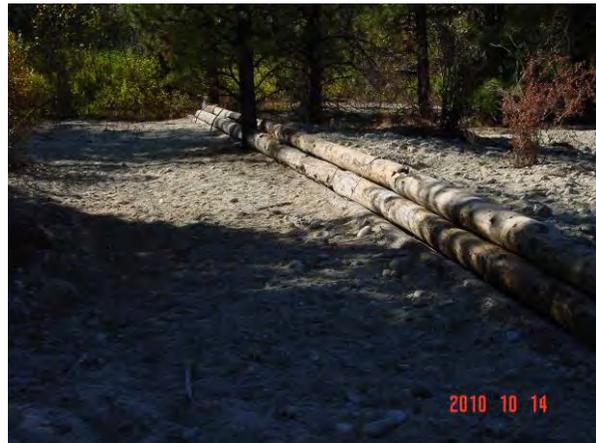
Figure 104. This 100-foot long log wall diverts sediment-laden flood water from Noble Gulch to a wetland treatment area, where the sediment is deposited prior to entering Mores Creek.

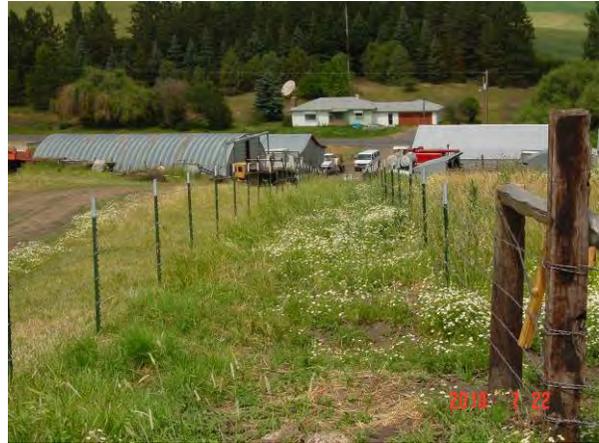
Figure 110. This site on the Burgess property is another AFO relocation. The double fence creates a corridor for cattle access to an upper pasture while preventing access to the nearby creek.

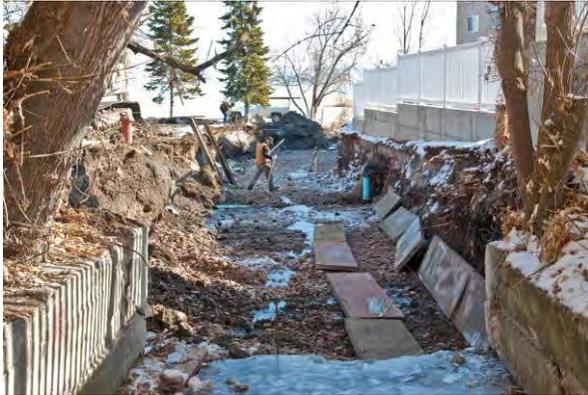
Figure 113. After the old culvert was removed, there was considerable preparatory work to be accomplished prior to construction of the new culvert.

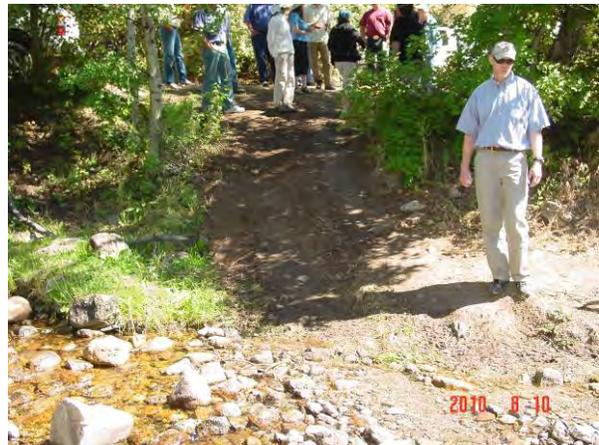
Figure 116. ATV traffic at this crossing and resulting sedimentation is quite high during the summer, which is why the bridge was necessary.

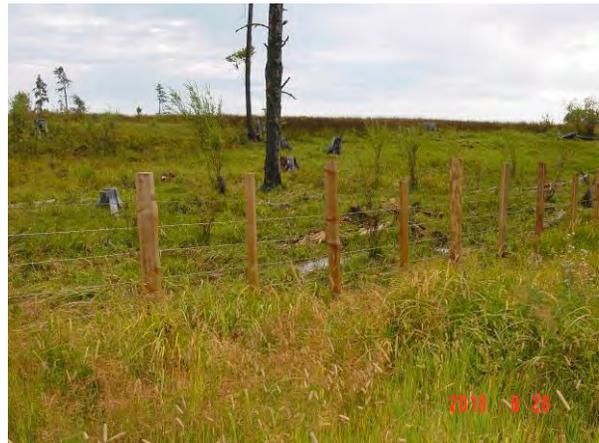
Figure 120. Fence posts have to be installed at four to five foot intervals to prevent damage from heavy snowfall.
