2009 Performance and Progress Report

State of Idaho
Nonpoint Source Management Program
2009

Idaho Department of Environmental Quality

February 2010

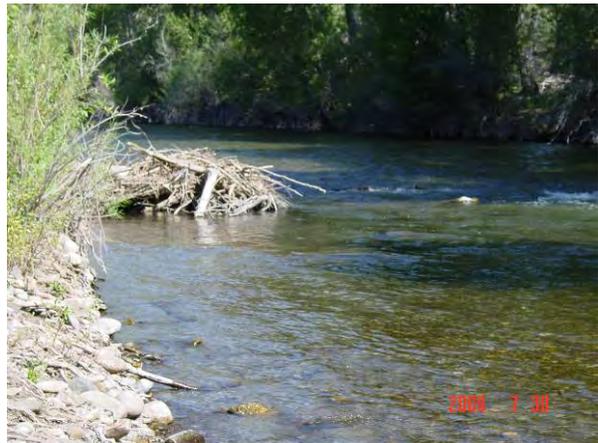
Figure 12. This drop structure is collecting debris, which is good for the fishery.

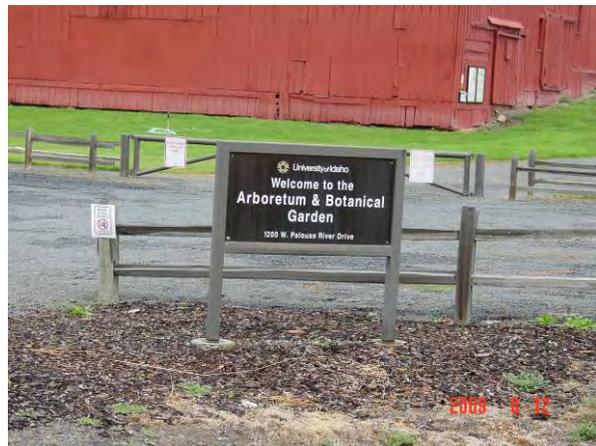
Figure 16. Storm water in this area typically contains herbicides and fertilizer from the university's arboretum.

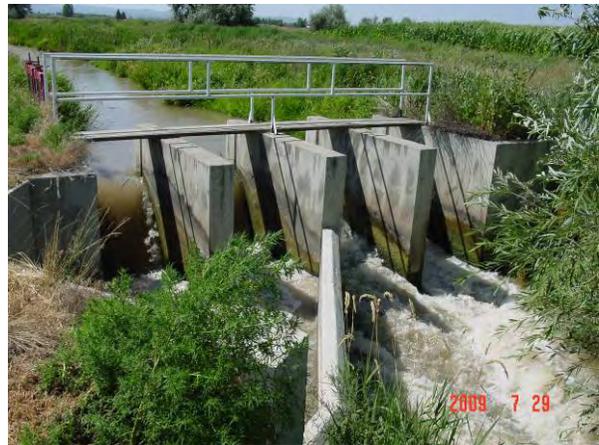
Figure 18. The intake where approximately 50 cfs of irrigation return flow is sent to the settling pond.

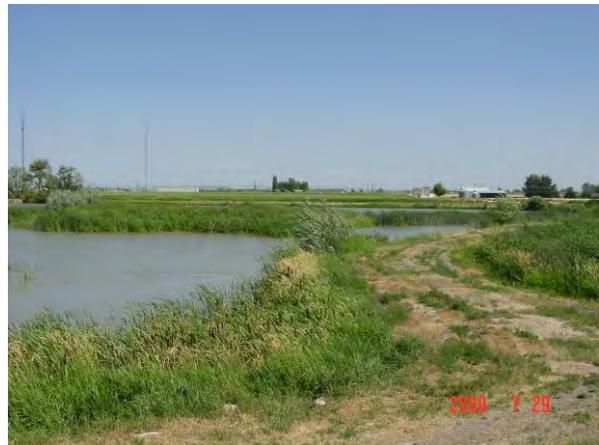
Figure 20. The wetland portion of the project is fully matured and functioning as intended to reduce nutrients from irrigation return flow prior to discharge to the Snake River.

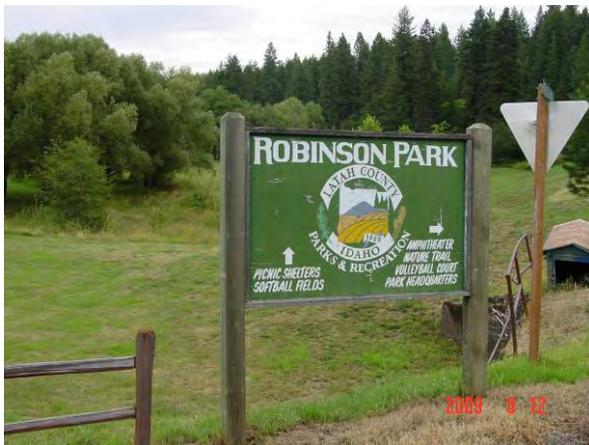
Figure 21. Robinson Park was created in a reservoir that became filled with silt over several decades. Once exposed, the silt became extremely vulnerable to erosion.

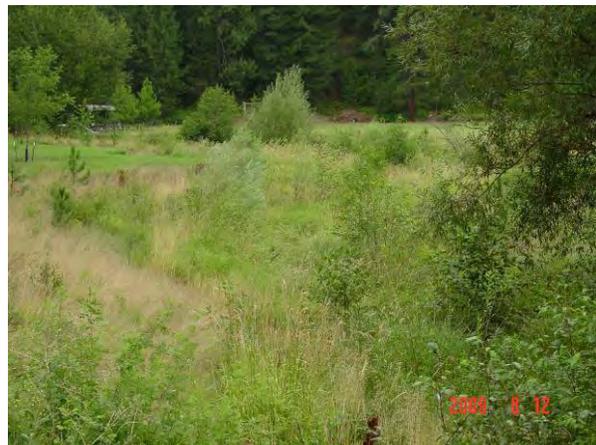
Figure 22. Vegetation planted in 2006 (seen in this photo and the next two) is doing extremely well. Prior to this project near vertical stream banks were severely eroding especially during spring runoff.

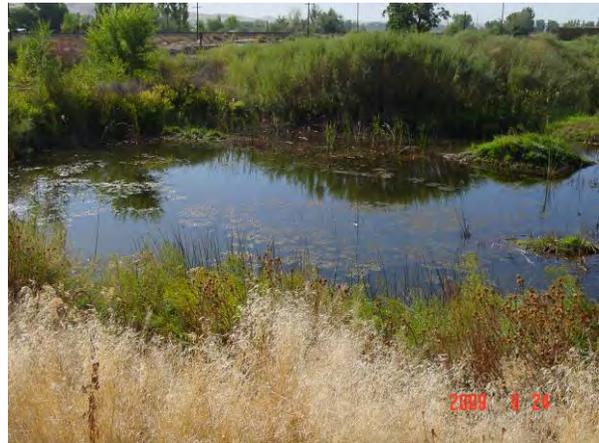
Figure 26. One of 16 settling ponds where irrigation return flow is treated prior to reuse or release to the Snake River. Previously, irrigation return flow discharged directly to the river.

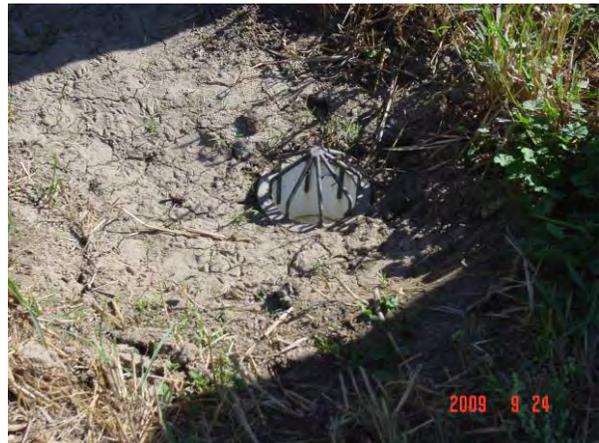
Figure 28. One method of capturing irrigation return flow is via this buried pipeline. The intake is shown at the upper-right center of the photograph.

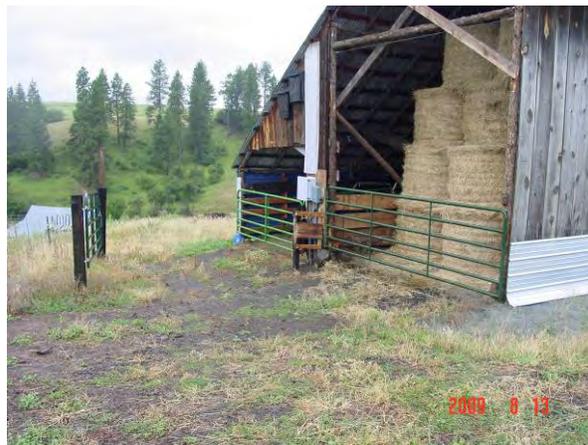
Figure 30. At site #2, watering stations were placed around this barn. Runoff is captured from the roof and infiltrated into the ground rather than into a nearby creek.

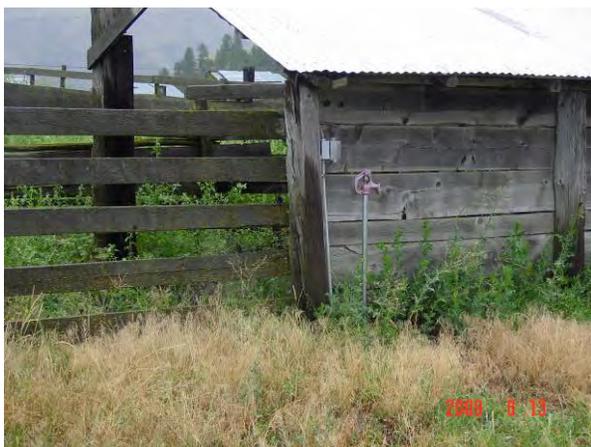
Figure 31. At site #2, water is supplied by a shallow well drilled nearby.

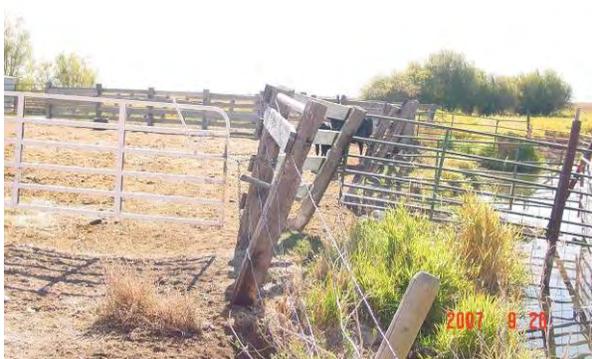
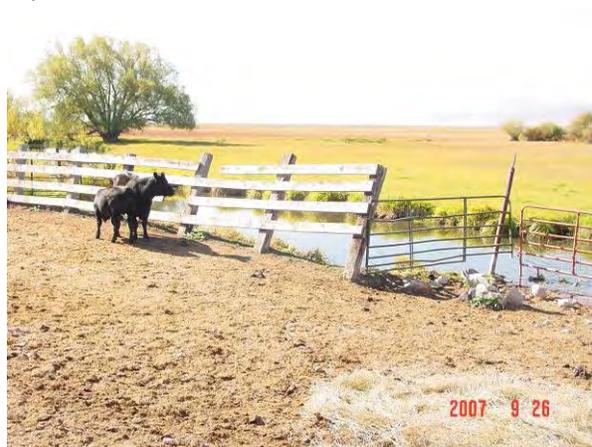
Figure 36. How this AFO looked in September 2007. After each precipitation event, and especially during each spring runoff, animal waste was flushed directly into the Bear River.

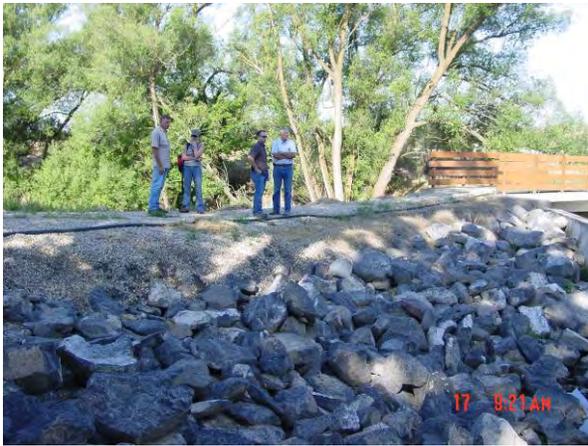
Figure 47. The diversion structure and flood control spillway. The previously built concrete structure was undermined by floodwater to the point that the entire spillway area beneath these people had to be rebuilt.

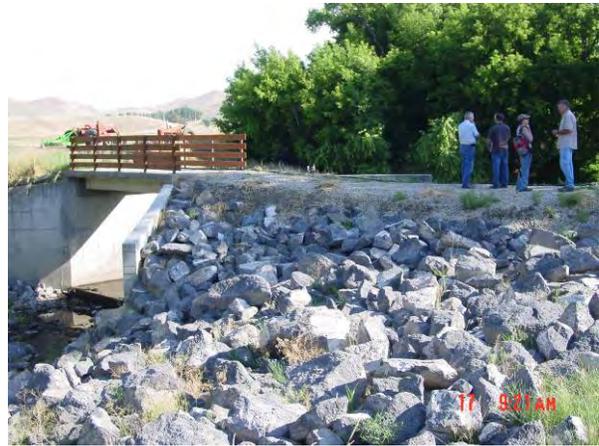
Figure 48. The spillway was engineered by an NRCS engineer and built by a contractor for the Ada Soil and Water Conservation District.

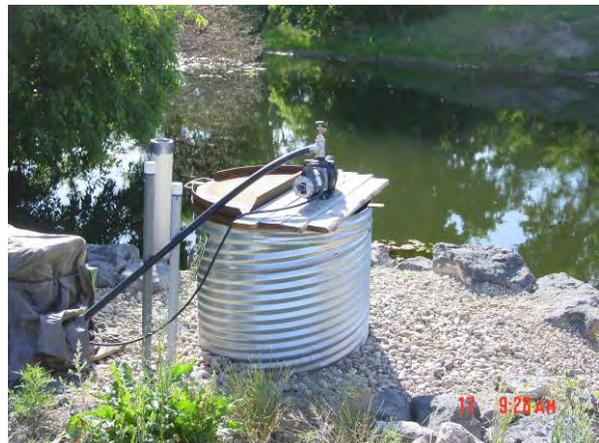
Figure 50. The sump and pump system that supplies water for sprinkler irrigation to 120 acres of farmland.

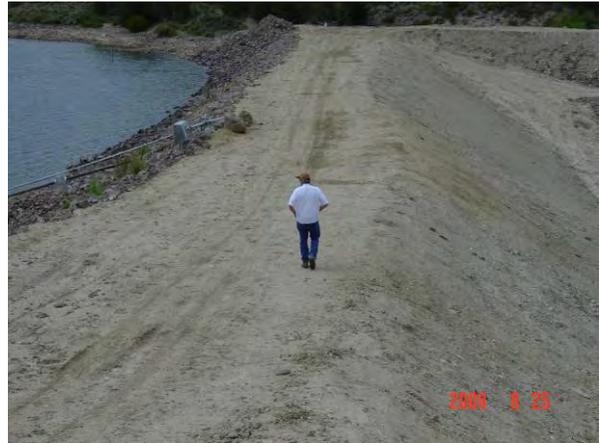
Figure 55. The newly replaced flow control system is shown top left in this photograph.

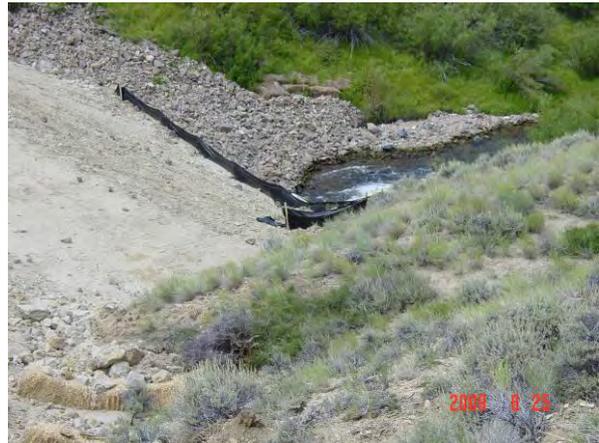
Figure 57. The water discharge area below the dam also had to be repaired.

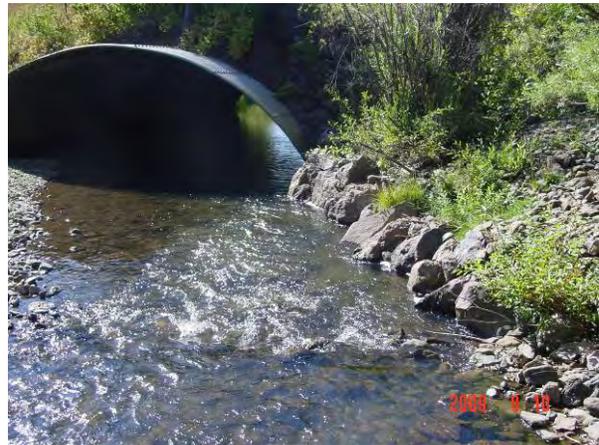
Figure 59. Rock riprap armor will prevent this road culvert from being washed out during high flows.

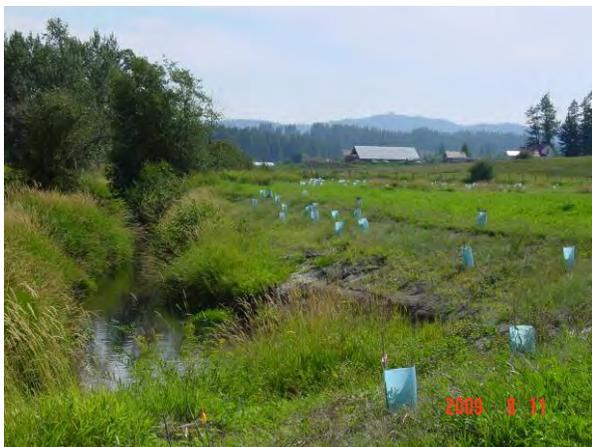
Figure 62. Several miles of Deep Creek have been damaged due to past improper grazing and farming techniques. Here approximately 1,800 feet of Deep Creek have been re-sloped from near vertical to a 3:1 angle, covered in a protective coconut fabric, and planted with riparian vegetation.

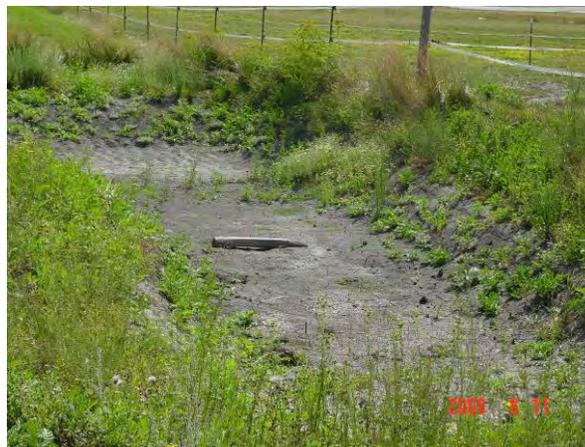
Figure 63. This settling pond was located at the bottom end of a horse pasture to treat storm and winter runoff for nutrients, bacteria, and sediment prior to discharge to Deep Creek.

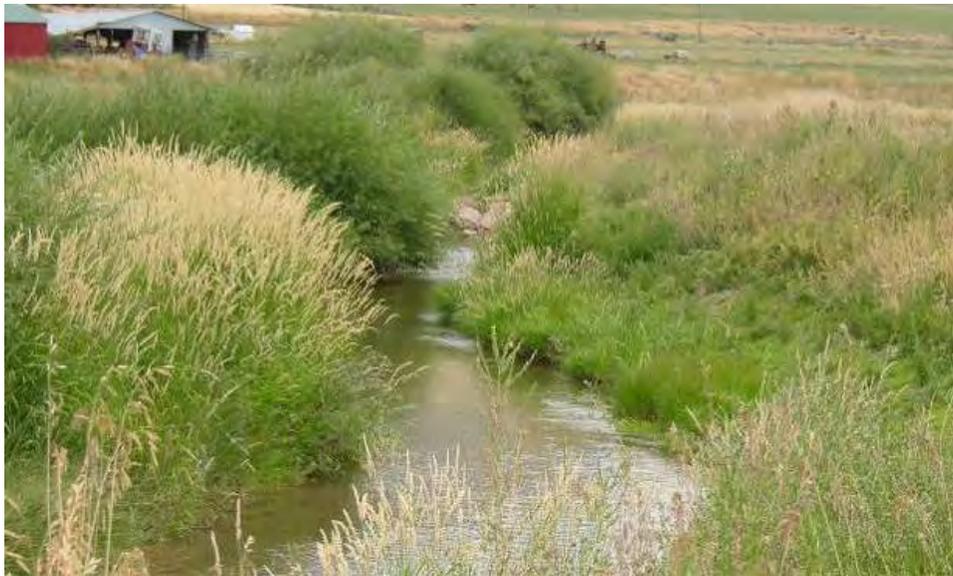
Figure 73. After two growing seasons, this stretch is typical of the 4,200 feet of re-sloped stream banks, where vertical banks were knocked down to a 3:1 slope, riprapped with native rock, and planted with native vegetation.

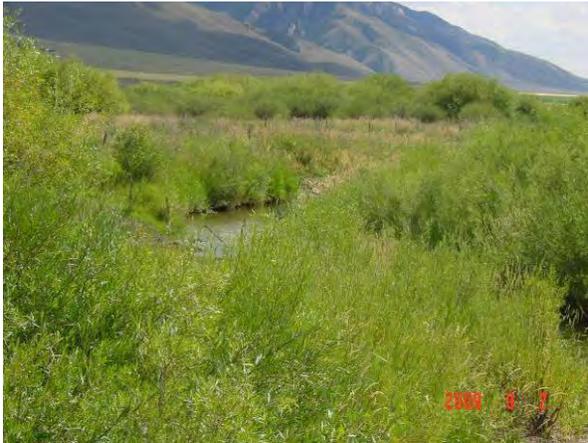
Figure 76. Visible along the far shore of the creek bank (near the center) is riprap placed along a 3,200 foot section of Thomas Fork Creek.

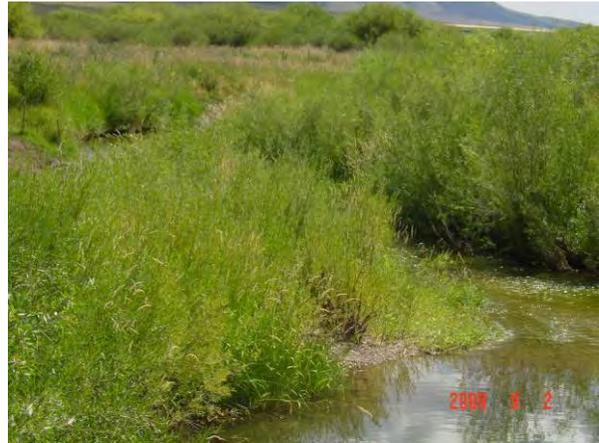
Figure 77. After two growing seasons, stream banks are stable, and vegetation has nearly covered the riprap that was placed along the re-sloped banks of the creek.

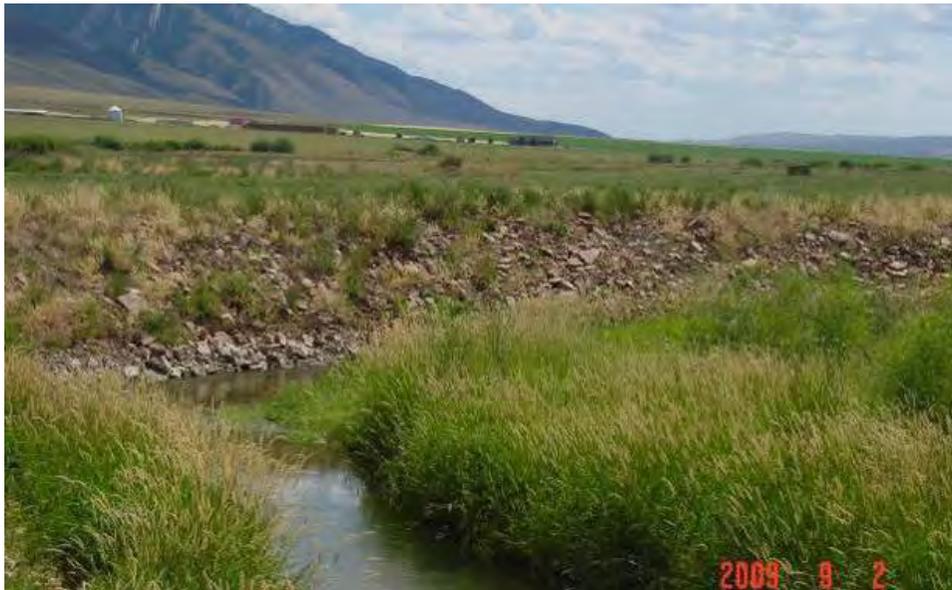
Figure 78. One of the few small sections of re-sloped stream bank that could use some additional vegetation. However, the riprap is preventing erosion of the bank even without complete vegetative cover.

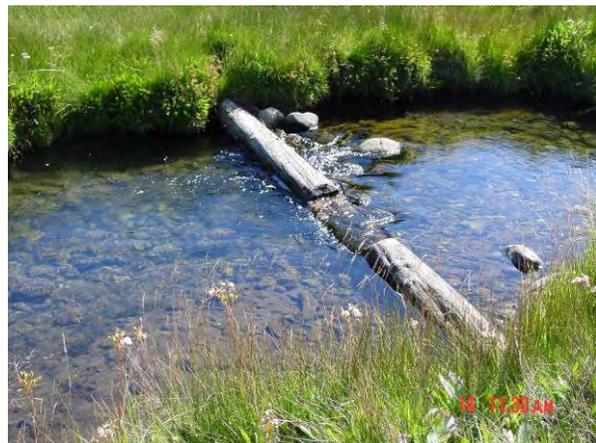
Figure 94. These log drop structures, placed along the river several decades ago, are beginning to rot and displace, obstructing fish migration.

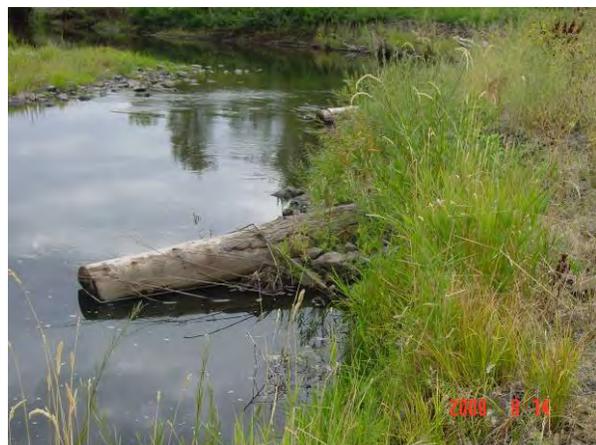
Figure 110. After stream banks are re-sloped from near vertical to a 2:1 or 3:1 angle, log and rock bars are keyed into the banks to force fast-moving water away from shore.

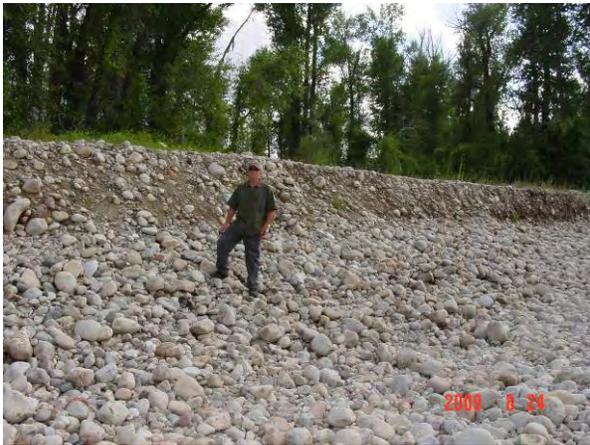
Figure 113. The developer removed thousands of yards of gravel from Teton Creek, resulting in severe headcutting.

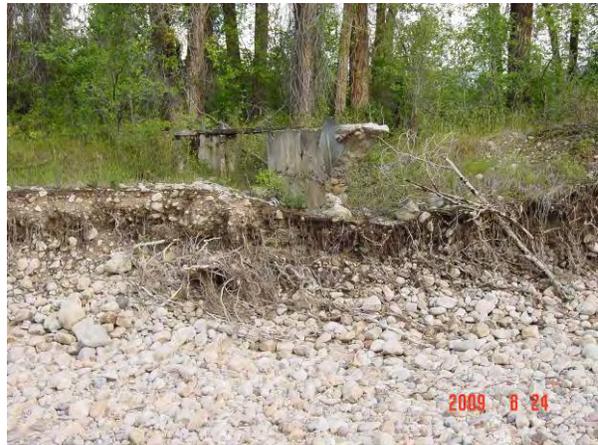
Figure 114. This old irrigation diversion gate shows where the stream gradient was prior to the damage.

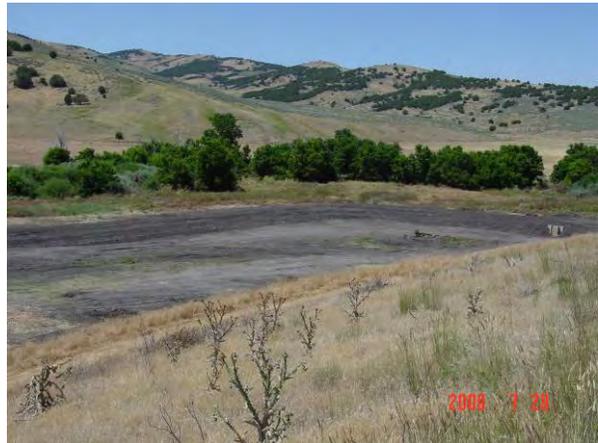
Figure 118. The lower end of the first cell will have a concrete spillway to regulate water depth over a 4-acre pond.

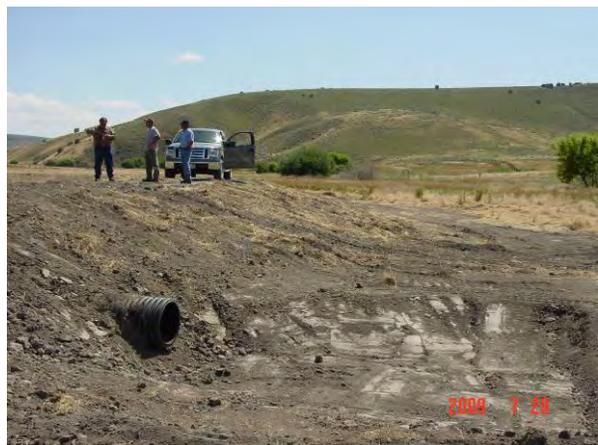
Figure 120. Flow to the inlet pipe for the second wetland cell can be regulated as needed.
