## 2003 REPORT TO CONGRESS

# Taking Plans to Action

STATE OF IDAHO NONPOINT SOURCE MANAGEMENT PROGRAM

## IDAHO NONPOINT SOURCE MANAGEMENT PROGRAM

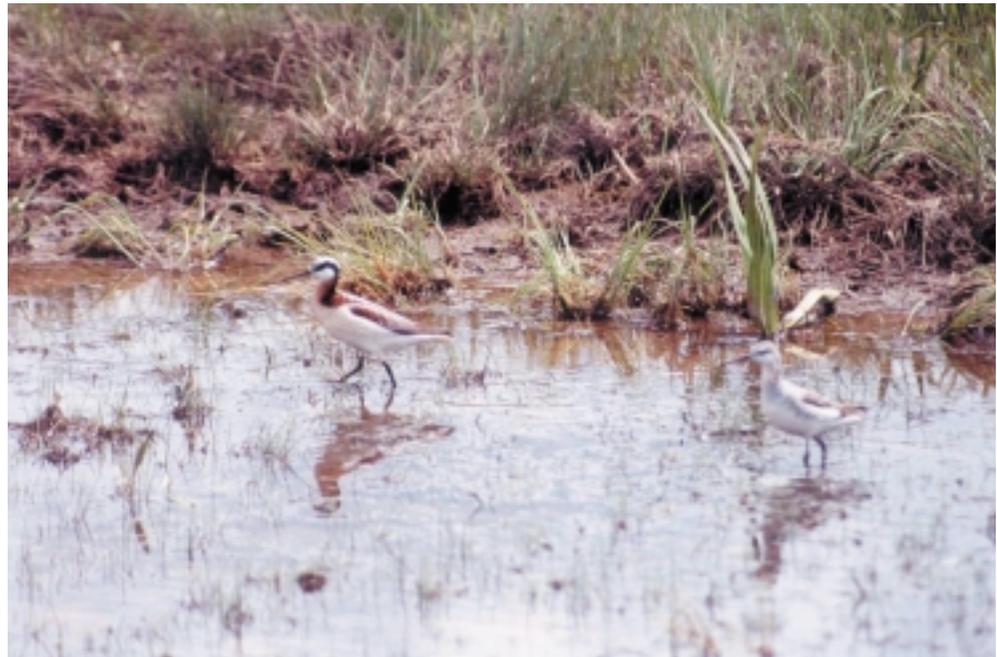
FIGURE 3  
*25-acre wetland built with participation of three landowners*

*Activity at a 25-acre constructed wetland completed as part of a section 319 project with participation of three landowners in the Jim Ford Creek of the Clearwater River system. Learn more about this project on pages 9-12 of this report.*

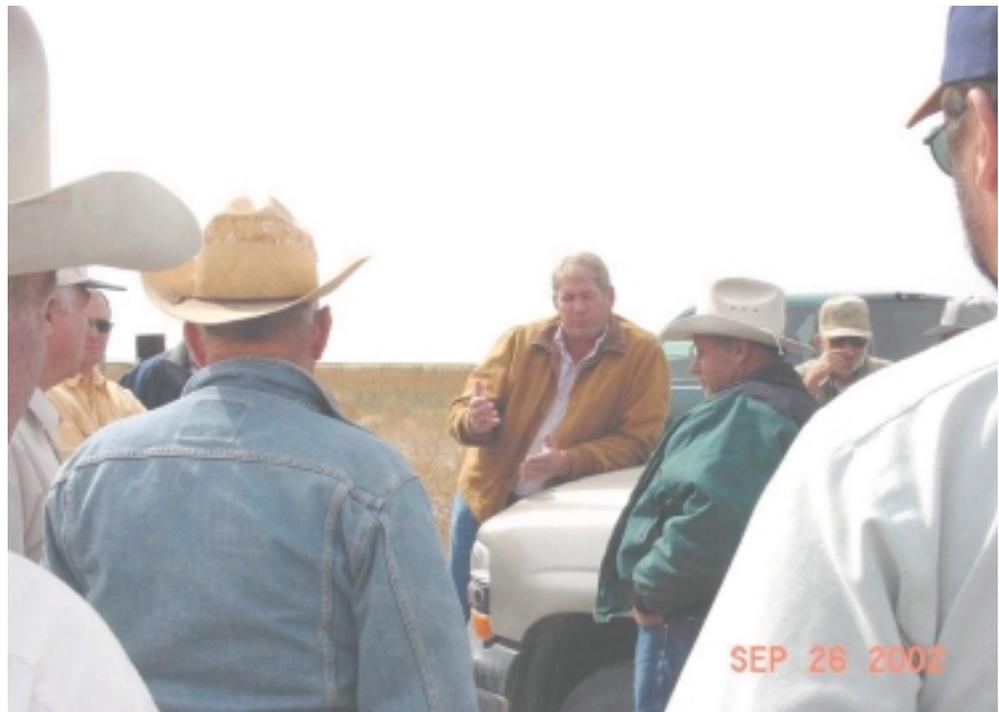
*FIGURE 2 The success of this program depended heavily on convincing local ranchers and landowners that State and federal agencies would work with them to improve water quality without negatively impacting ranching operations.*

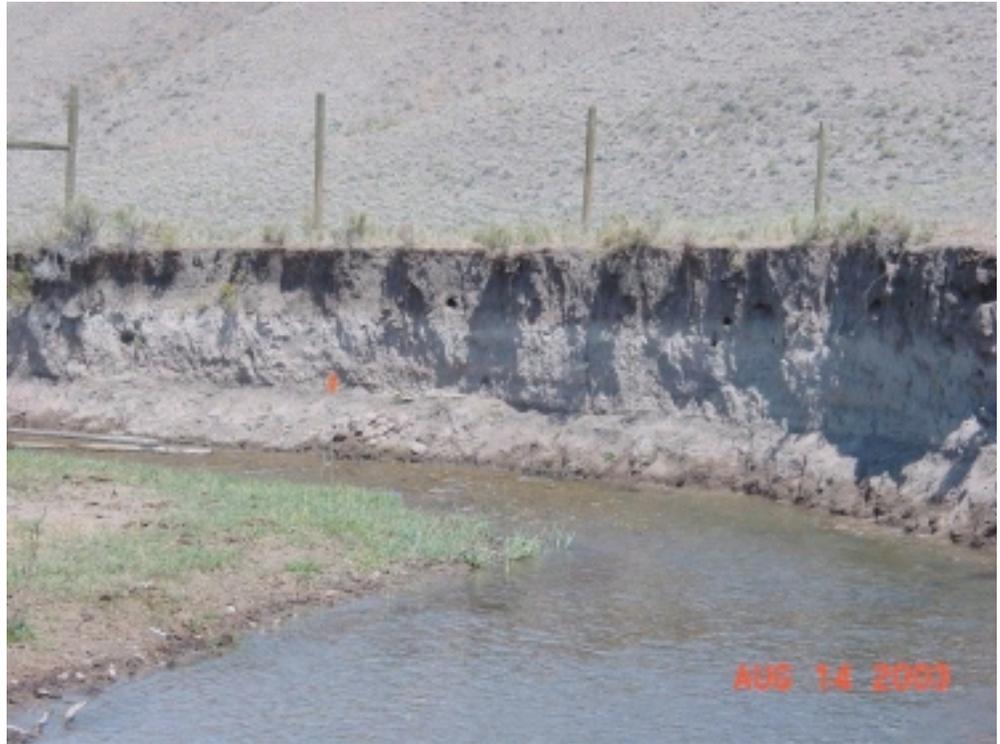
*FIGURE 3 Problems that are routinely found along Medicine Lodge Creek include unstable, steep stream banks caused by improper grazing techniques. This problem has been exacerbated by unusual weather patterns over recent years.*

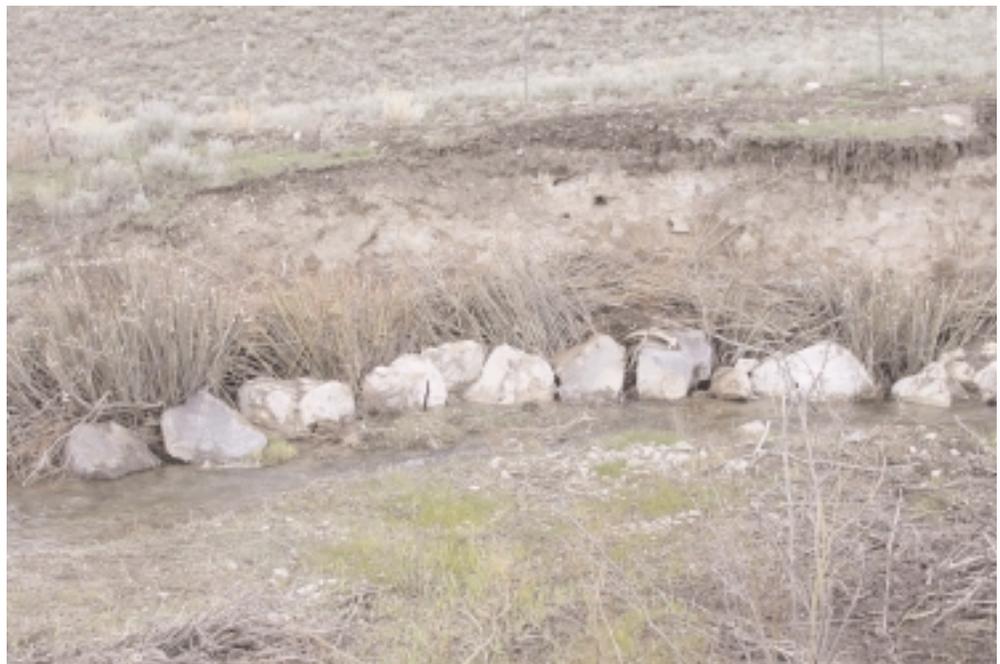
*FIGURE 4 One solution to bank erosion is to carefully place rip-rap and woody vegetation at the toe of the bank. With time, this bank will become completely vegetated and stabilized.*

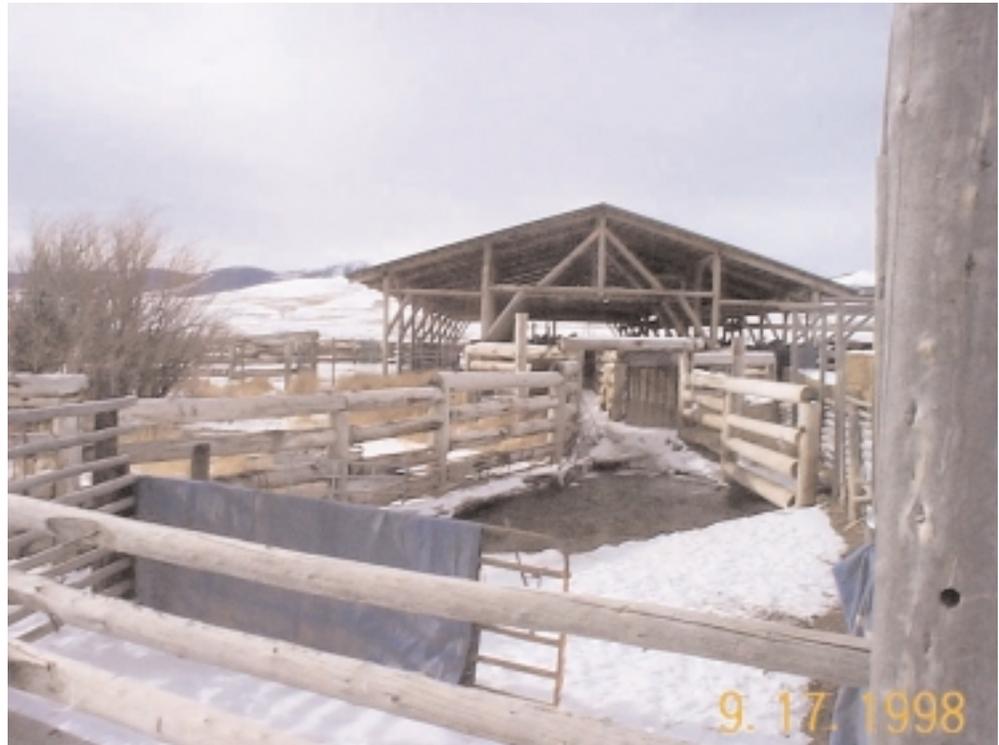
FIGURE 5 *Confined Animal Feeding Operation relocated away from Irving Creek*

Another common problem along Medicine Lodge Creek is that confined animal feeding operations (CAFOs) have historically been placed in and adjacent to streams in order to provide water for livestock. The CAFO seen in Photo 4 used to be located in Irving Creek. This facility was recently relocated away from Irving Creek and now has water piped into it.

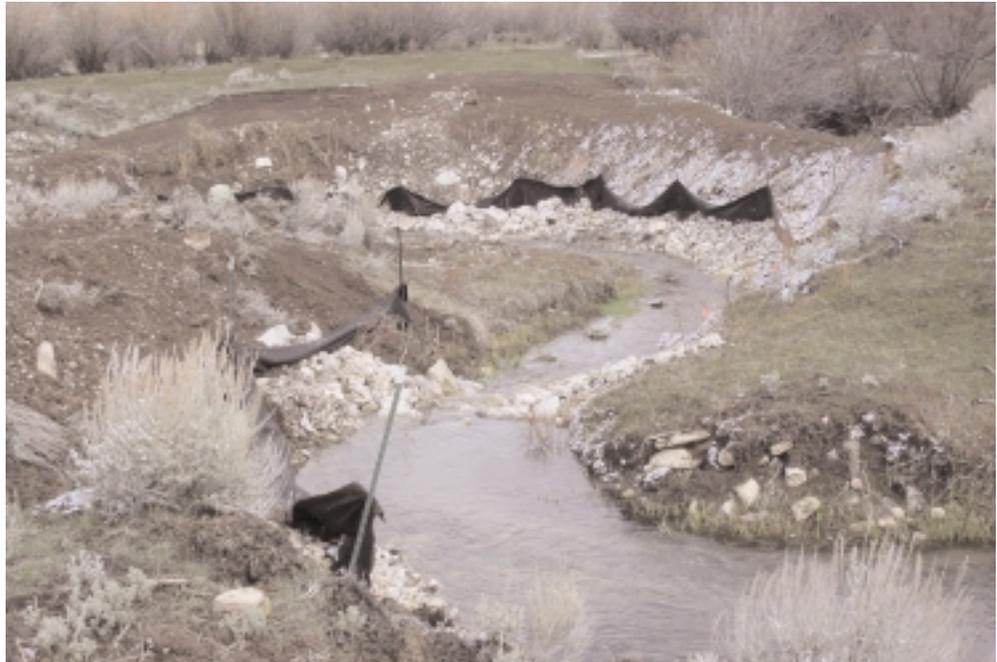
*FIGURE 6 Vertical slopes from overgrazing were knocked down. Rip-rap and willows were added to stabilize the bank. This looks unsightly now but will appear quite natural after one or two growing seasons. The biodegradable silt fencing will break down.*

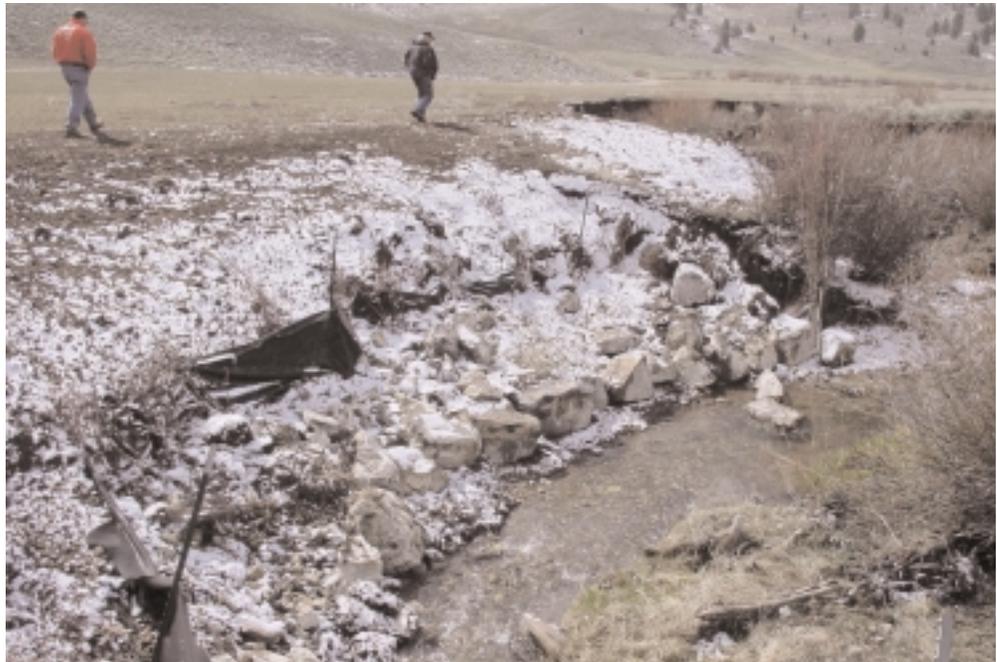
*FIGURE 7 The stream bank in the foreground has been re-sloped, stabilized with rip-rap, and replanted. The vertical stream bank in the background has not yet been rehabilitated.*

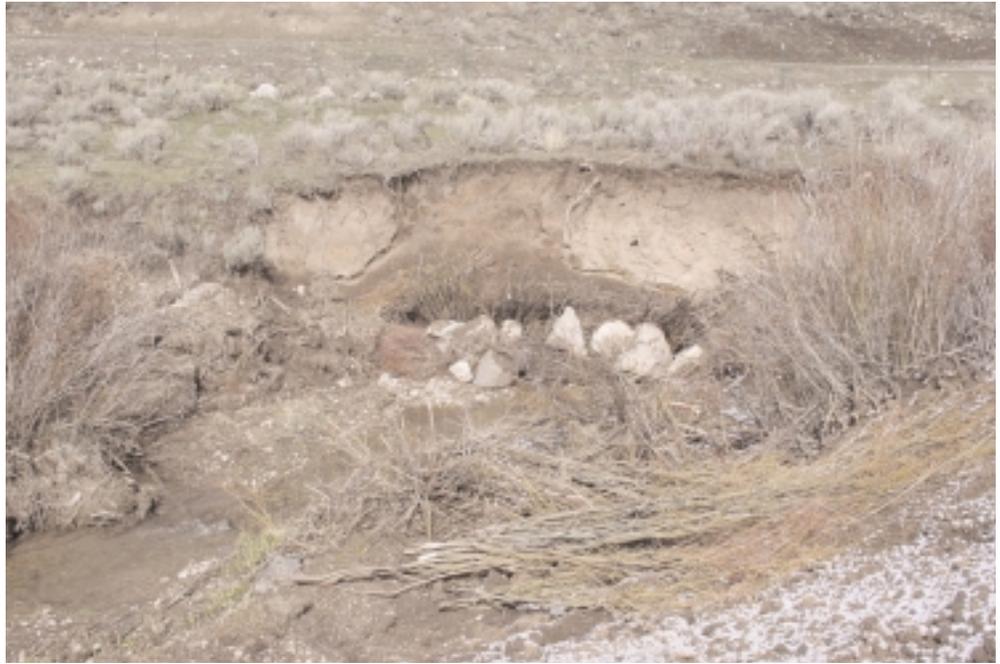
*FIGURE 8 Willows were planted as horizontal bundles and as transplanted rooted clumps. All woody plants are locally derived. Many of the vertical banks were stabilized at their toe with large rocks and woody plants. The upper bank will slough back until stabilization is naturally achieved. Vegetation will then continue to establish itself naturally.*

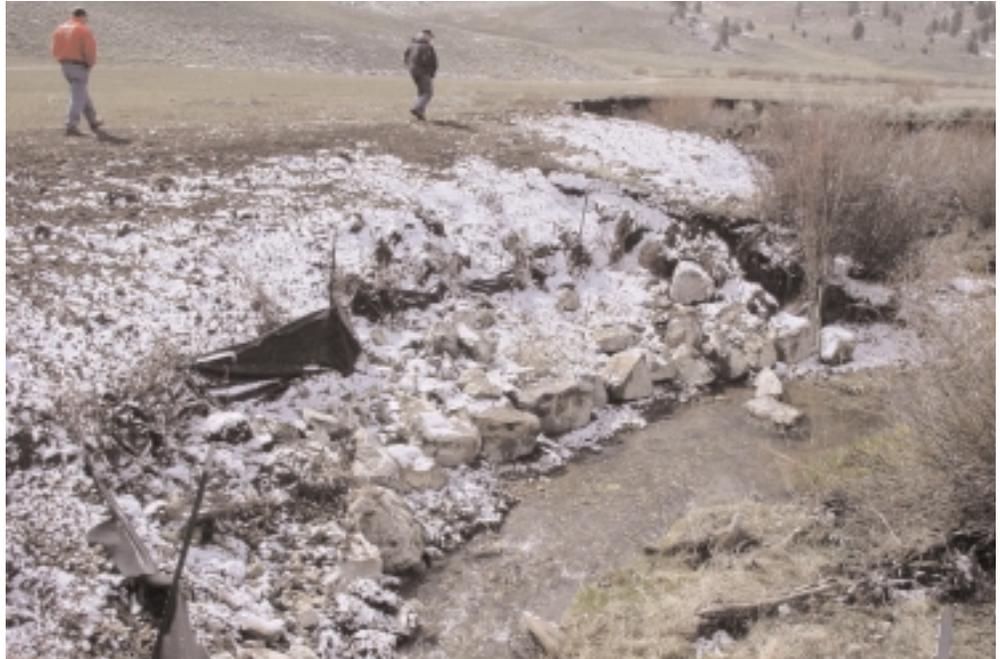
*FIGURE 9 One very effective method for planting willows involves the use of a water jet. This high-pressure water injection technique allows the willow cuttings to be quickly and easily planted several feet deep along the bank and within the water table.*

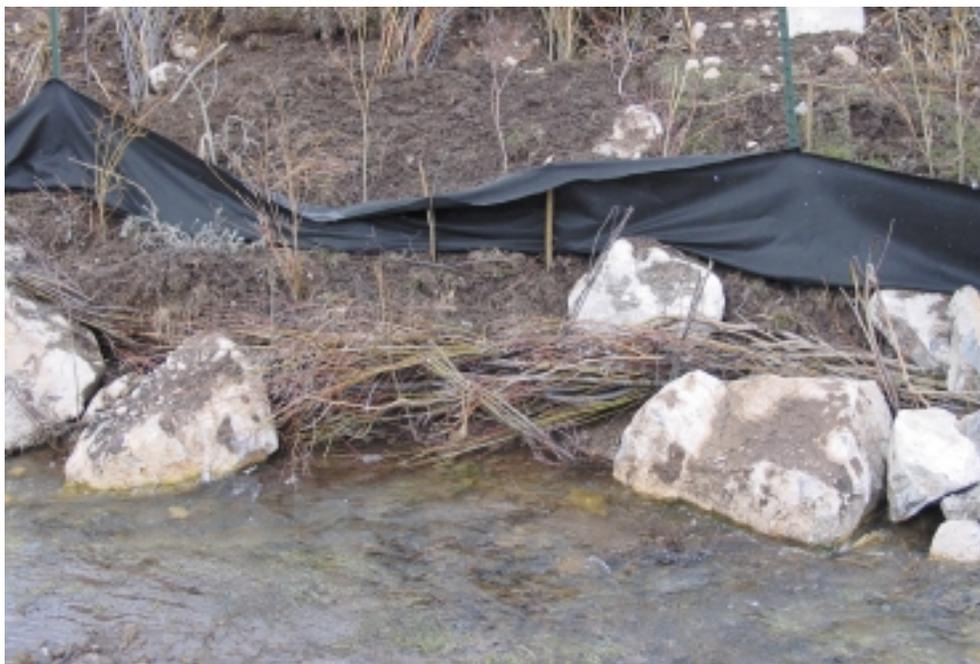
FIGURE 10 A

*These willow cuttings were planted with the assistance of water jet injection. Each vegetative revetment consists of several large trees, carefully embedded along the stream banks, to create a slower moving stream velocity where previously faster moving water was causing erosion. By cutting select trees on nearby forest service land, an additional benefit is gained: thinning the trees and reducing the fire danger in the adjacent forest.*

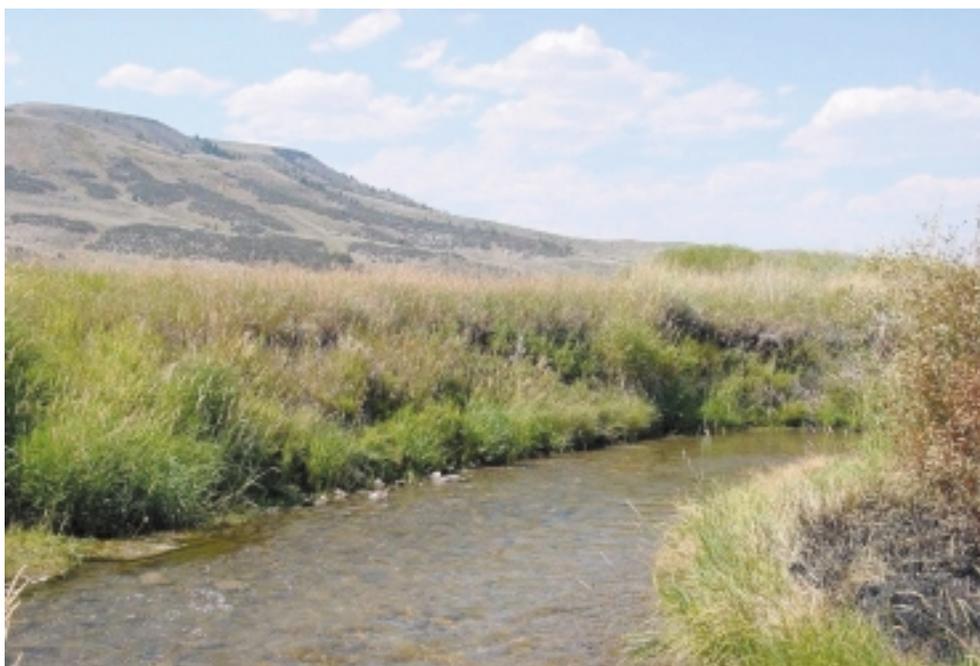
FIGURE 10 B

*Willow cuttings from a broader perspective.*

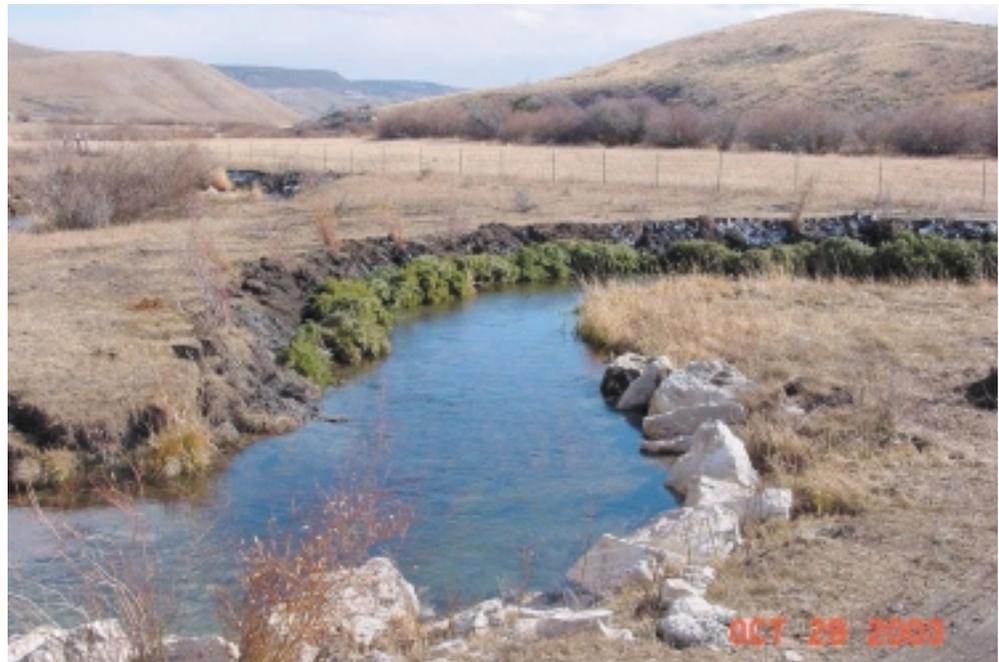
FIGURE 11 *Within several years, all of the areas shown in the previous photographs will look as good and function as well as this section that was completed just two years ago.*

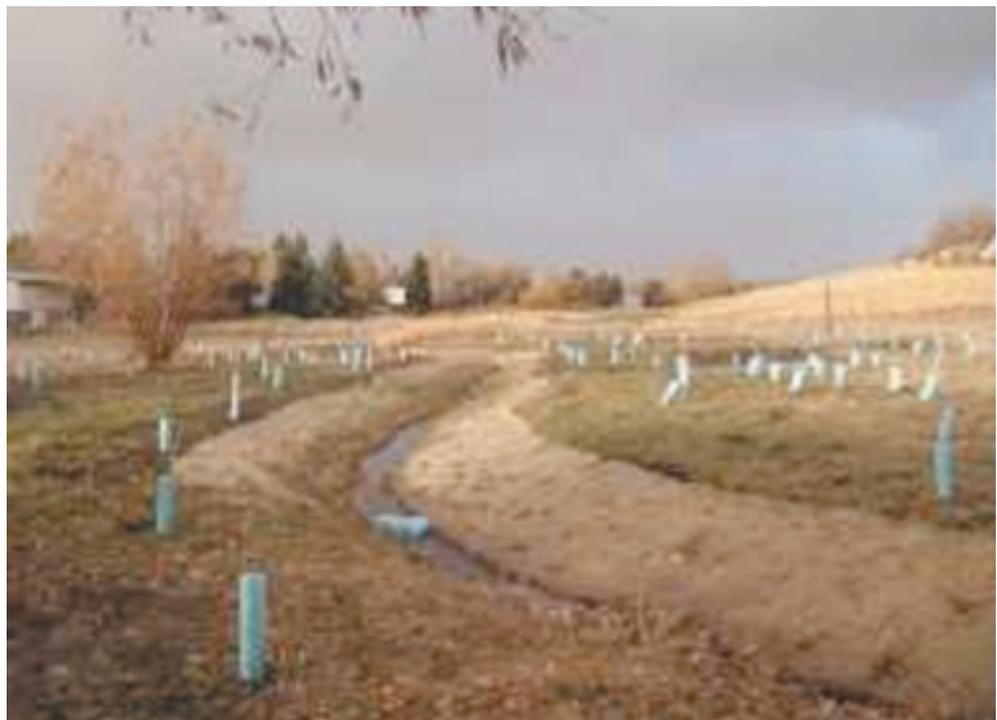
FIGURE 2 *Leffingwell-Reid property after work was complete in Fall 2003*

To accomplish these goals, a narrow meandering stream channel and three associated wetlands were constructed. Wetlands vary in depth from 1 to 2.5 feet. Professional Operators Company excavated the site with a track hoe, using an 18-inch toothed bucket. The construction phase took approximately three days to complete. The wetlands are adjacent to the new channel to receive and filter runoff before entering the stream and to increase flood storage capacity (Figure 2).

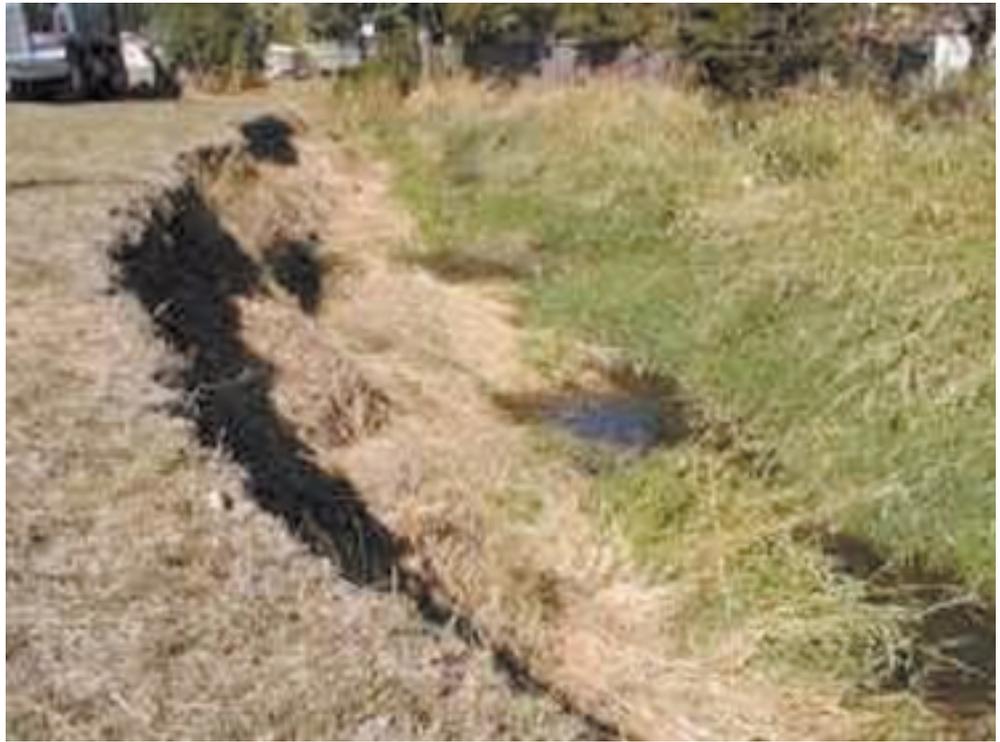
FIGURE 3 *Lightfield Stream bank before work*

**PREVIOUS CONDITIONS:** The stream segment had nearly vertical, slumping, eroding stream banks that contribute to the sediment load in the creek. Reed canary grass was the predominant species on this stream reach. There was a lack of existing native woody vegetation close to the creek to help shade out weeds and decrease water temperature. In the past, this reach of Paradise Creek was dredged, which exacerbated the steep banks and promoted incising (Figure 3).

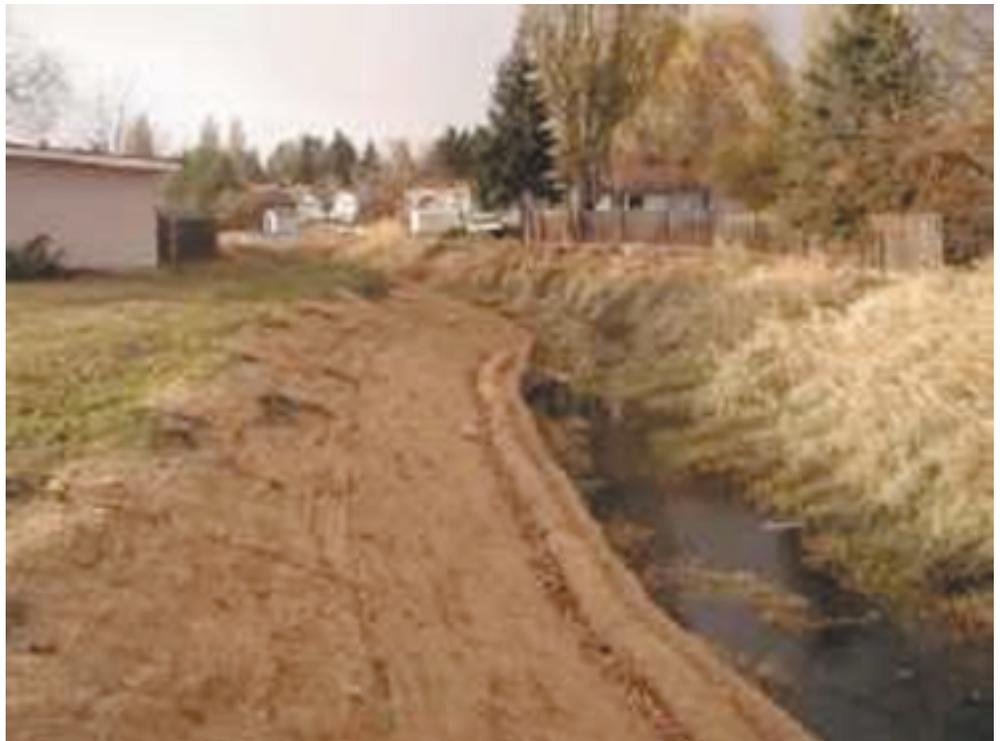
FIGURE 4 *Lightfield Stream bank after work*

**DESCRIPTION OF COMPLETED ACTIVITY:** The construction phase of the project was completed September 23, 2003. Moscow contractor, Dale Stubbs, excavated the existing bank to create a 2:1 slope. Slope construction took approximately six hours using a 48-inch toothed bucket. Bio-logs were installed at the toe of slope to provide a shelf for plant material and bank stabilization. The coir logs were terraced two high on the upstream section of the project, this technique used to minimize undercutting in an area of high velocity. The re-sloped bank was promptly seeded with native grasses (tufted hairgrass, ticklegrass, fowl bluegrass, western managrass, prairie junegrass, and Idaho fescue), herbaceous plants (small-fruited bulrush, common rush, creeping spikerush) and native woody species (red-osier dogwood, sandbar and Mackenzie willow [plugs], quaking aspen, Douglas hawthorn, Nootka rose, serviceberry, shiny leaf spirea, and syringa) (Figure 4).

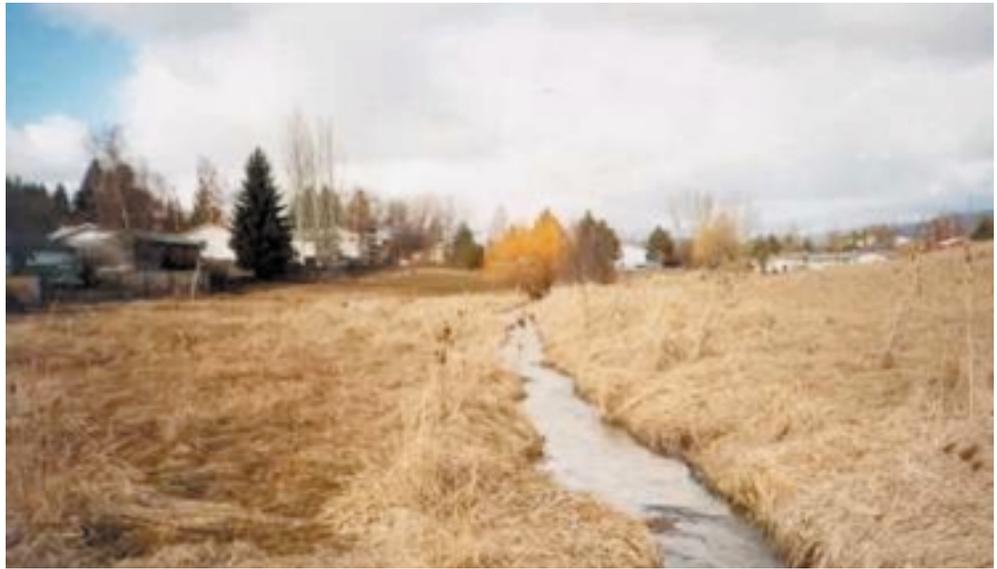
FIGURE 5 *Streets site before planting*

Wetlands were constructed on the tributary to Paradise Creek to improve flood control, provide native habitat for wildlife, and filter pollutants. The constructed wetland also provides recreational and educational opportunities for the community. Native species of woody shrubs, trees and grasses were planted along the bank to provide shade to the stream and wetlands and wildlife habitat. Herbaceous wetland plants were planted in the wetland to help improve water quality by reducing nutrient loading through filtering. All plantings are protected from animal damage with plastic tubes.

Native willow and cottonwood cuttings were planted along the banks of the stream to secure the banks and introduce shade to the system, creating a woody riparian buffer. Woody riparian buffers offer many benefits, including filtration of runoff, wildlife habitat and flood water retention. PCEI also organized a day of camas planting with students from Renaissance Charter School and Lapwai Elementary School. The students learned about the ecological and cultural significance of the camas from a member of the Nez Perce Tribe and helped restore the plant to its native Palouse Prairie (Figure 5 and Figure 6).

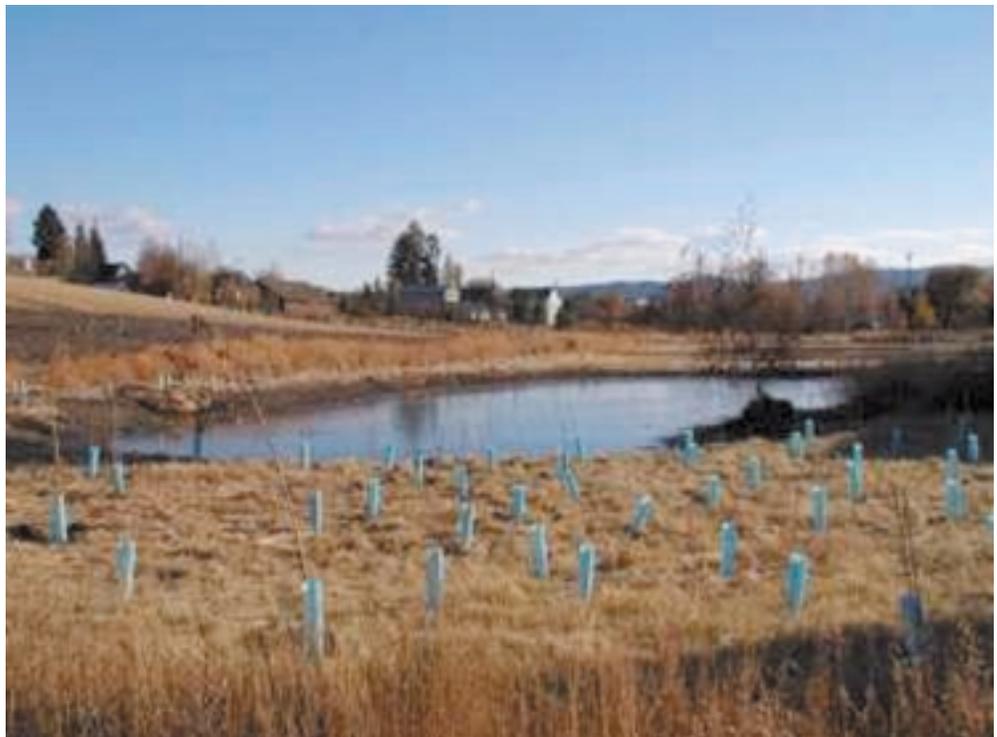
FIGURE 6 *Streets site after planting*

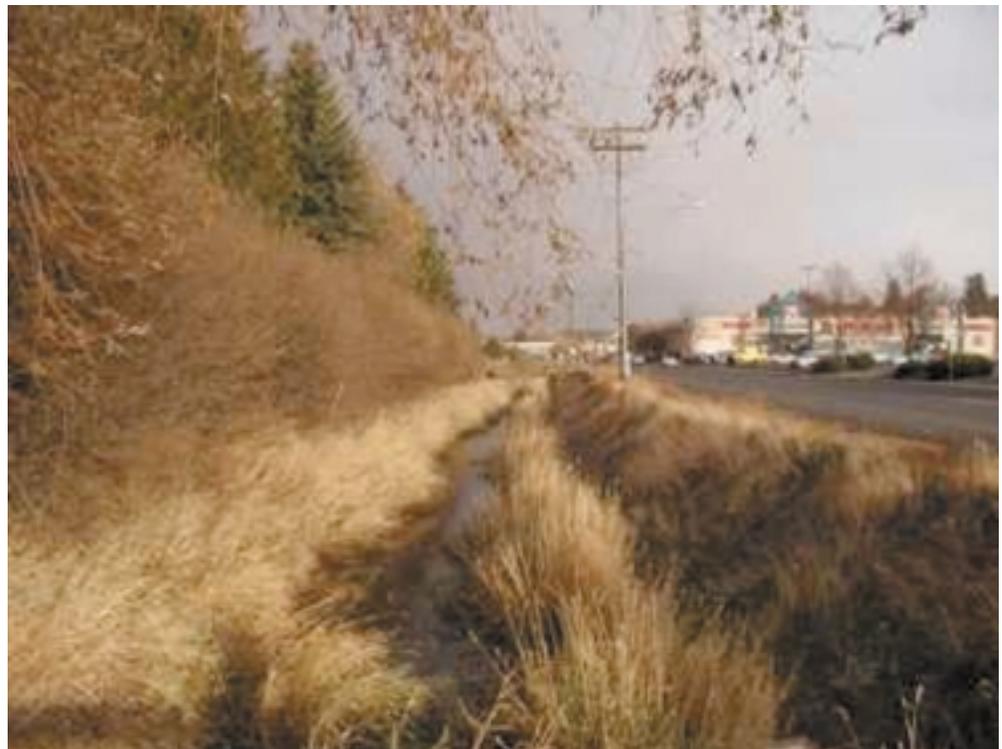
FIGURE 7 *Moscow wastewater treatment wetlands planting*

**DESCRIPTION OF COMPLETED ACTIVITY:** The purpose of this project was to reslope the stream bank to a 2:1 or 3:1 slope from its near-vertical state reduce erosion, and allow for the establishment of woody vegetation. The project site is 358 linear feet of a heavily damaged, ditch-like creek. The stream bank is composed almost entirely of fill, especially gravel and concrete chunks. After removal of the debris, the site was hydroseeded with a native seed mix and then covered with erosion control fabric. Snowberry and Wood's rose were planted on the site. A few sedges and rushes were planted at the toe of the slope (Figure 7).

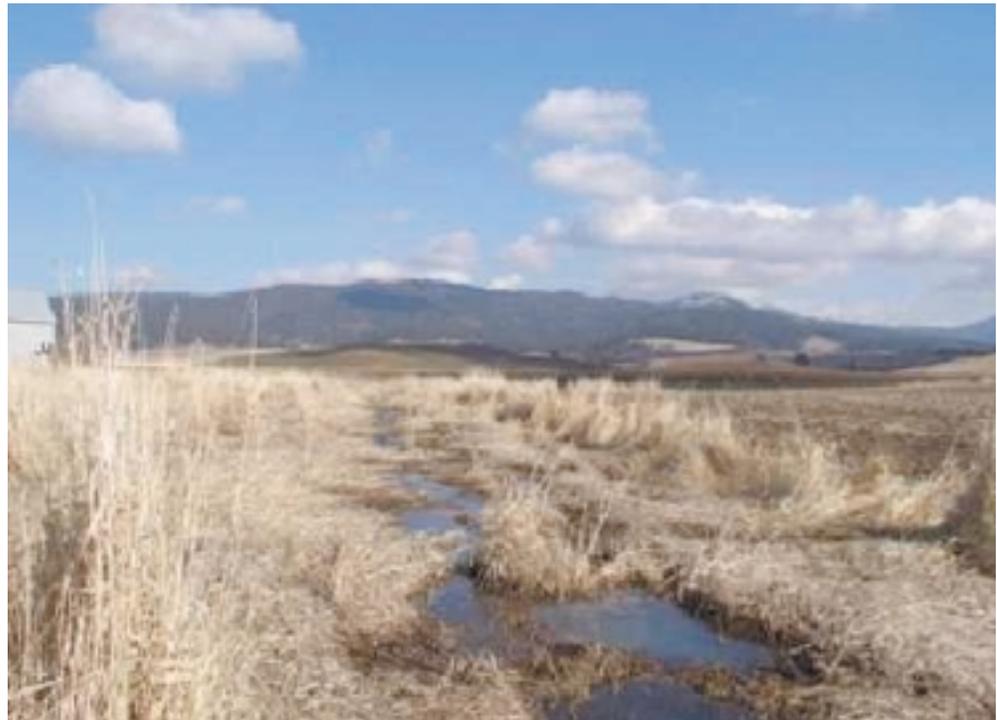
**PREVIOUS CONDITIONS:** Reed canary grass lined the banks of the two Paradise Creek tributaries flowing through the Brockington property. Active wheat fields were directly adjacent to the stream. A riparian buffer was absent in this section of the creek, which exposed the creek to direct solar radiation as well as runoff containing sediments, nutrients, and pesticides. There were multiple equipment crossings through the eastern tributary.

FIGURE 8 *Brockington Riparian Area prior to planting woody vegetation*

**DESCRIPTION OF COMPLETED ACTIVITY:** The scope of this project was to plant a variable width buffer along the two tributaries on this property, including a total length of 2,500 feet. The riparian buffer ranges from 10 to 40 feet in width and consists of native shrubs and trees. The buffer area of the eastern tributary was also seeded with native grass seed. PCEI completed minimal excavation along the eastern tributary to create a narrow, low flow channel with associated floodplain, in conjunction with the adjacent Townsend project. In addition to the excavation coordinated by PCEI (the current agricultural operator), Larry McMillan contributed by excavating the sediment-laden channels of both tributaries. McMillan's work included excavating to the level of the culvert below the Brockington driveway. The Brockington project borders the Big Draw project to the north and the Townsend project to the east and south, therefore it is expected to have significant benefit as a wildlife corridor as vegetation matures (Figure 8 and Figure 9).

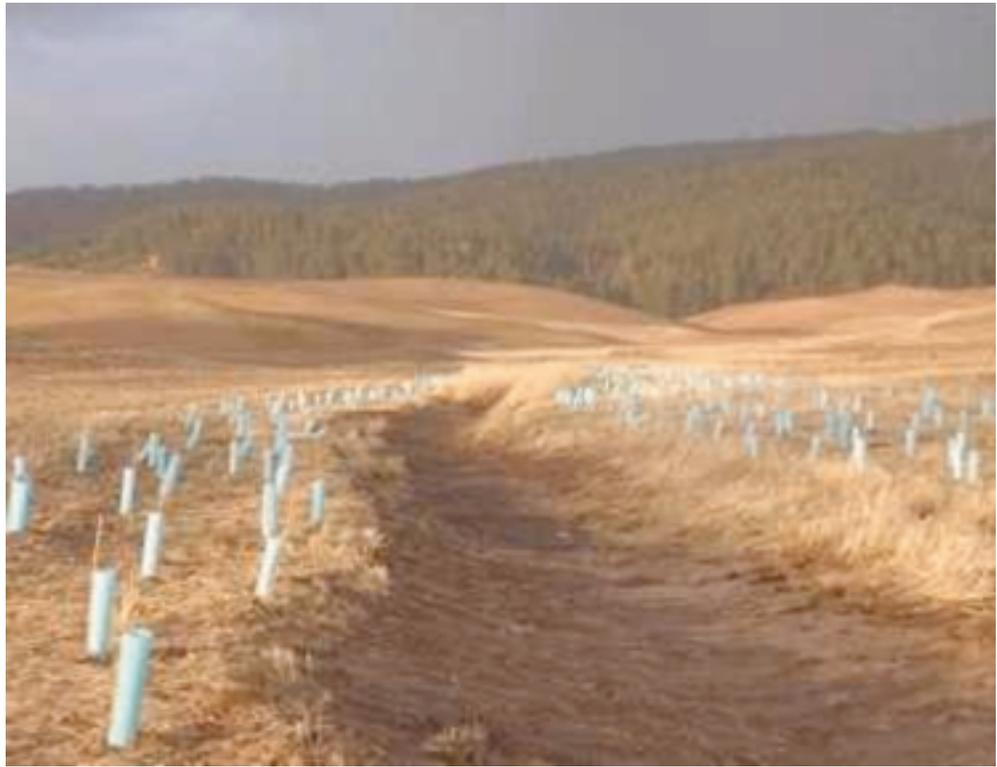
FIGURE 9 *Brockington Riparian Area immediately after woody vegetation was planted. Farm equipment will be restricted to designated waterway crossings. Plastic collars protect young plants from deer and elk until plants become established.*

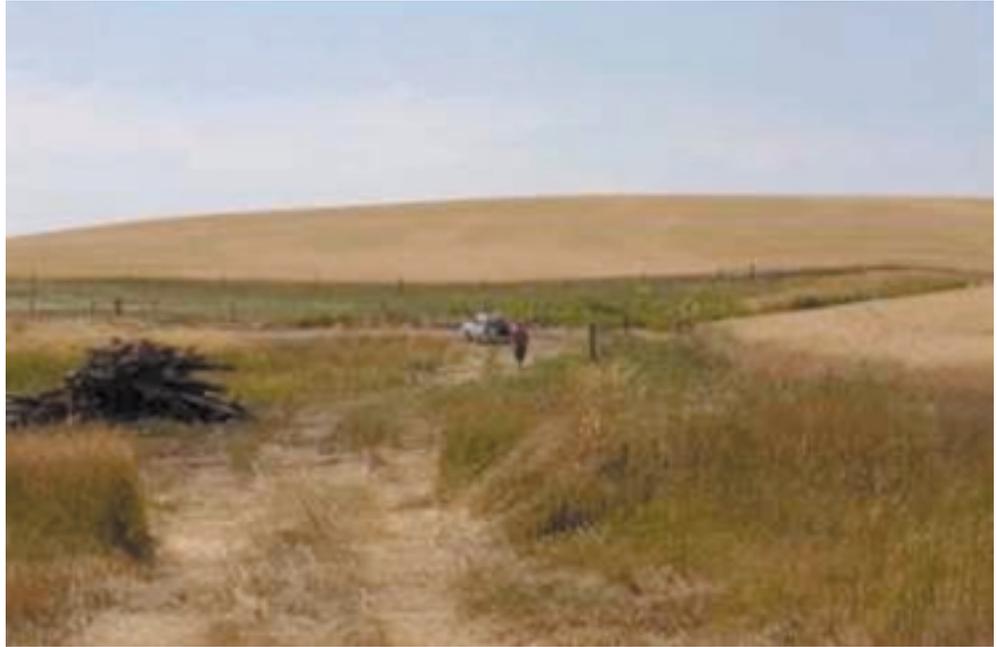
**PREVIOUS CONDITIONS:** This seasonally wet draw with intermittent springs collects a significant amount of water from the surrounding hills and is a tributary to Paradise Creek in the spring. In the past, this draw has been utilized as horse pasture. The Forbes family recently purchased the property and decided to enhance its value as native habitat and improve its water quality. Prior to restoration, reed canary grass, meadow foxtail, morning glory, and other invasive weeds dominated ground cover. There was little vegetative diversity at this site.

FIGURE 10 *Forbes area in Spring 2003, prior to wetland construction and riparian planting*

vegetation was planted in the fall of 2003. Herbaceous plants will continue to be planted over the next few years as the storage capacity and other characteristics of the wetlands become more apparent. PCEI organized a planting of 150 camas bulbs in October of 2003 with students from Lapwai Elementary School. The students learned about the cultural and ecological significance of camas in addition to helping restore the species (Figure 10 and Figure 11).

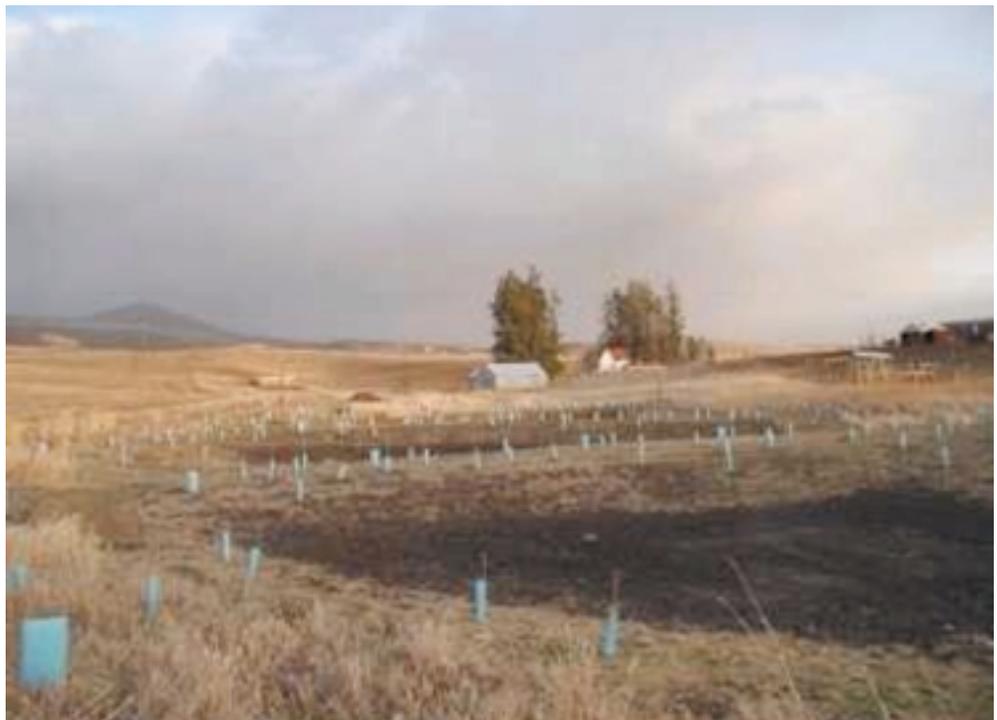
FIGURE 11 *Photo 4. Forbes area after Fall 2003, including wetlands and woody riparian plants*

All exposed soil was seeded and mulched after construction. Species used were fowl bluegrass, tufted hairgrass, ticklegrass, prairie junegrass, and yarrow. Native woody and herbaceous

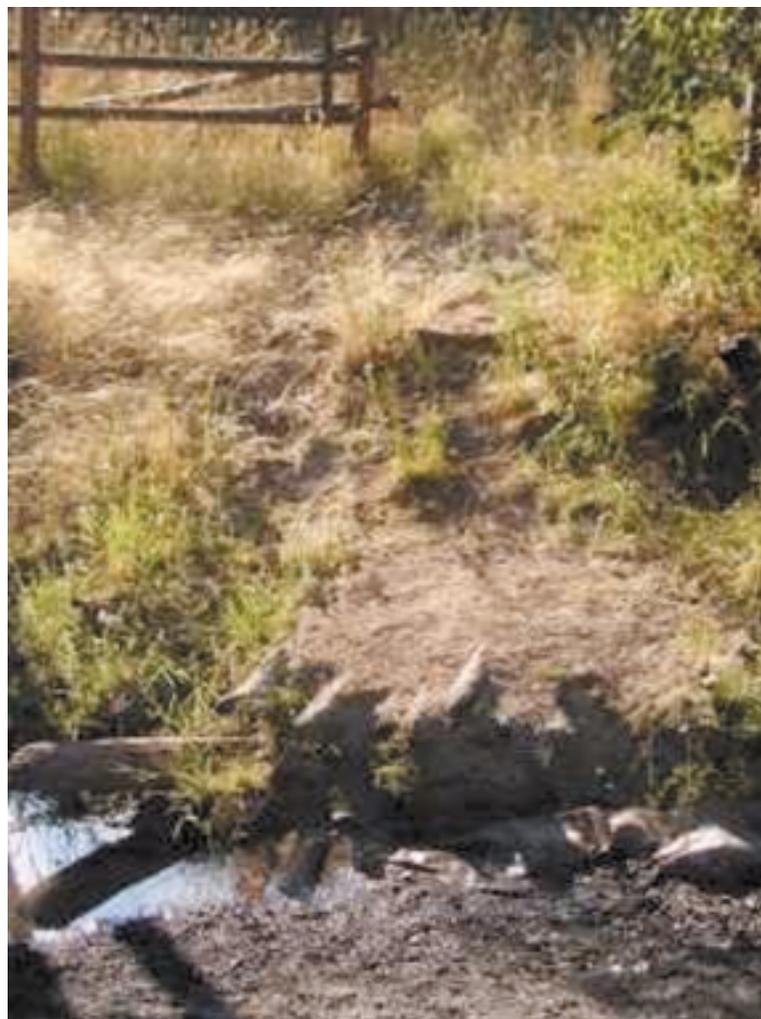
**PREVIOUS CONDITIONS:** This section of Paradise Creek, located three miles north of Moscow, has populations of quaking aspen, Douglas hawthorn, snowberry, serviceberry, cow parsnip, and many other species that compose a healthy riparian buffer. Restoration effort targeted a specific problem area disturbed by an established horse crossing that provided access to pasture on both sides of the creek. Prior to restoration, continuous use of the stream section for animal passage contributed to nutrient and sediment inputs. The presence of large stands of Canada thistle in proximity to the creek was also of concern.

FIGURE 12 *Garton Stream before the work*

Mark Hawley of Moscow was hired to do shallow excavation and to place the rock fill. Rock, eight inches or less in diameter, was used to fill the depression, and a two foot strip of gravel dressing was placed down the middle of the crossing to lessen the possibility of injury to the animals. Filter fabric was installed beneath the rock. Project construction lasted about five hours. Figure 12 and Error! Reference source not found. show the crossing before and after the work was accomplished.

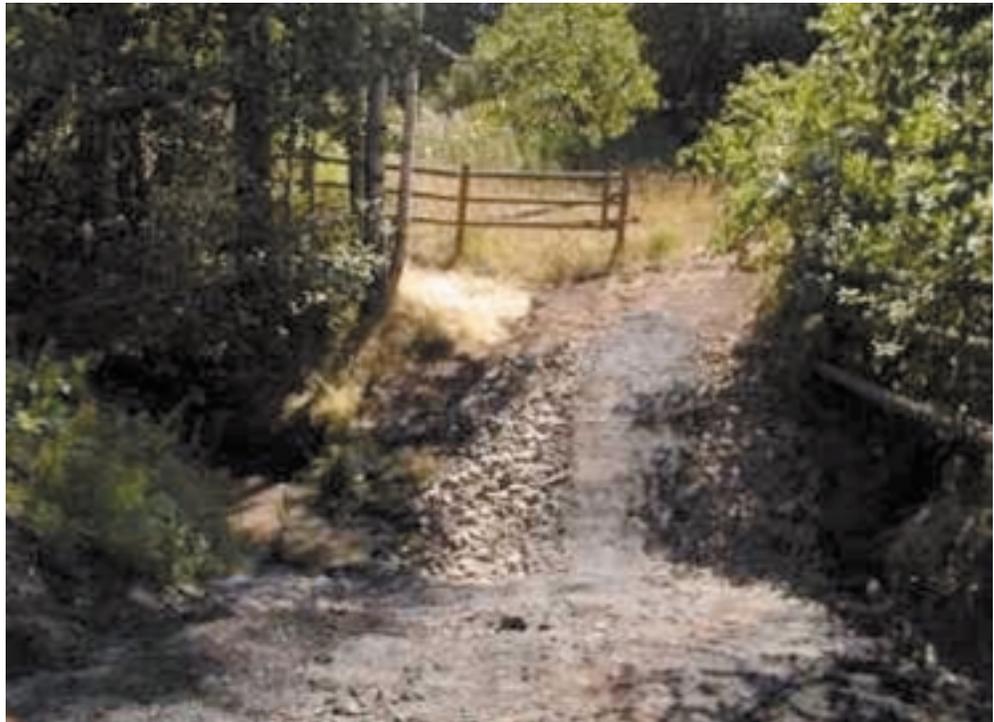
FIGURE 14 *Garton Stream After the work*

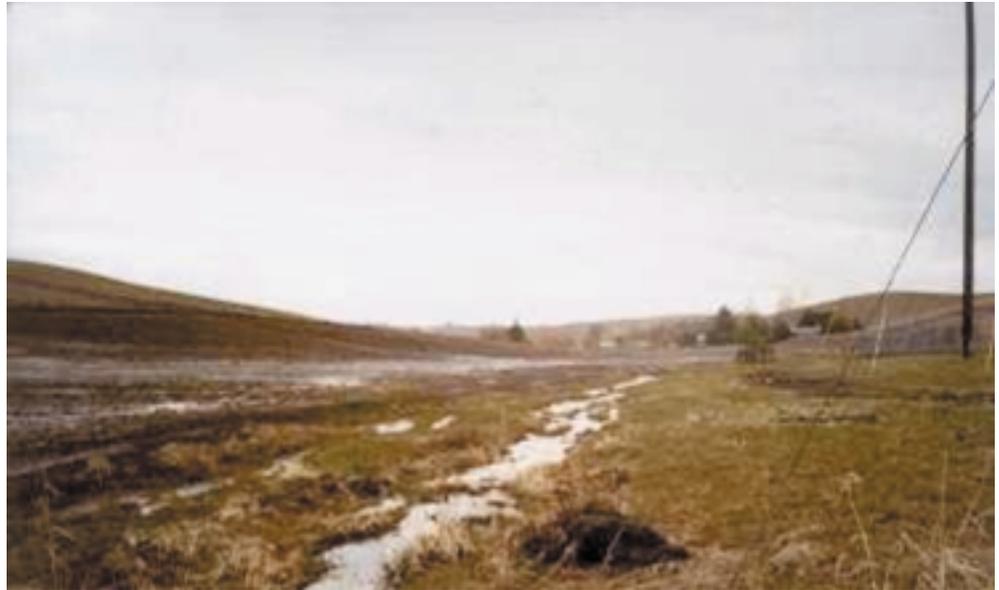
**PREVIOUS CONDITIONS:** Prior to restoration, the channel of this tributary to Paradise Creek had been straightened to allow for cultivation to the stream's edge. Reed canary grass lined the banks of the creek, and active wheat fields were directly adjacent to the stream on the east side (Figure 15). A riparian buffer was absent in this section of the creek, which exposed the creek to direct solar radiation as well as agricultural runoff containing sediments, nutrients, and pesticides.

FIGURE 15 *Harden Riparian Area prior to work*

**DESCRIPTION OF COMPLETED ACTIVITY:** The purpose of this project was to create a riparian buffer along an 860-foot reach of a tributary to Paradise Creek, so 563 trees and shrubs were installed along the stream channel. Woody riparian buffers offer many benefits, including filtration of

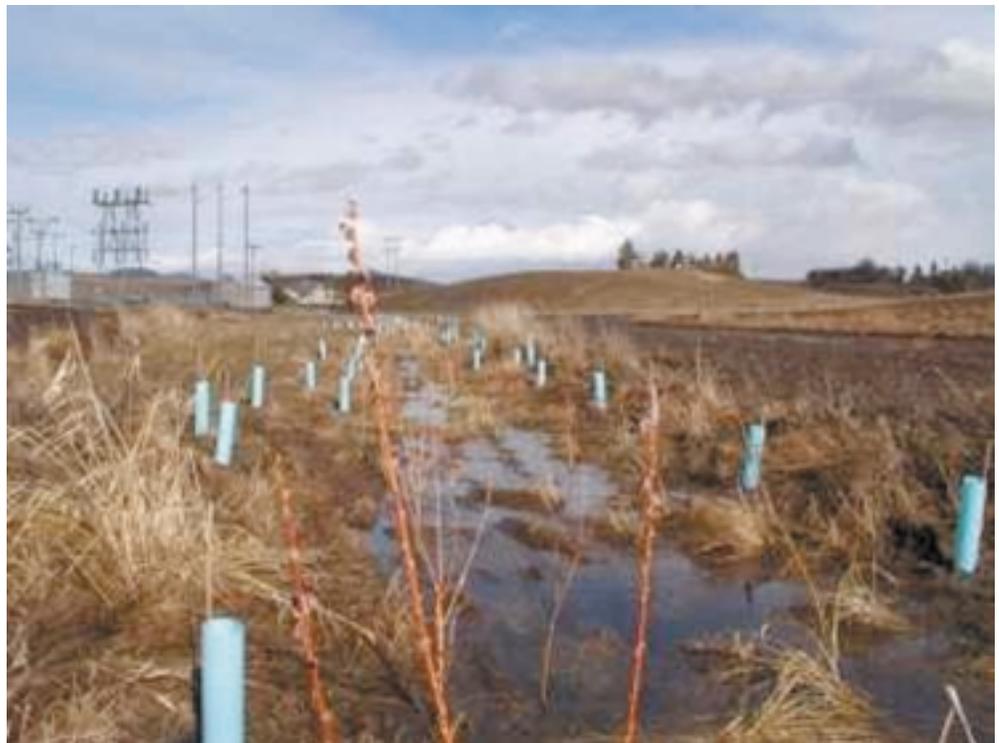
FIGURE 16 *Harden Riparian Area after work completed*

runoff, soil stabilization, wildlife habitat, and floodwater retention. These plantings will be protected from vole damage with plastic tubes. The plants in Figure 16 were watered and weeded on multiple occasions in 2003.

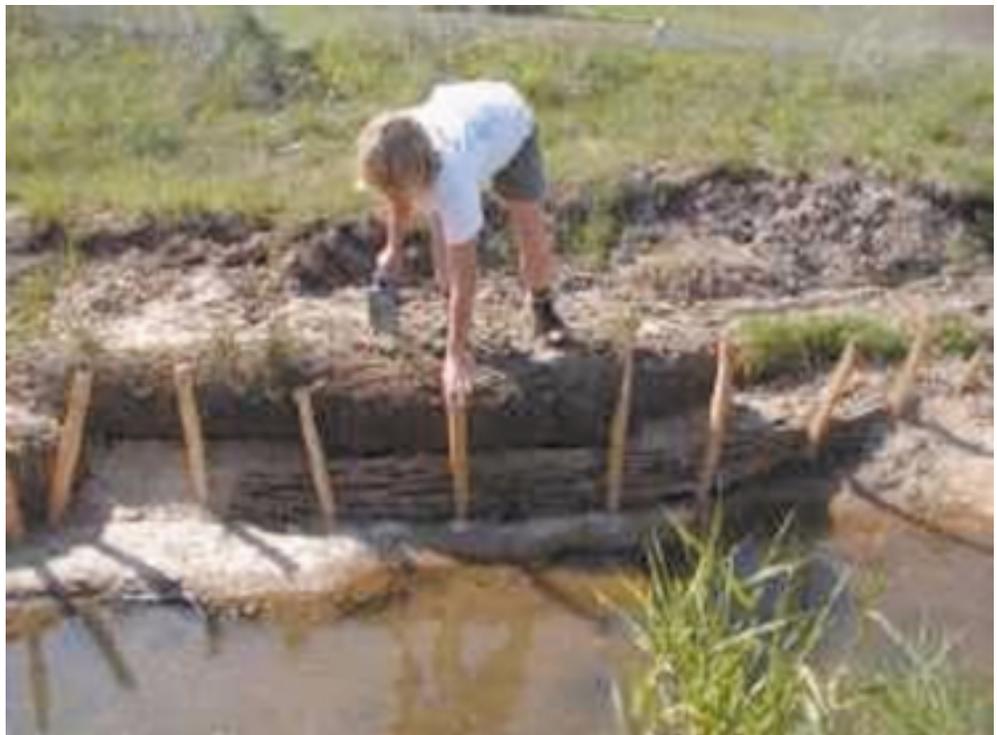
FIGURE 18 *Stream bank stabilization being installed Summer 2003*

In the spring of 2003, willow and cottonwood poles, and red osier dogwood plugs were planted on the stream banks in spots lacking woody vegetation. Fascines were constructed from live cottonwood and willow cuttings and were placed where banks were bare and sloughing into the creek during high flows. Native wetland plugs, including small-fruited bulrush, Nebraska sedge, and Baltic rush were planted along bare sections of the streams. These deep-rooted plants will hold the stream bank in place and filter sediment and nutrients from the stream. Ponderosa pines from the National Tree Trust were also planted adjacent to the stream to provide long-term shade, contribute woody material to the stream system, and provide wildlife habitat. All work was done with the help of AmeriCorps\* NCCC teams (Figure 17 and Figure 18).
