## 2003 REPORT TO CONGRESS

# Taking Plans to Action

STATE OF IDAHO NONPOINT SOURCE MANAGEMENT PROGRAM

## IDAHO NONPOINT SOURCE MANAGEMENT PROGRAM

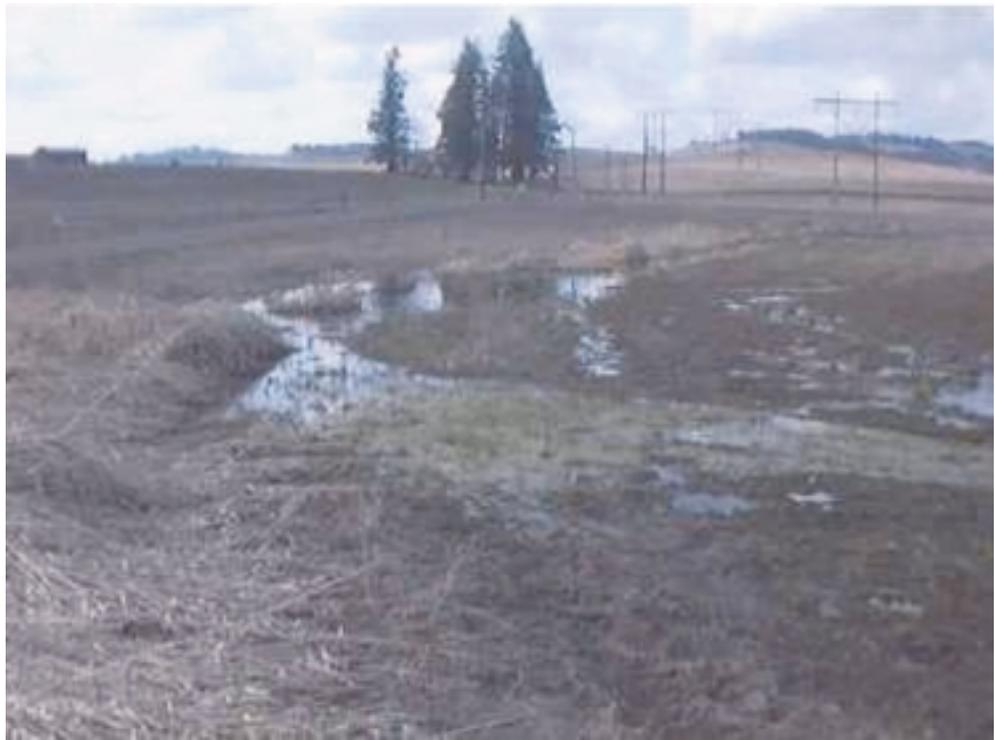
FIGURE 19 *Morton extension area prior to work*

**DESCRIPTION OF COMPLETED ACTIVITY:** A new "E" type stream channel approximately 1' wide and 10" deep was dug with a trackhoe. Channel sinuosity was increased by the inclusion of numerous meanders in the newly constructed channel, doubling the channel length within this reach. An increase in sinuosity will encourage more natural sediment deposition, develop stream-associated wetlands, and reduce stream velocity and thus erosive force.

Native riparian shrubs were planted after channel construction. A riparian buffer of woody vegetation will shade the stream, reduce water temperatures, stabilize soil, filter runoff from adjacent roads and farm fields, and contribute woody material to the stream system (Figure 19 and Figure 20).

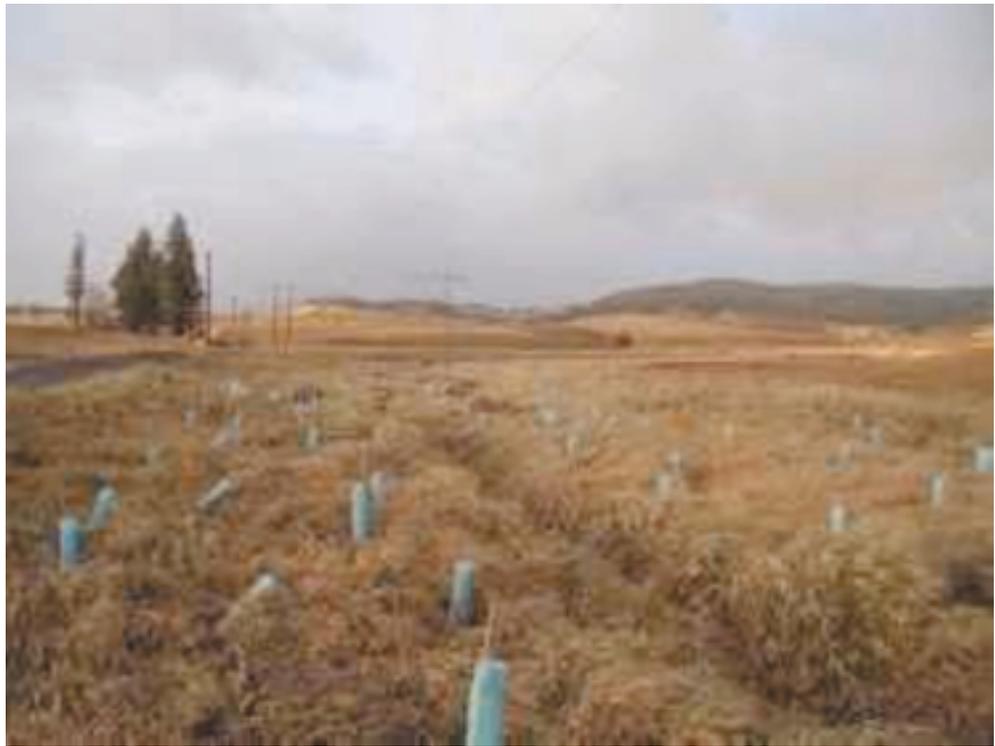
FIGURE 20 *Morton extension. Area after work completed*

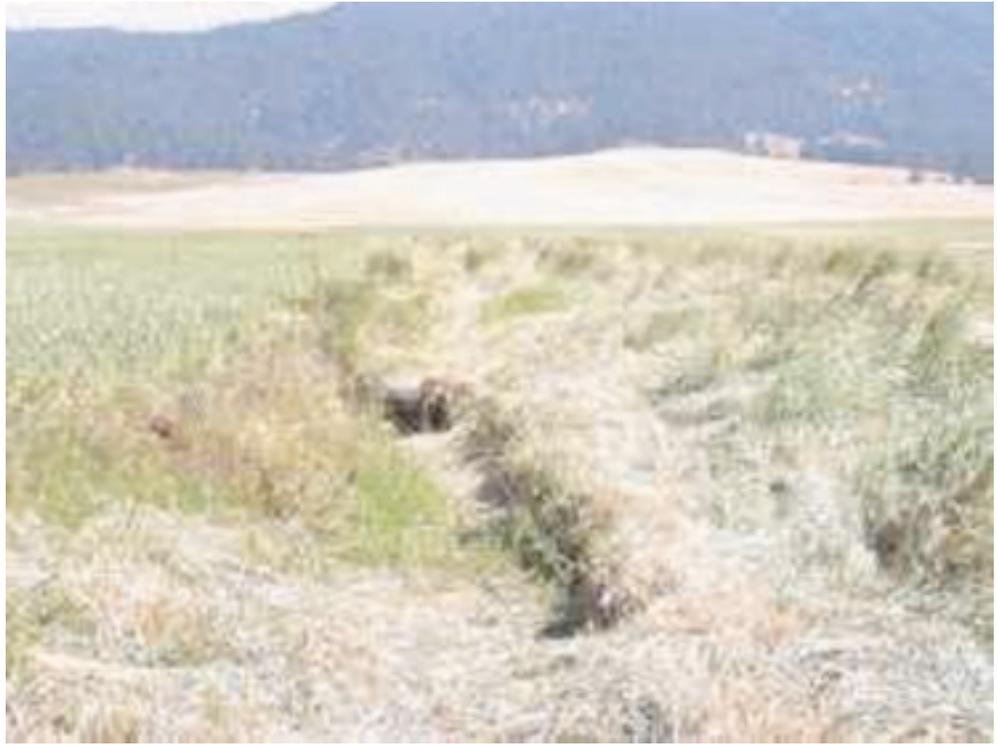
**PREVIOUS CONDITIONS:** Due to agricultural development, the stream was braided into several small channels with steep, eroding banks in many places. The site was cultivated to the edge of the stream channel and no riparian vegetation existed. Reed canary grass lined the 40 foot wide braided channel. Our goals were to improve the water quality of the two tributaries that flow through the Townsend property, to increase diversity of native riparian vegetation, and to create habitat for wildlife. Water quality improvements focus on non-point source pollutants like temperature, sediment, nutrients and bacteria. Improvements at this site will contribute to improving water quality in the mainstem of Paradise Creek.

FIGURE 21 *Townsend Waterway prior to reclamation*

**DESCRIPTION OF COMPLETED ACTIVITY:** The scope of work included excavating the floodplain, defining a narrow, low flow channel and planting a riparian buffer of woody and herbaceous species. Excavation occurred in September 2003. Excavation was done in two phases. The downstream end, below the confluence of two tributaries was completed first and excavation of the eastern-most tributary was second. The channel was constructed using an excavator and excess soil was spread outside the floodplain on the Townsend property using a bulldozer. A multi-level floodplain was constructed to accommodate varying flow levels. Meanders were

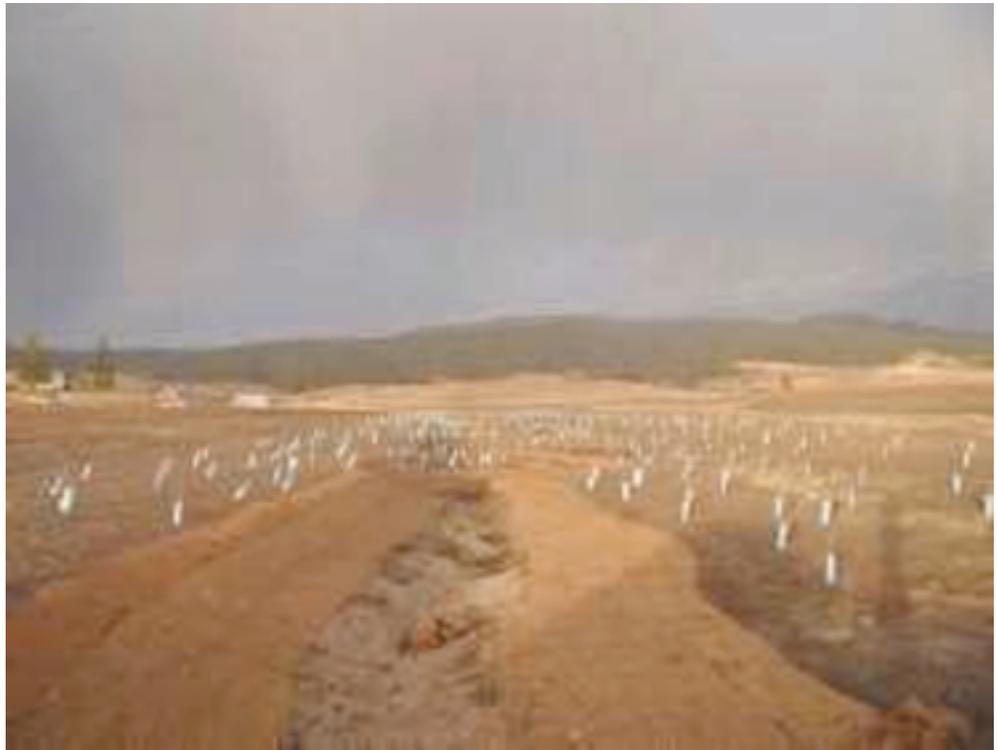
FIGURE 22 *Within one year Townsend waterway will have stable banks and support sustainable, healthy riparian vegetation.*

constructed in the new stream channel. A two layered soil wrap revetment was constructed on the downstream end of the project to protect against further erosion of a previously existing scour pool. After construction, all exposed soil was seeded with native grasses and banks were covered with erosion control fabric. In October and November of 2003, a riparian buffer of native trees and shrub, varying in width from 45 to 90 feet, was planted on either side of the stream (Figure 21 and Figure 22).

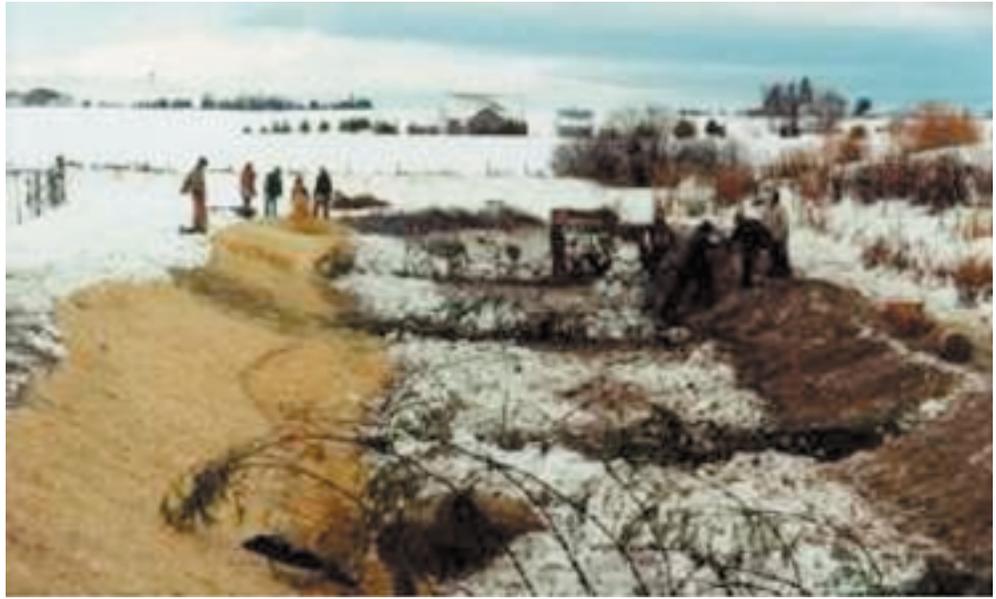
FIGURE 23

**PREVIOUS CONDITIONS:** Stream banks along this tributary to Paradise Creek were eroding due to a lack of woody vegetation and steep banks. Reed canary grass formed a dense monoculture, whose shallow root mats did not prevent slumping of the stream bank. Thus, stream banks were frequently undercut during heavy storm events. The lack of trees or woody vegetation along this stream segment allowed direct solar radiation to heat the stream water. There were also high levels of sediments in this tributary that added to the sediment loads of Paradise Creek.

**DESCRIPTION OF COMPLETED ACTIVITY:** The main purpose of this project was to create a sediment catchment system to trap sediment-filled high water. Another goal was to stabilize and revegetate a 300-foot section of the tributary to provide habitat for wildlife, provide shade to reduce stream temperatures, provide a vegetated buffer from agricultural runoff, and reduce the amounts of sediments entering the stream. Earth moving was completed by Professional Operators Company. PCEI staff and volunteers completed the bank stabilization activities. The catchment banks were sloped to a 3:1 slope. This moderate slope reduces erosion, reconnects the stream to its floodplain, and creates a prime area for native vegetation. The resloped banks were seeded with a riparian grass mixture and covered with geotextile fabric. Native woody vegetation was planted in the spring of 2002. All excavated material was removed off-site. In selected areas (Figure 23), coconut fiber-filled BioLogs®, pre-planted with wetland plants, were installed along the toe of the stream bank for stabilization and to improve water quality through the water-filtering qualities of wetland plants. Woody debris of cedar and pine were installed in the catchment to act as a filter and, in turn, to slow the velocity of the water so sediment could settle out. Planting of native woody and herbaceous vegetation was completed in the spring of 2002 by PCEI staff and volunteers.

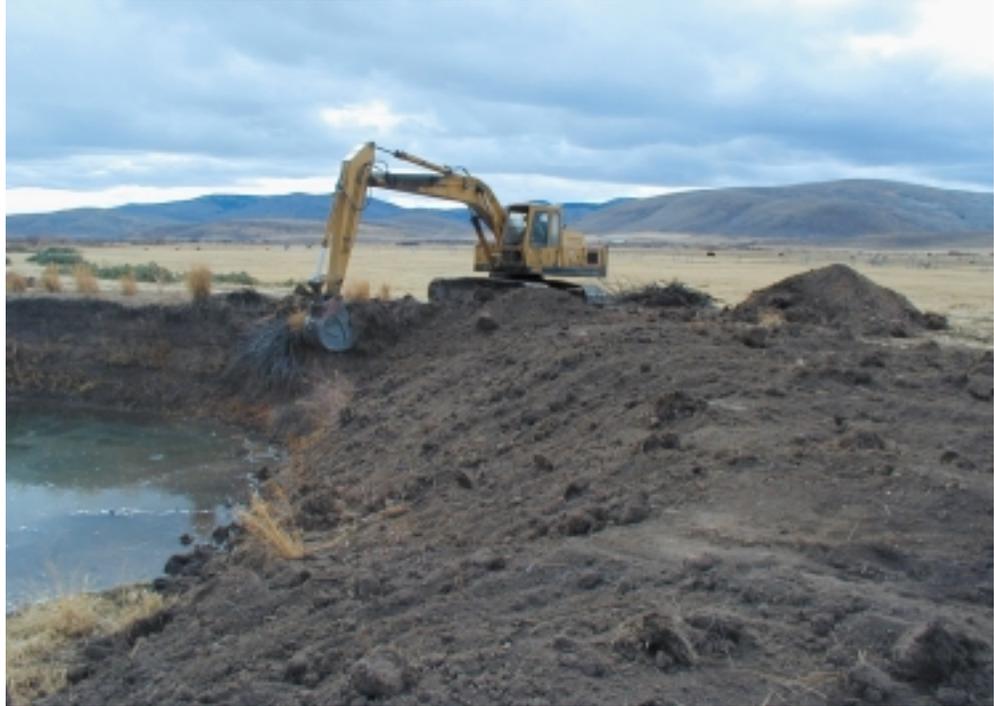
FIGURE 2 *Photo 1. Heavy equipment used to move soil and place large rocks for stream bank stability.*

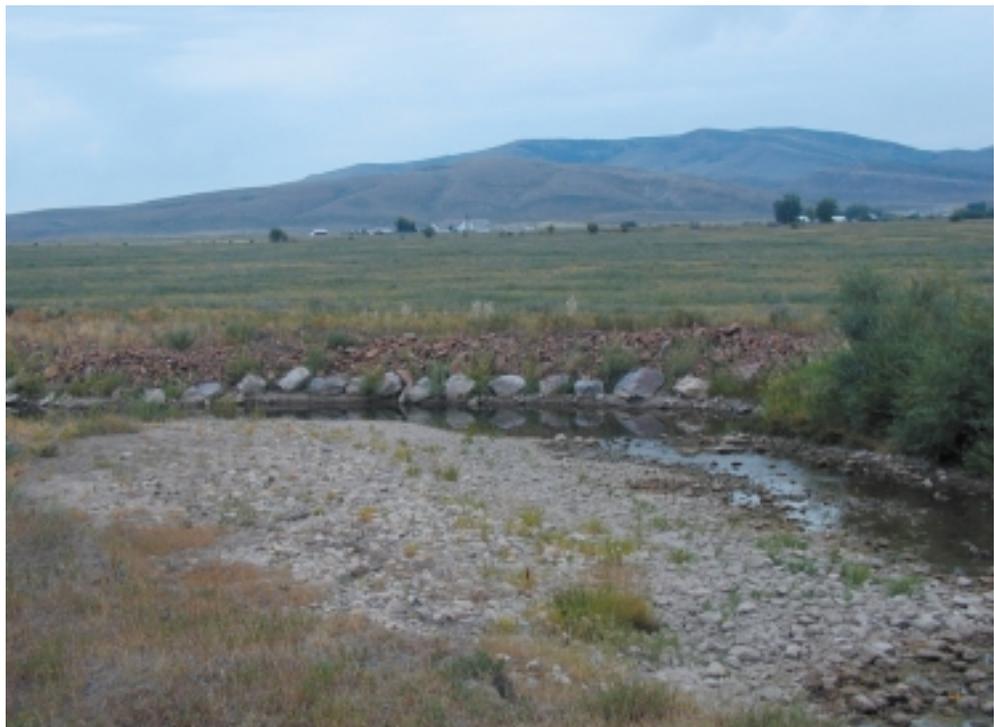
FIGURE 3 *Photo 2. Toe armoring and rip-rap bank protection techniques*

location is laid end to end along the toe of the slope at the water's edge. This rock, like that used for rip-wrap is hard, angular, and dense but of greater diameter. These rocks are typically 2-3 feet in diameter and placed by trackhoe, one at a time rather than by the bucket load. (Photo 2).

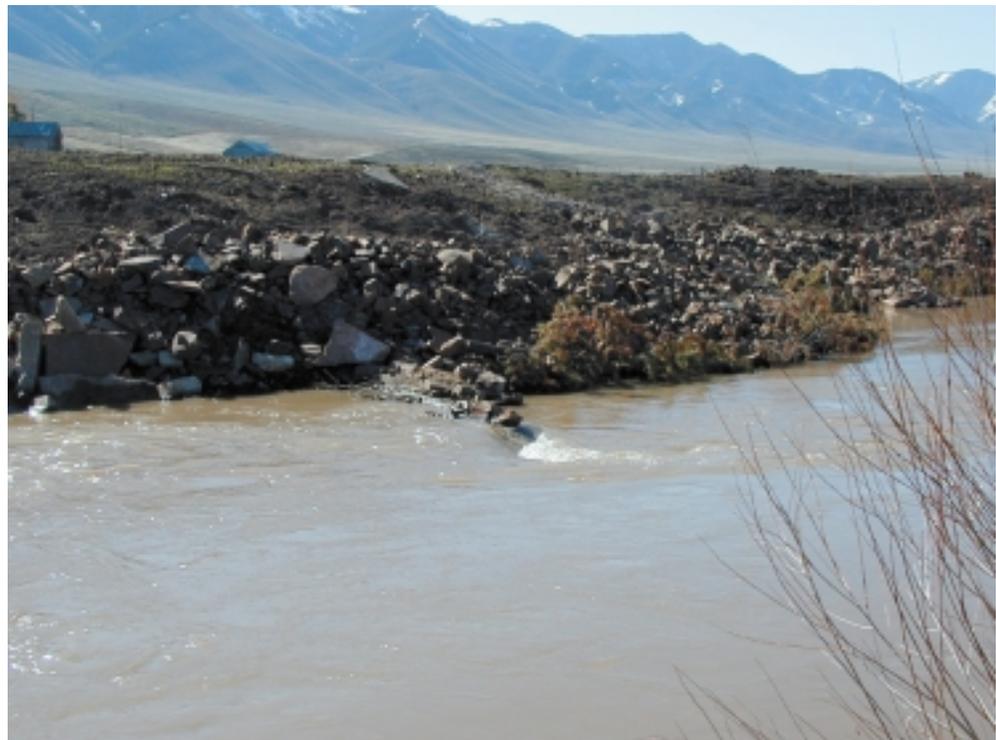
FIGURE 4 *Photo 3. Flow deflector or 'bank barb' diverting flow away from sensitive areas*

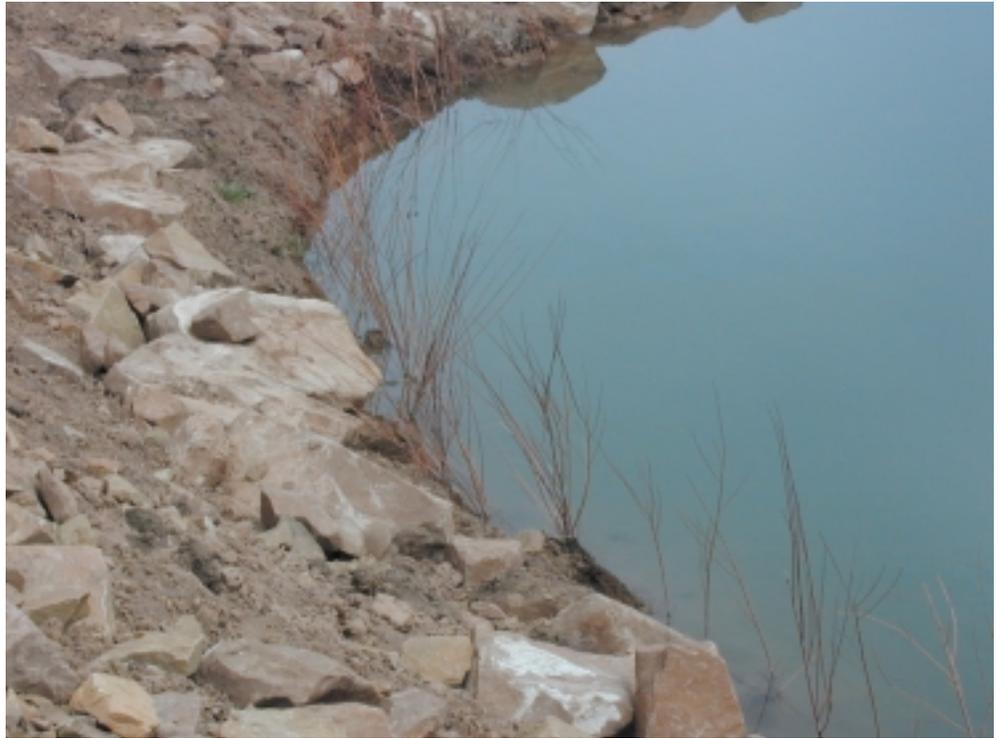
FIGURE 5 *Photo 4. Willow cuttings pressed into toe of bank slope*

Revegetation provides long-term sediment and nutrient reduction in addition to other benefits. Revegetation consists of planting willows (Photo 4) and other on-site vegetation and broadcasting a native seed mix on affected areas. Native seed mix is blended at a local seed mill and consists of Sheep Fescue, Crested Wheatgrass, and Stream bank Wheatgrass. This mix was selected based on site conditions such as soil type and drought resistance of the seed. Willow plantings are cut from healthy on-site communities and pressed into the soil at the toe of all affected slopes. Care is taken to ensure contact is made with the water table at the base of the willow cutting. Cuttings are planted 4 to 6 inches apart during the late fall or early spring. When possible, entire willow stands (willow plantings) and other existing riparian vegetation are transplanted into the toe of the slope along the bank. Planting during dormancy greatly improves chances of survival. Once the soil has been disturbed, the seedbed is prepared by using a harrowing device (Photo 5). The harrow in Photo 5 is a homemade piece of equipment. A six by ten foot piece of nine gauge chain link is cabled to a tractor or other four wheel drive piece of equipment. Chain link has shown to be optimal in these circumstances due to the fluid nature of the linkage. Larger harrows get snagged on rocks and are less maneuverable in confined spaces. The chain link disturbs only soil as it “snakes” along over the rocks and other protrusions. The seed is broadcast by hand as a final application just prior to snowfall. Seed is broadcast over disturbed soil at the recommended density of 30 pounds per acre then treated by dragging the harrow over the soil (Photo5).

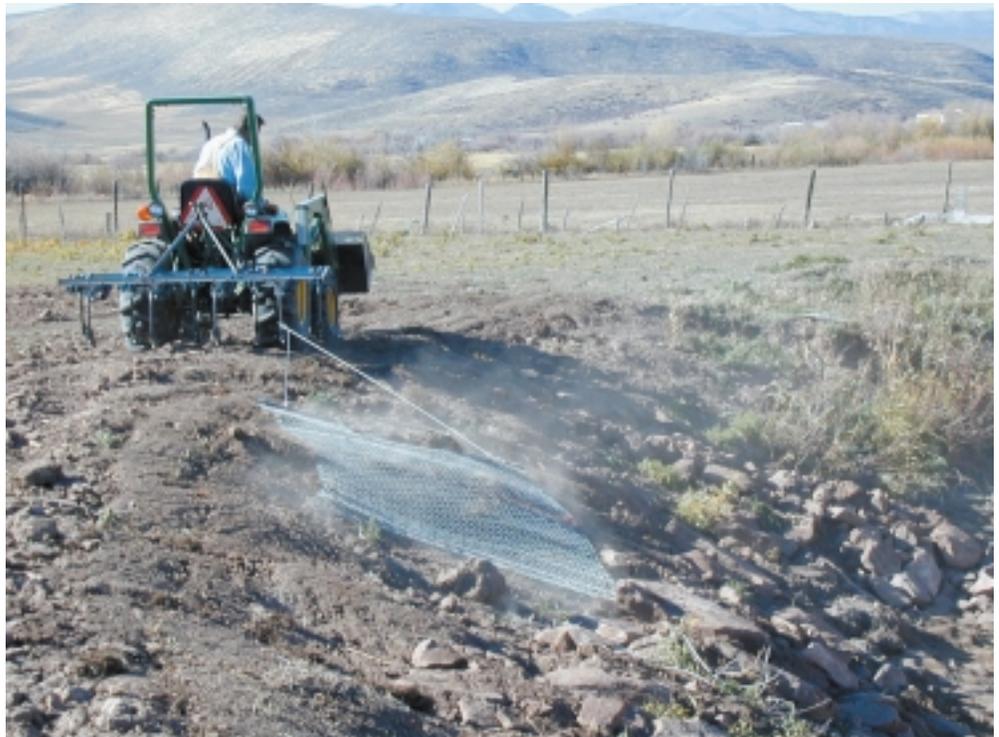
FIGURE 6 *Photo 5. Harrowing soil after broadcasting seed*

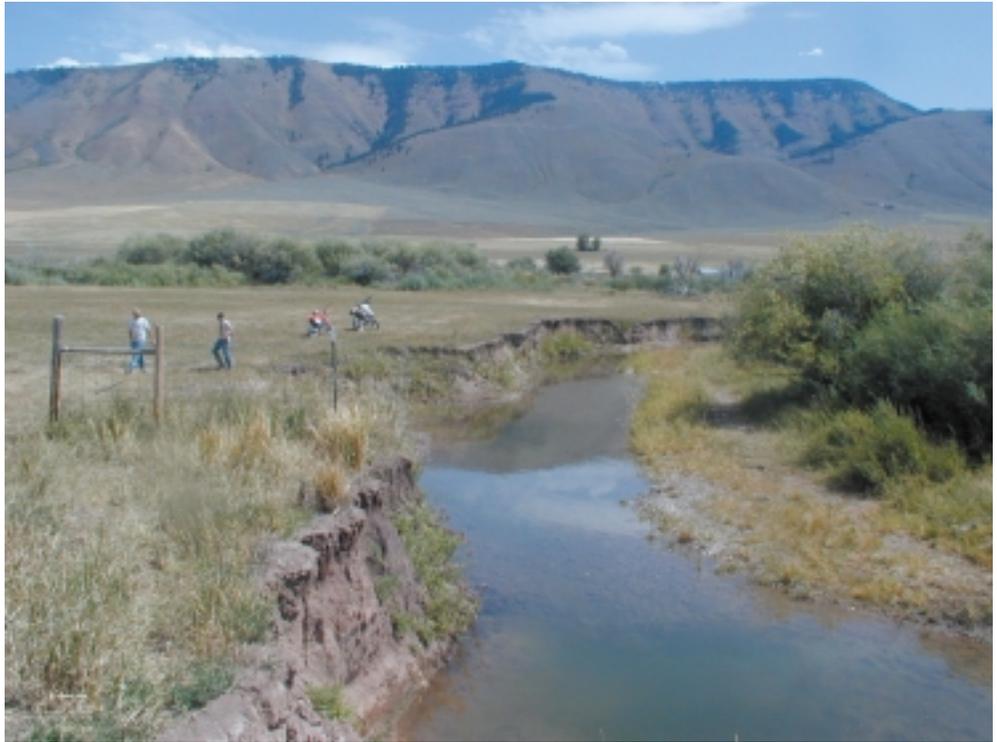
FIGURE 7 *Photo 6. Prior to implementation of BMPs (Fall, 2002)*

This is the third bank stabilization project that Garth Boehme has participated in. Photos 6 and 7 were taken in the fall of 2002 and spring of 2003 after construction. Of particular interest is the width of the channel in these photos. Prior to construction, the creek spanned the width of the channel. After reducing the angle of the bank and constructing a bank barb, the channel width was reduced. Also of interest is the amount of sediment deposited next to the bank. This occurred during a two-month period over the spring runoff. As a result of the recently aggraded gravel bar, new emergent vegetation is starting to take root on the newly established gravel bed. The location of this project has been an asset based on the amount of vegetation present at the site. We have been able to experiment with different methods of revegetation and have seen some encouraging results. Prolific stands of willow and sedge have been available for transplant. We have found that by excavating a hole in the bank next to the water's edge that entire willow communities can be transplanted. This has also held true for sedge and reed grasses. A plug can be transplanted from one location on the project to another without disturbing their life cycle. The benefit of transplanting whole willow plantings can be seen from Photos 8 and 9. Specifically, this corner was treated using a mix of willow plantings and cuttings, which resulted in vibrant growth within six months. The difference in planting and cutting is the number and method used for transplant. A planting involves removal of the entire plant while a cutting is the selective removal of branches. Planting requires heavy equipment to transplant it from one location to another. Cuttings are cut and pressed into the soil at the water's edge. The light colored willow in the middle of the picture on the left-hand side of Photo 9 was the only standing vegetation on this cutbank prior to revegetation. All of the rest were willow plantings and cuttings. Willow cuttings are present in this picture although less visible. This project required treatment of 2163 linear feet of stream bank and construction of 12 bank barbs. Ecological enhancements include three new pool-riffle complexes and re-defined thalweg (deepest point of the channel). Other occurrences of interest at this location include reduction in stream width to depth ratio at three locations as a result of gravel beds forming.

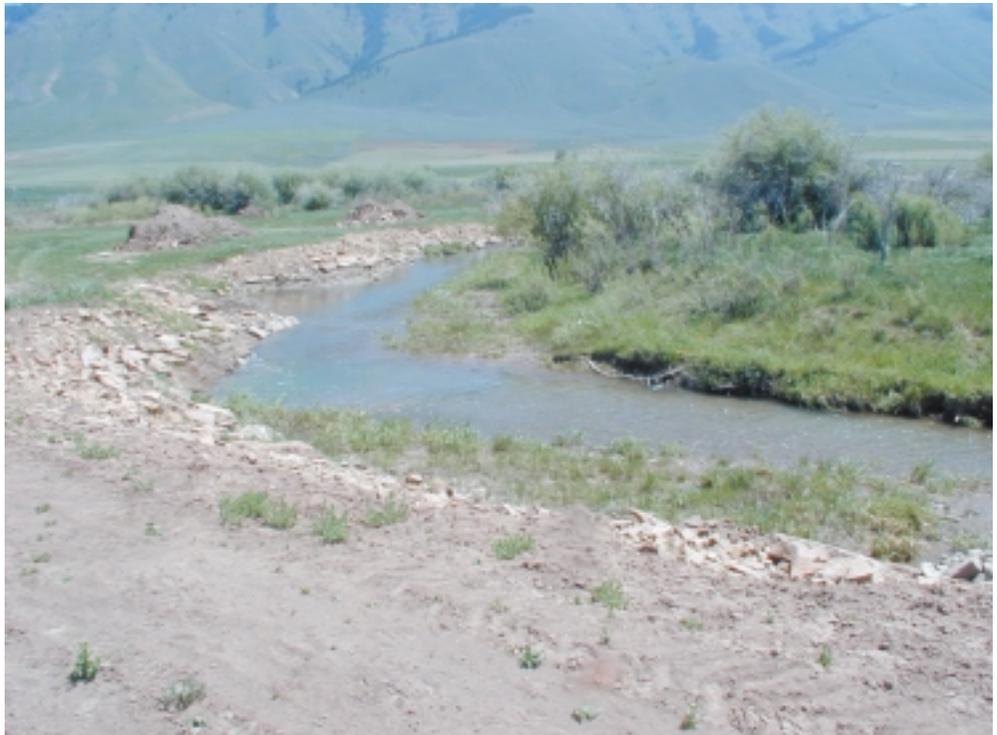
FIGURE 8 *Photo 7. Post-BMP implementation (Spring 2003)*

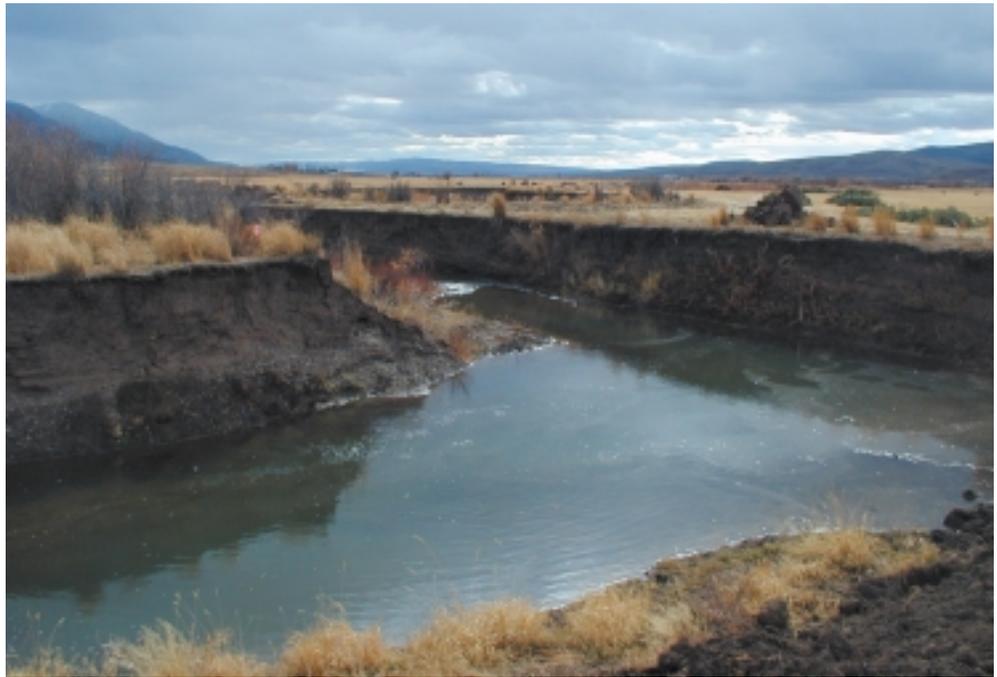
FIGURE 9 *Photo 8. Cutbanks prior to reclamation*

Often banks are found to be eroding at transitional areas between cutbanks on corners. Photos 8 and 9 illustrate how little time is required for riparian vegetation to re-establish on the banks once the soil is stabilized in place using BMPs (Photo 9). Time lapse between Photos 8 and 9 is roughly six months. Treatments along 4275 linear feet of stream bank and 15 bank barbs were required at this project. Roughly, 2100 linear feet of log revetments were used as additional retention devices at strategic locations.

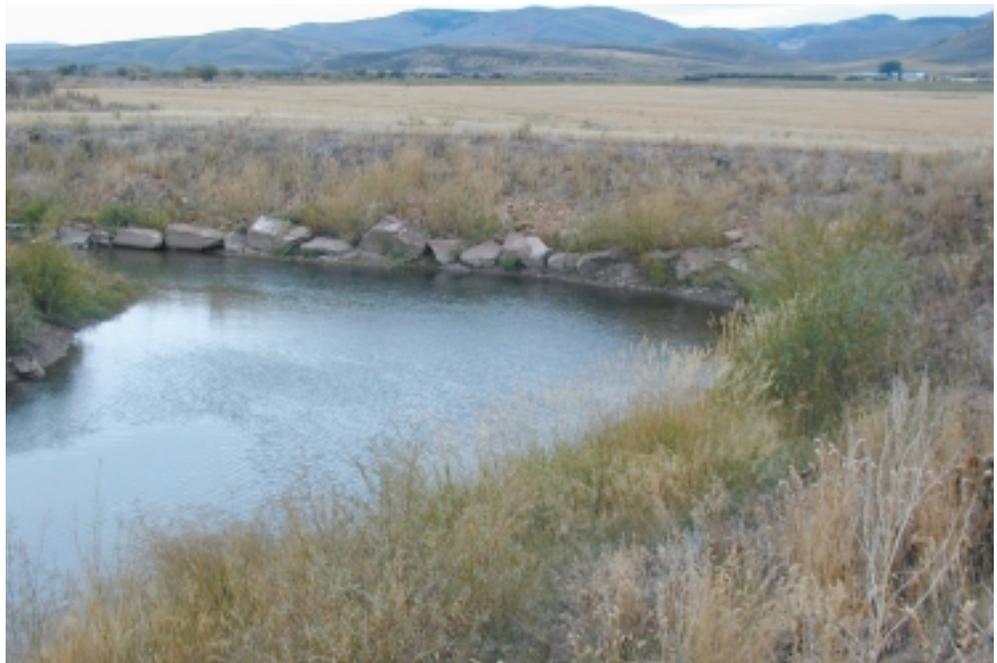
FIGURE 10 *Photo 9. Cutbanks six months after reclamation*

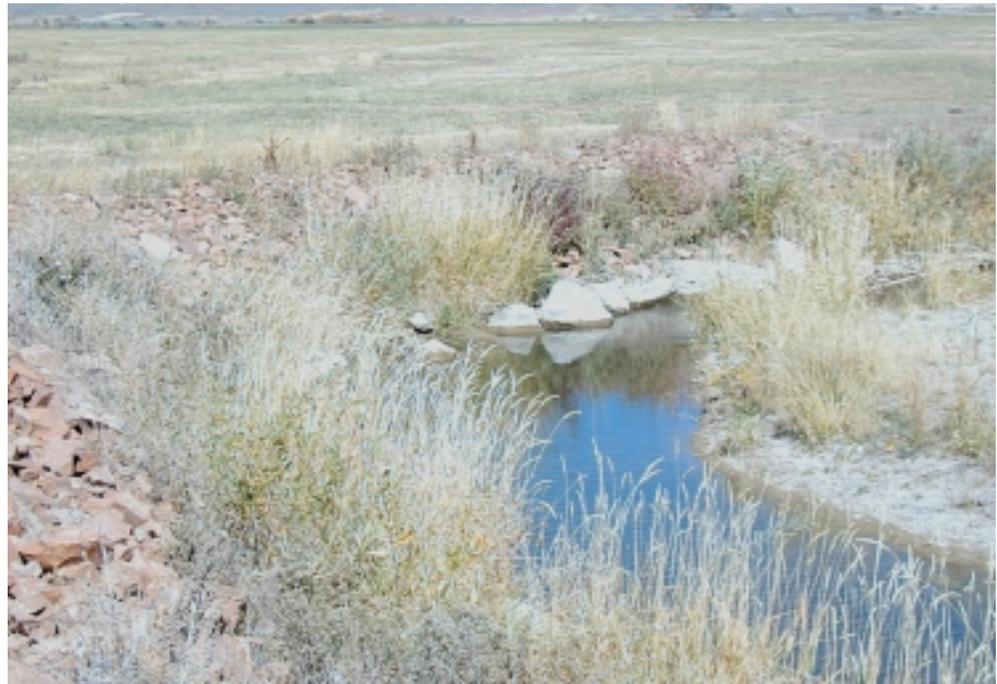
FIGURE 11 *Photo 10. Results of vegetation after five years*

This project was one of the first along Thomas Fork to address bank stability. Now, five years old, riparian vegetation is abundant along treated and untreated banks. Photo 10 shows the ability of vegetation to stabilize the bank when treated and protected. This picture also represents a dichotomy in rehabilitation. The vegetation in the picture along the banks is Canary Reed Grass, which is a non-native species. In some locations this species out competes the native grass seed mix applied. Rock provides a temporary solution until a more permanent vegetative cover can be established. This bank was rip-wrapped from top to bottom to keep soil in place until vegetation could establish. Despite the fact that in purist terms it should not be used as a remedy for erosion, rock rip-wrap accomplishes the objective of bank stabilization and nutrient uptake and is particularly useful in areas where aesthetics are not as important as functionality. Conversation with landowners along Thomas Fork has indicated they lose about three feet of valuable farm ground each year as a result of erosion. After BMPs are implemented that number is drastically reduced. Further illustration of the benefit of BMP implementation can be seen in Photo 11. The left side of the picture is Heber Boehme's property after treatment with BMPs and allowing re-establishment of riparian vegetation. The right side of the picture lacks BMPs and an alternative to grazing management. Prior to treatment both sides of the fence looked like that on the right side. Clearly, implementation of BMPs and landowner cooperation results in a distinct improvement over the converse. Bank shaping and other treatments on this project totaled 1743 linear feet with placement of 13 bank barbs.

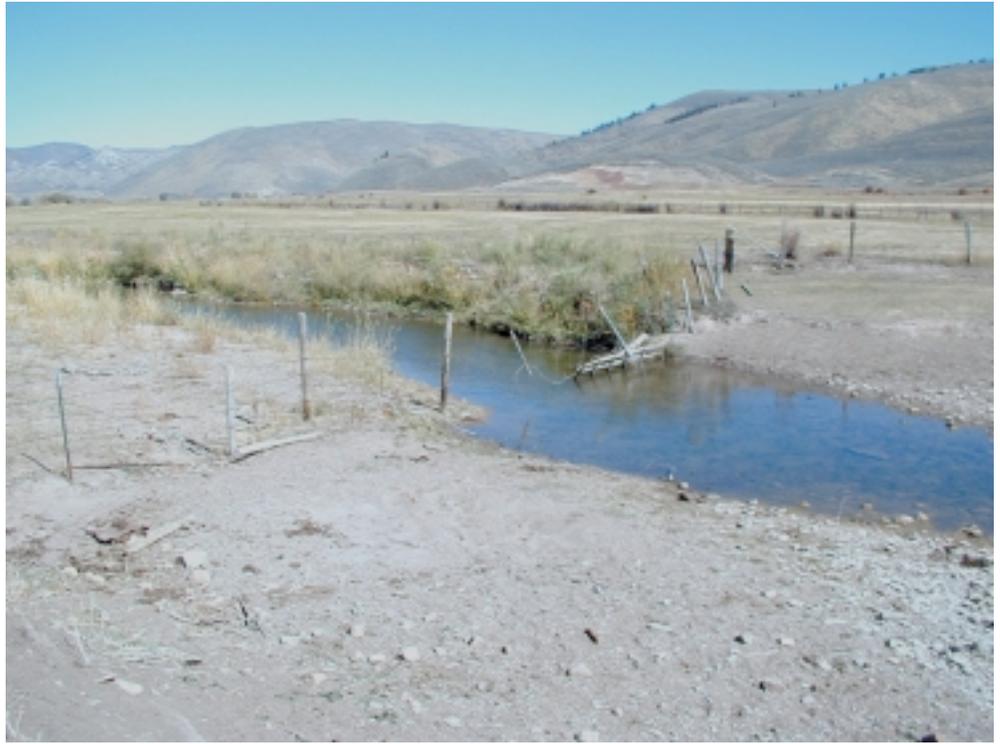
FIGURE 12 *Photo 11. Illustration of the benefits of treated versus untreated land*

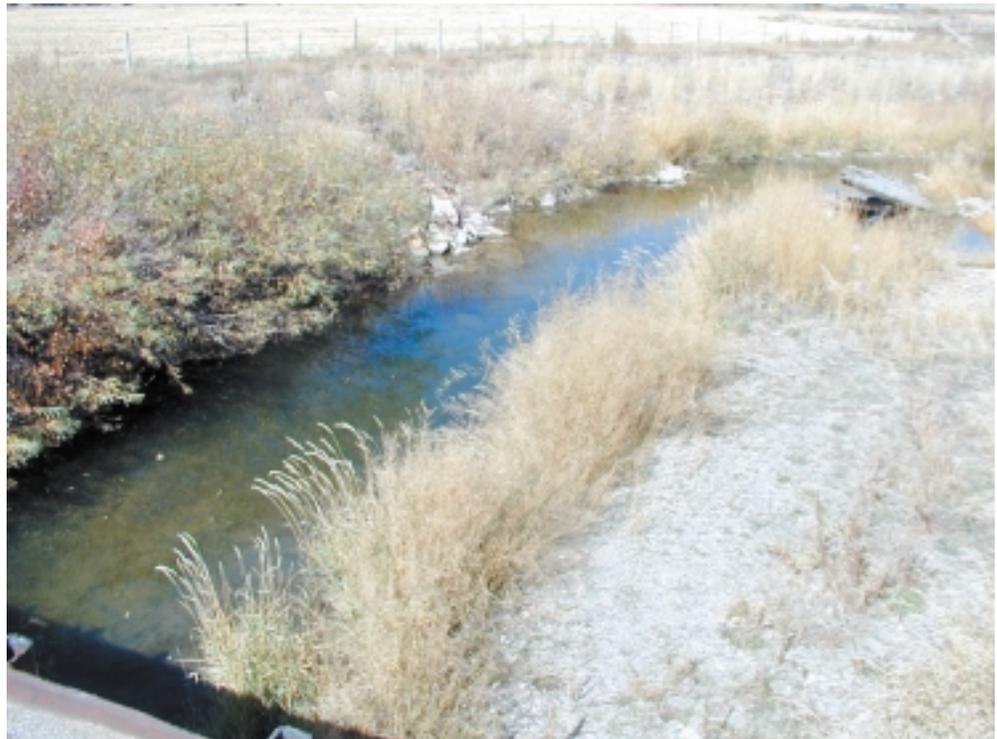
FIGURE 13 *Photo 12. Vegetation and stream channel after six years*

Garth's first bank stabilization project was completed in conjunction with several other projects that seek to keep sediment and nutrients out of the Thomas Fork. Photo 12 was taken six years after treatment. The photo was taken at the downstream terminus of the project from the bridge installed during previous projects. This photograph illustrates the benefit of implementing BMPs on eroding banks and the resulting effect on the channel. Like many other locations along Thomas Fork Creek, this stretch was much wider during low flow before BMP implementation. Prior to construction of upstream bank barbs and bank shaping at this site the channel possessed a much greater width to depth ratio. Post-BMP implementation has found the streambed in a more confined channel with an aggraded gravel bed only submerged during higher flows. Monitoring indicates that prior to construction the streambed was over twice the current width. The right edge of the photo was the edge of the creek prior to rehabilitation. Rip-wrap placed as temporary treatment has been secondary in benefit to riparian vegetation. This location has a strong community of willows on the opposing bank where previously only vertical bank was present. The bank on the left-hand side was shaped, then rip-wrapped. After several years the rip-wrap is no longer visible and has been completely overgrown with willow communities. The other benefit in this area is the gravel bed, which has aggraded vertically and horizontally and reduced the channel width. Treatments at this location include: bank shaping along 1500 linear feet, 900 feet of log revetments and 15 bank barbs constructed at strategic locations. In addition, 2000 linear feet of fence were erected for livestock exclusion.

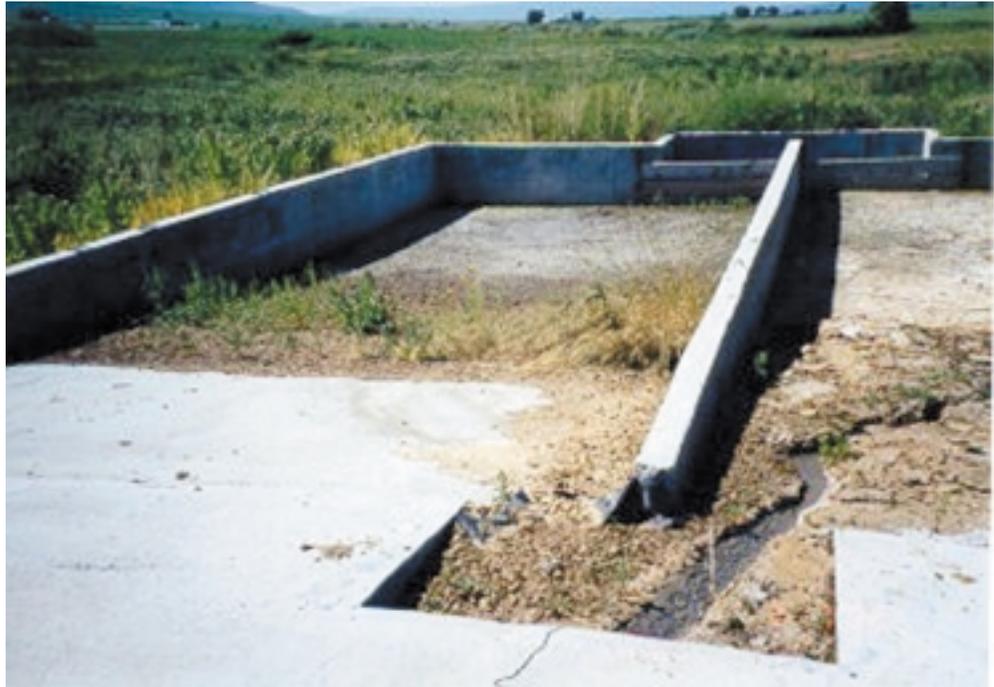
FIGURE 14 *Photo 13. Manure bunker with wetland in the background*

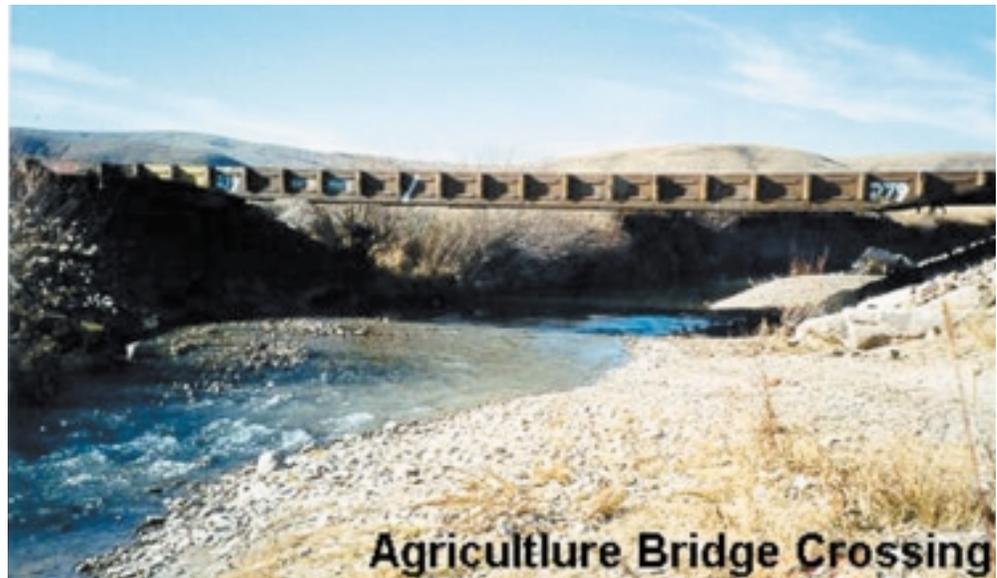
FIGURE 15 Photo 14. Bridge crossing made from an old railroad flatbed car. Since this photo was taken, vegetation has taken over the flood plain where the photographer stood.
