LIBERTY GEM MINE AND MILL SITE

PRELIMINARY ASSESSMENT AND SITE INSPECTION REPORT

Blaine County
State of Idaho

January 2011

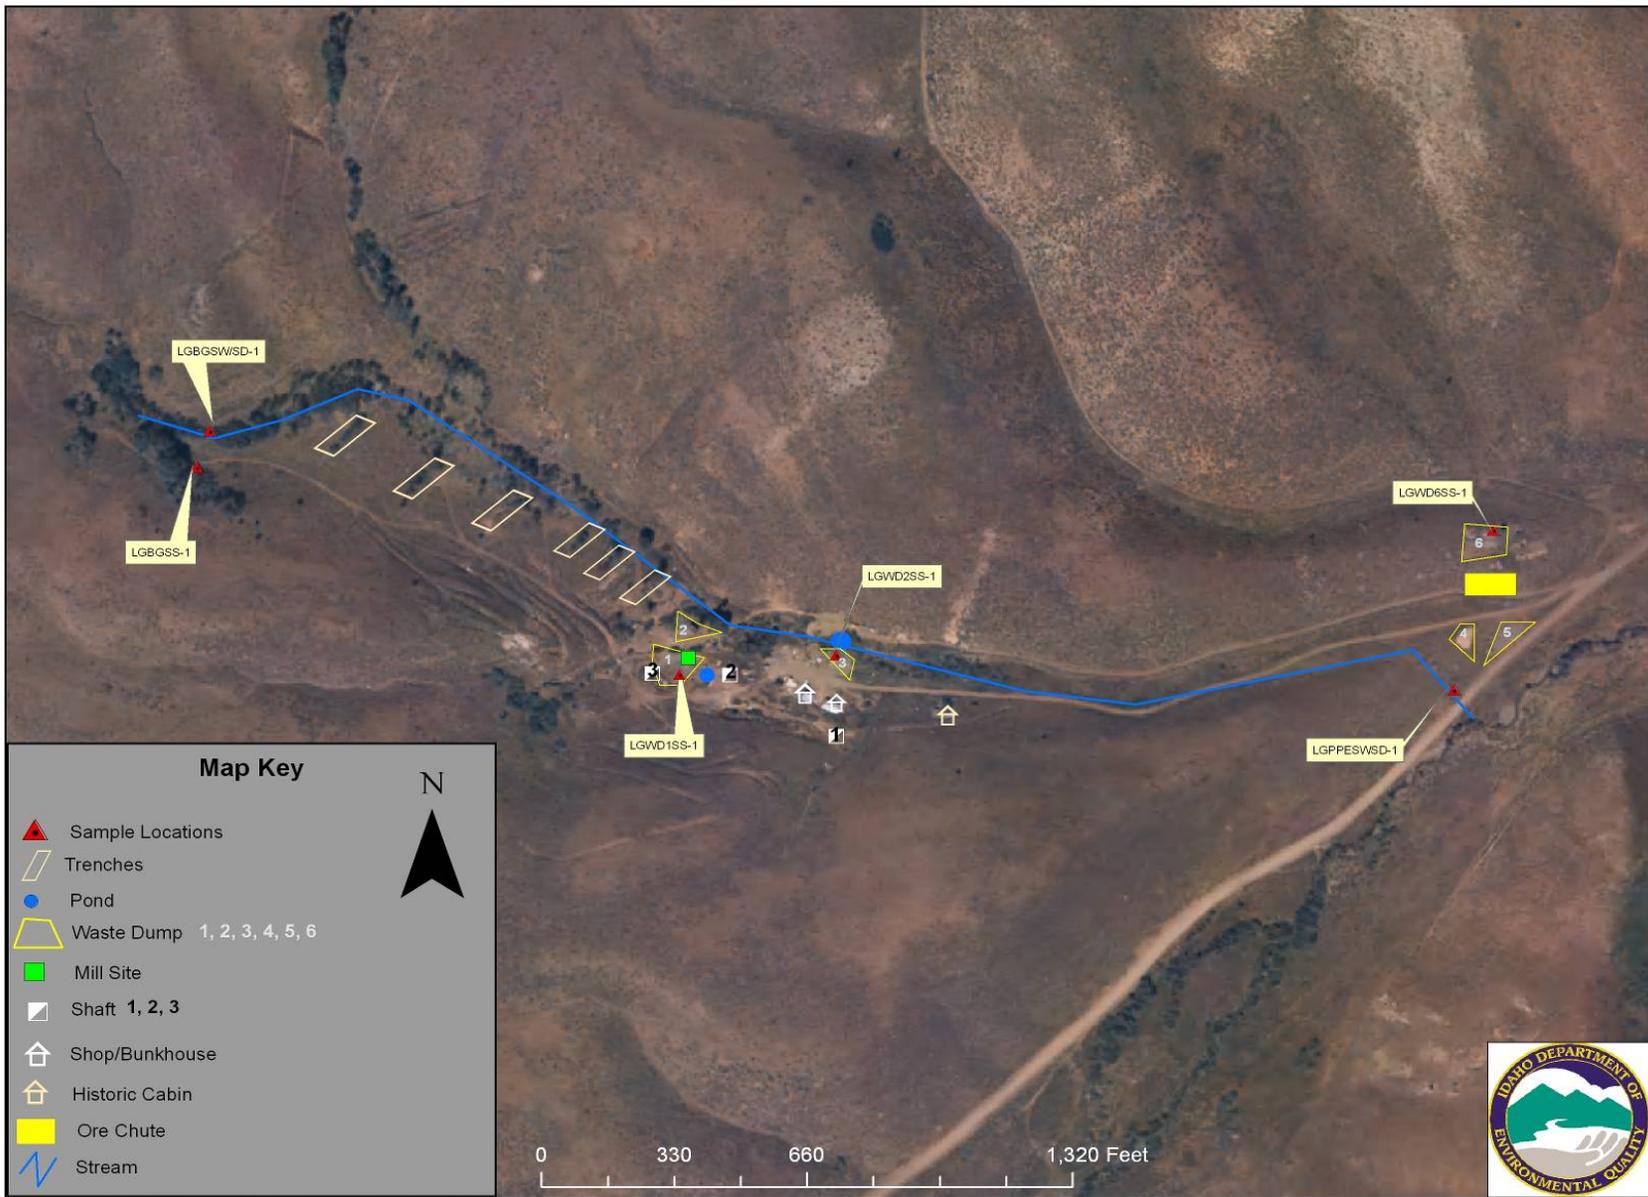
Figure 4. Site map for Liberty Gem mine workings and mill site; sample locations identified. (Map source: NAIP 2004).

The investigation team noted three (possibly four) shafts. Two of the shafts were partially open and two were completely collapsed shut. There were also at least six waste dumps. Samples were collected from three of the waste dumps (LGWD1SS-1, LGWD2SS-1, and LGWD6SS-1). Figure 4 is the site map for Liberty Gem mine and mill site and shows the sample locations.

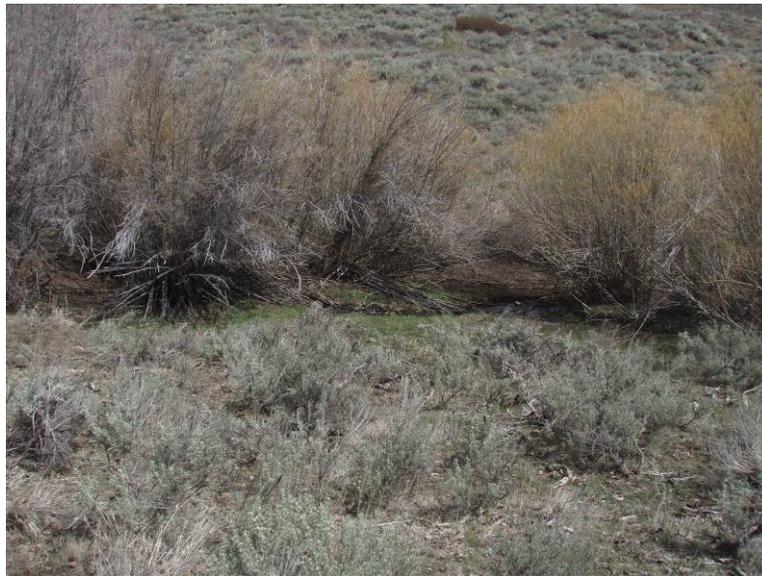
Background samples were collected approximately 1/3 mile upstream from the mine and mill site in Liberty Gulch. Samples LBGGSW1 and LBGSD1 were collected from Liberty Gulch Creek.

Photo 1. Upstream background station on Liberty Gem Gulch Creek. Samples LBGGSW1 and LBGSD1 were collected in the stream channel. (Photo by Schuld 5/10/10)

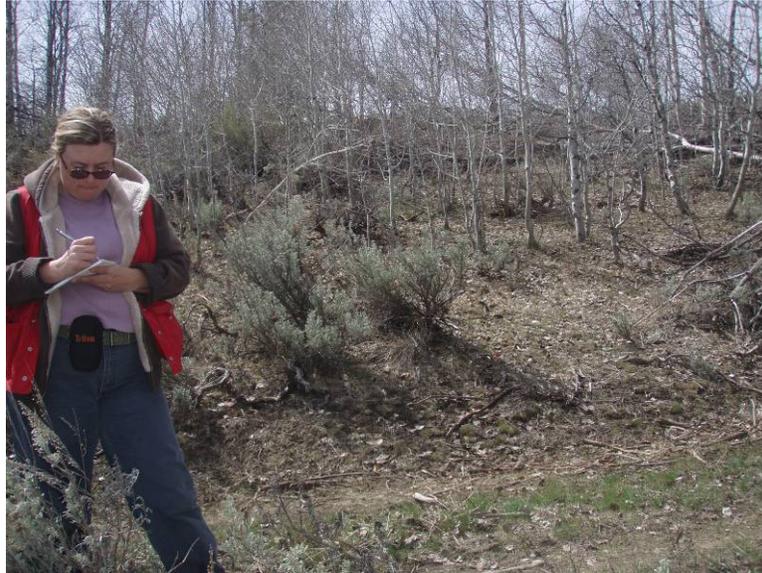
Sample LBGSS1 was collected from above the cut bank of the roadway approximately ¼ mile upgradient in Liberty Gulch Creek drainage.

*Photo 2. Liberty Gem background soil sample LBGSS1 was collected above the cut bank from the roadway.
(Photo by Schuld 5/10/10)*

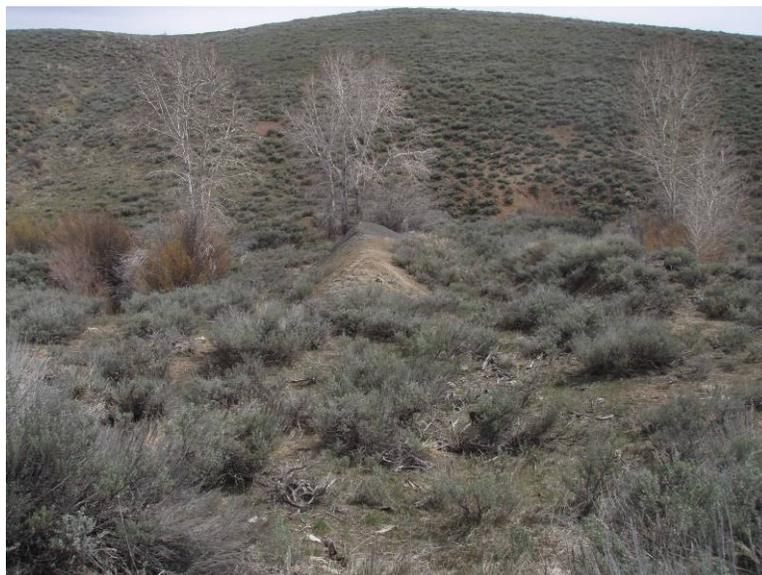
DEQ observed perhaps six trenches and berms above the main workings that were constructed perpendicular to the flows of Liberty Gulch Creek, presumably to store water. These trenches may have been intended for exploration. None of the dumps are significant in size and are well vegetated and stable.

Photo 3. Trenches and berms constructed perpendicular to the flows of Liberty Gulch Creek. (Photo by Schuld 5/10/10)

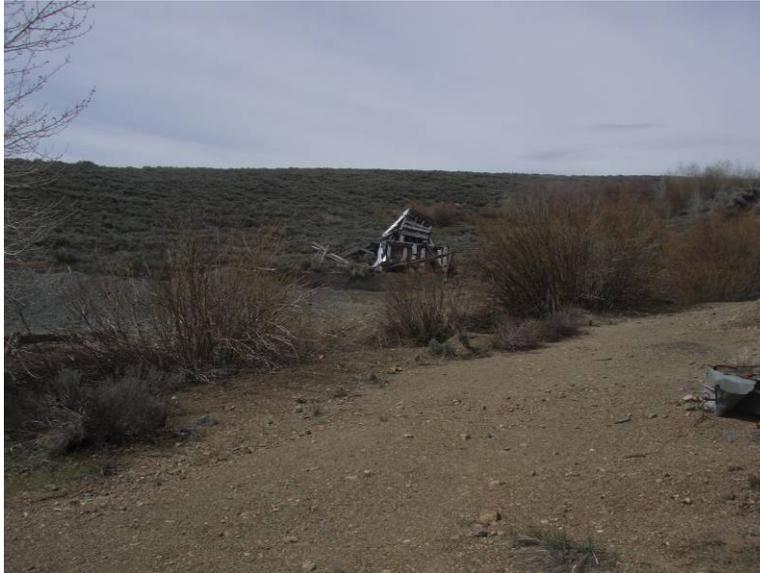
Liberty Gem Shaft #3 is partially open and is considered a dangerous opening which should be closed or restricted.

Photo 4. Residual wreckage of head frame above Liberty Gem Shaft #3. (Photo by Schuld 5/10/10)

According to Johnny Garth (BLM) in a phone interview, the head frames for the shafts may be removed by the BLM if future funding permits. Fencing around the shafts could provide some protection against trespassing.

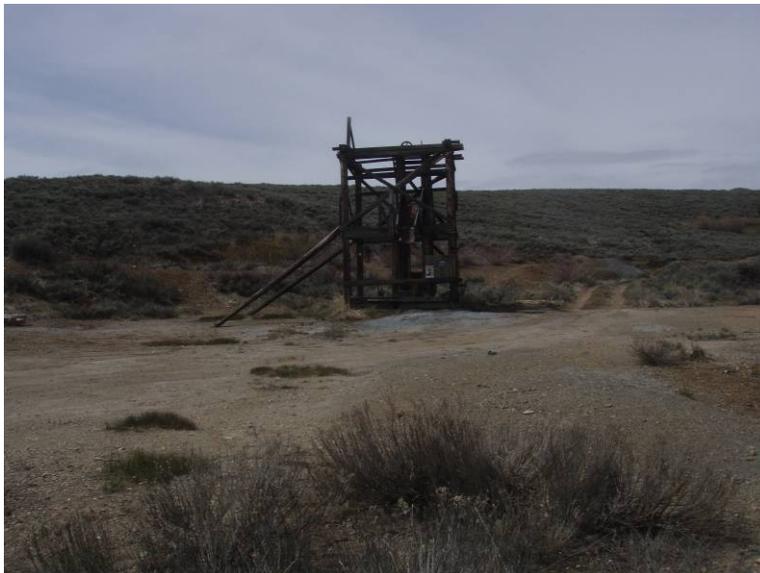
Liberty Gem Shaft #2 is partially open and may be a dangerous opening that should be permanently closed or restricted.

Photo 5. Headframe above Liberty Gem Shaft #2. (Photo by Schuld 5/10/10)

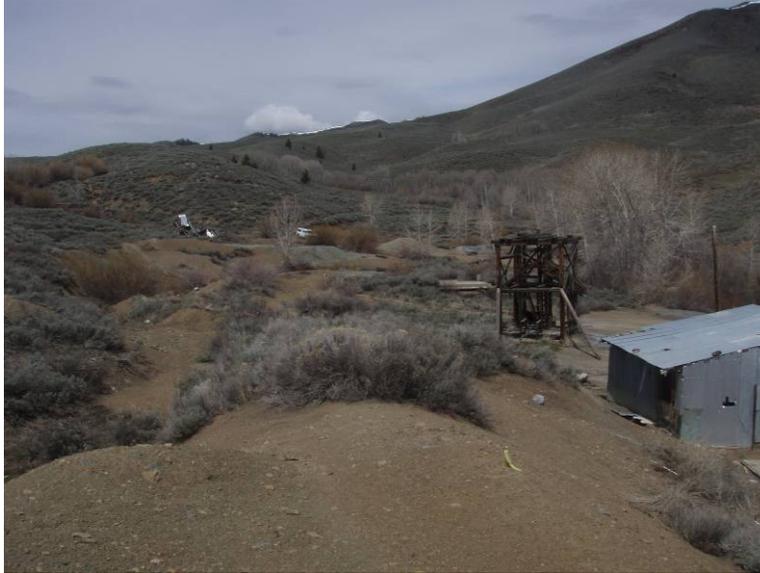
Photo 6. From right to left, shop building, Shaft #2 and Shaft #3 in the distance. (Photo by Schuld 5/10/10)

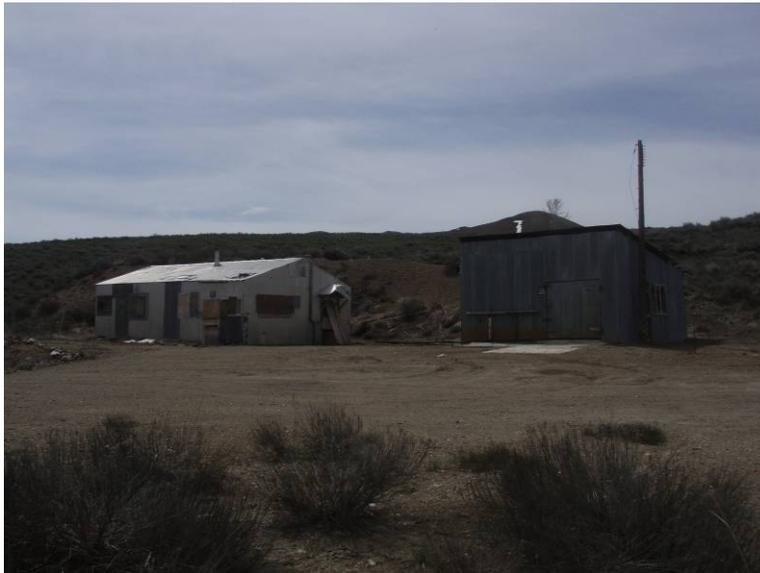
DEQ observed the shop and bunkhouse remaining on the site. Both buildings have access restricted and are posted against trespass.

Photo 7. Liberty Gem shop and bunkhouse. (Photo by Schuld 5/10/10)

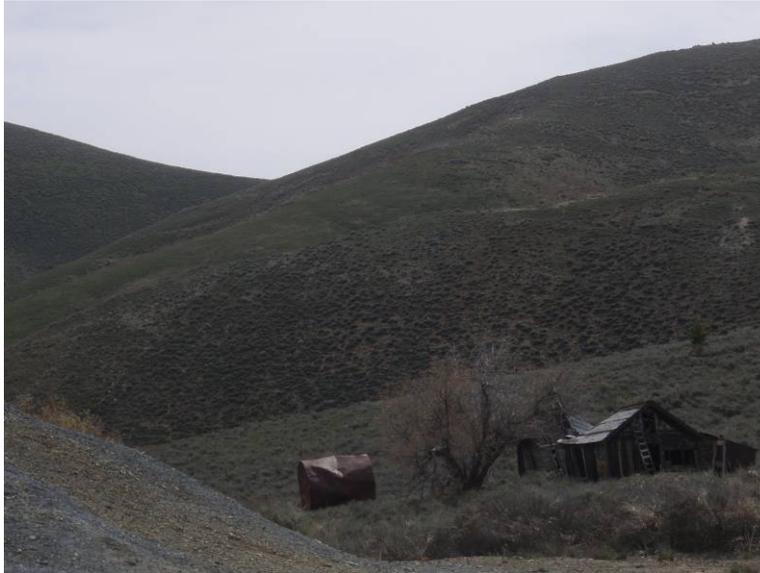
DEQ observed a historic mine shack or bunkhouse approximately 300 yards downhill from the main mine and mill facilities.

Photo 8. Historic mine shack or bunkhouse. (Photo by Schuld 5/10/10)

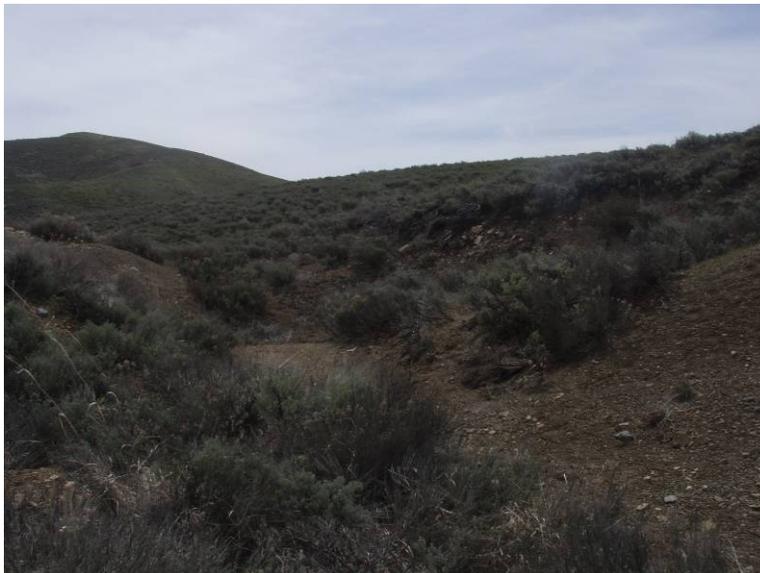
There is a cat cut behind and west of the mine shop and bunkhouse. There is a collapsed structure in the center of this cat cut that resembles the surface expression of another shaft. This could possibly be the Shaft #1.

Photo 9. Cat cut behind and west of the mine shop and bunkhouse. (Photo by Schuld 5/10/10)

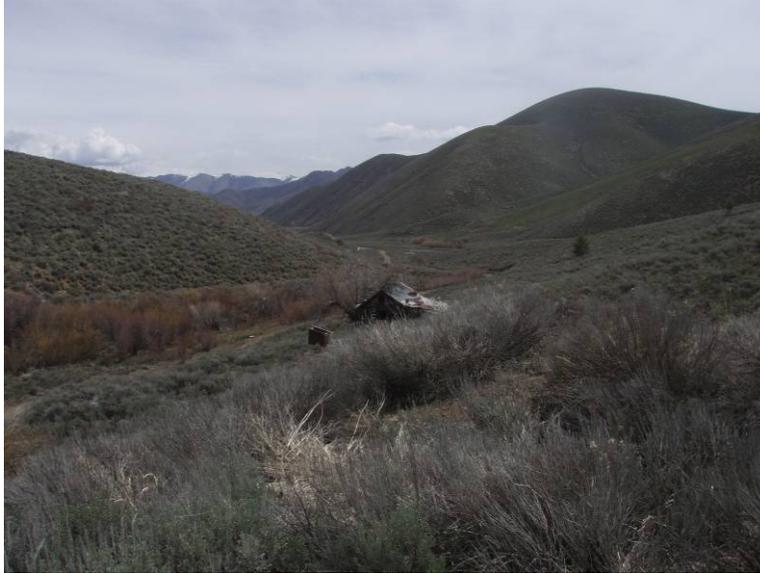
Photo 10. View of Liberty Gem Gulch where it joins with the Croy Creek drainage. (Photo by Schuld 5/10/10)

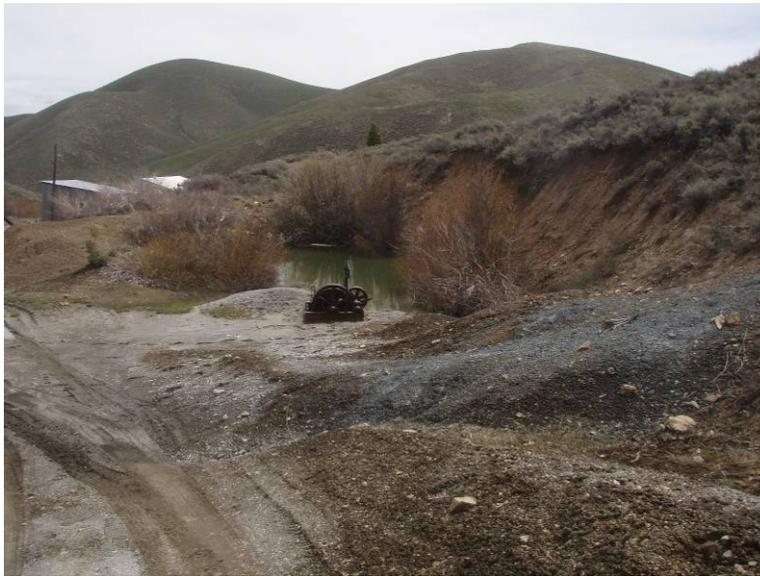
There are two ponds on the mine and mill site. The first pond is located northwest of the shop and bunkhouse and has a hoist drum and foundation platform at the pond's edge. This depression may either be the actual location of Shaft #3 depicted on topographic maps or it may be the location for a fourth Shaft. The perimeter of the pond is well vegetated.

Photo 11. A small pond containing water. (Photo by Schuld 5/10/10)

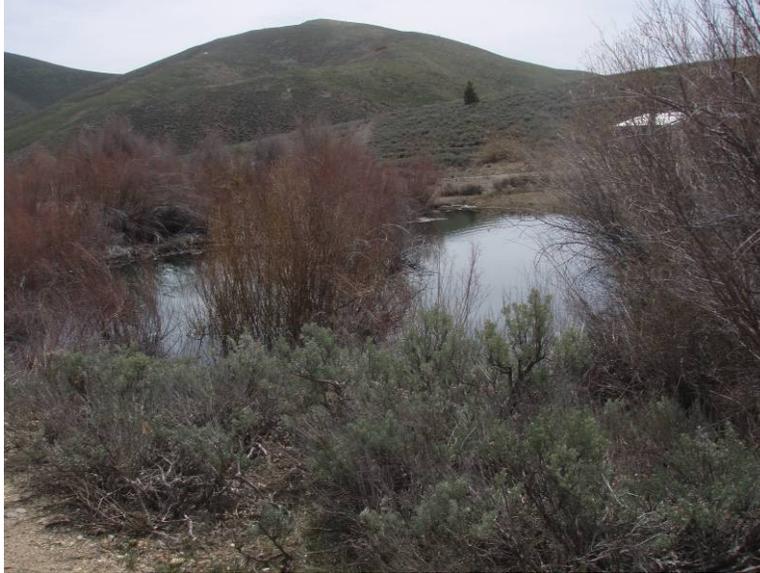
The second pond is on Liberty Gulch Creek. There is a man-made dam on the south end of the creek. The pond is heavily vegetated. IGS observed ducks nesting on their site inspection. DEQ observed macro invertebrates in the pond. This pond is approximately 50 ft in diameter and may be a jurisdictional wetland. During inspection of the second pond, DEQ noticed refuse in the pond.

Photo 12. Pond on Liberty Gulch Creek adjacent to the mine shop and mill facilities. (Photo by Schuld 5/10/10)

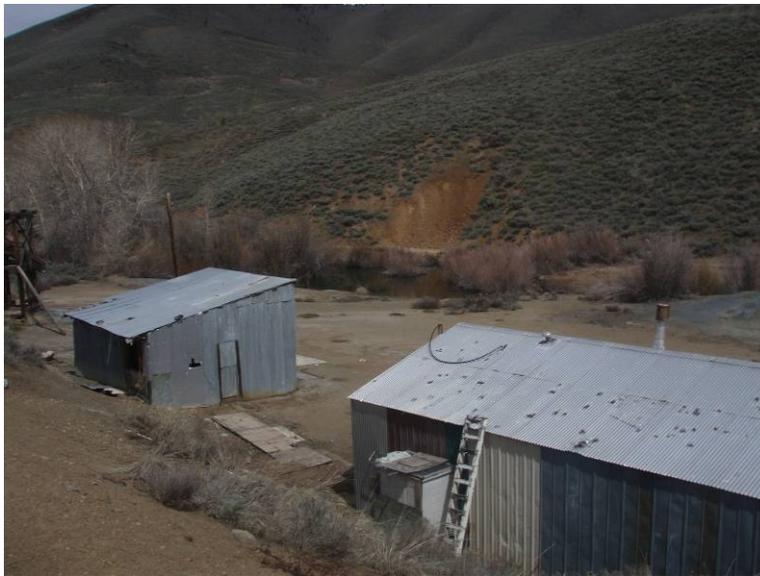
Photo 13. Looking over the back of the shop and bunkhouse to the second pond in the background. (Photo by Schuld 5/10/10)

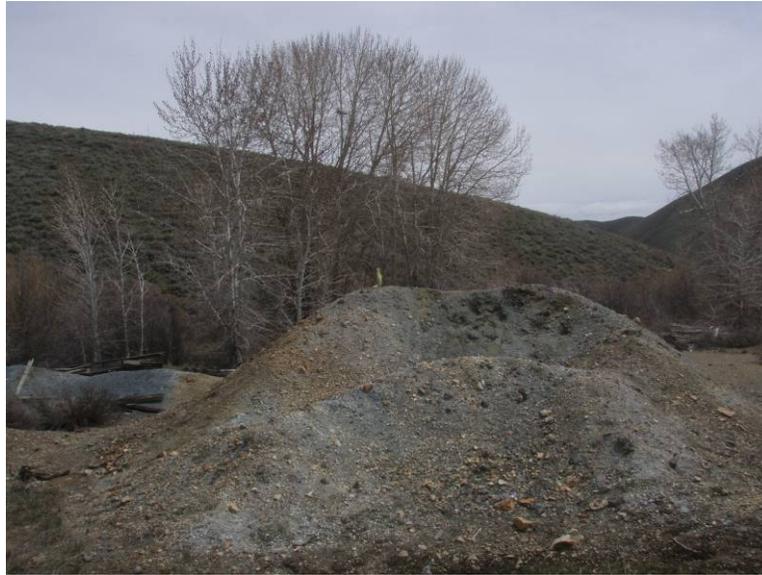
Waste Dump #1 appears to contain less than 700 yards of grey/buff colored oxidized ores and approximately less than 100 cubic yards of low grade ore. Soil sample LGWD1SS-1 was collected from Waste Dump #1.

Photo 14. Stockpile of perhaps 10 cubic yards of mineralized waste rock on Waste Dump #1. Sample LGWD1SS1 was collected here. (Photo by Schuld 5/10/10)

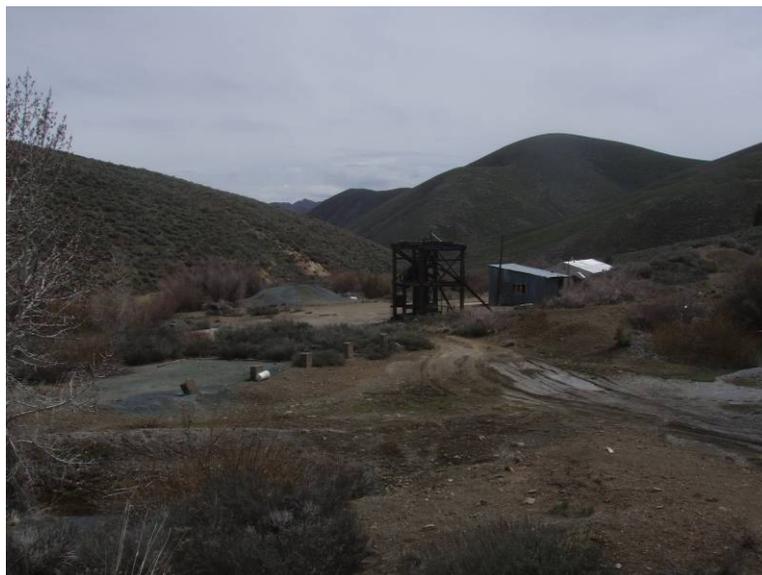
Waste Dump #2 probably contains less than 1,000 cubic yards of waste of mostly non-metaliferous country rock. Approximately 50 cubic yards of material appeared to be low-grade ore.

Photo 15. Waste Dump #2 is located in the foreground of the picture, on the left side. Shaft #2 head frame and Waste Dump #3 are in the background. (Photo by Schuld 5/10/10)

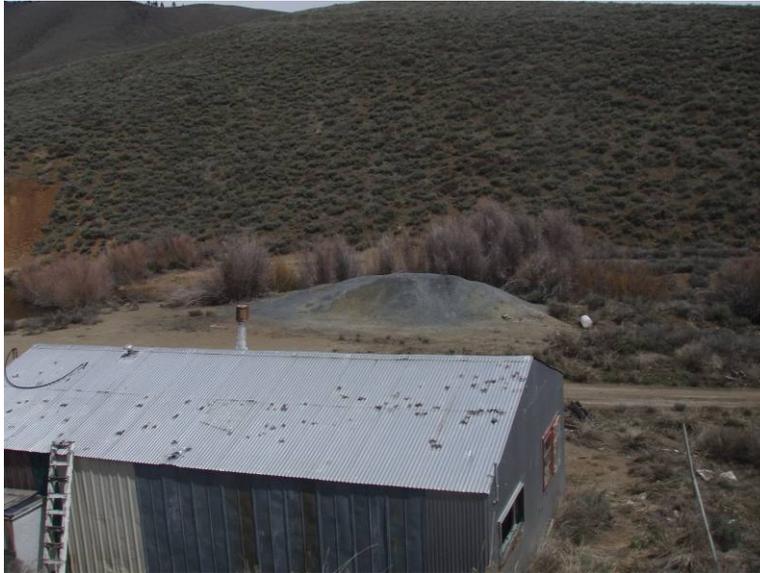
Waste Dump #3 is located adjacent to the second pond on the site. Sample LGWD2SS-1 was collected at this location. The sample designation is incorrect and should be LGWD3SS-1. Sample LGWD2SS-1 is designated this way in the sample analysis. Like the previously mentioned waste dumps, the material was a mixture of grey/buff colored oxidized ores. Approximately 50 percent of the material passed through a +9 mesh and was coarse.

Photo 16. Low grade ore stockpile on Waste Dump #3. (Photo by Schuld 5/10/10)

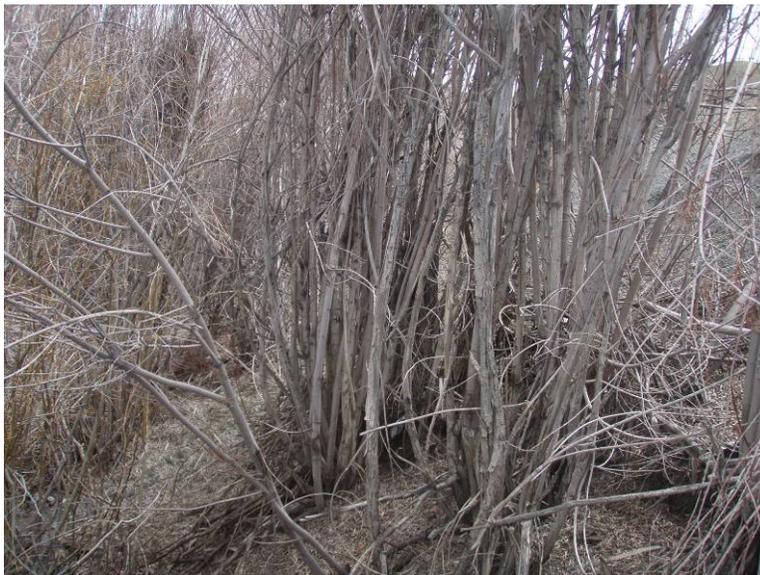
The toe of a low grade ore stockpile on Waste Dump #3 is in the adjacent flows and riparian area of Liberty Gulch Creek.

Photo 17. The toe of a low grade ore stockpile on Waste Dump #3. (Photo by Schuld 5/10/10)

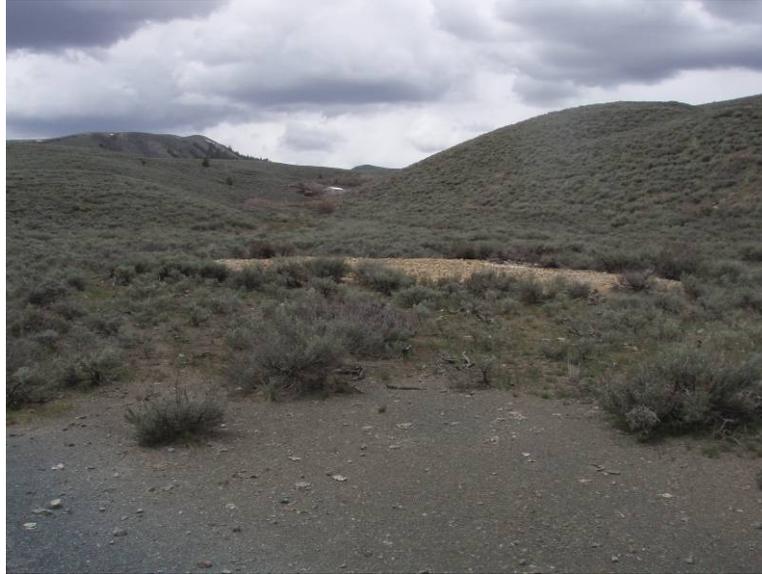
the main stockpile and loading area (not pictured) and the two thinly dispersed stockpiles photographed here. Combined there probably isn't 30 cubic yards of mine wastes present. The larger stockpile was designated as Waste Dump #4. Waste Dump #4 contains approximately 20 cubic yards of buff/tan altered rock with iron staining.

Photo 18. One of the thinly dispersed stockpiles designated as Waste Dump #4. (Photo by Schuld 5/10/10)

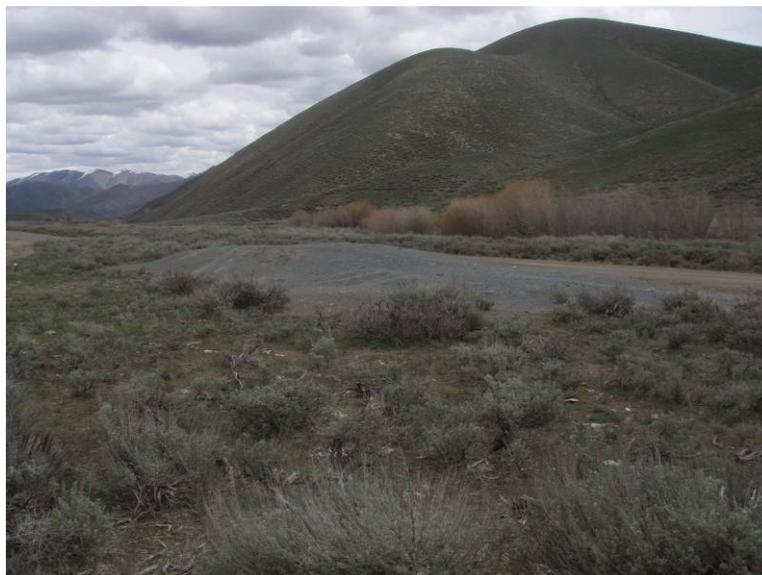
The small low grade stockpile pictured below was designated as Waste Dump #5. This dump contained less than 30 cubic yards of waste rock, mostly grey in color from the Milligen formation which consists of limestone and slate.

Photo 19. Small low grade stockpile designated as Waste Dump #5. (Photo by Schuld 5/10/10)

The dust from Waste Dump #5 may pose a risk to recreationists, if they are in the area for long periods of time. Access controls may manage some of those risks, particularly for Off Road Vehicle users. Therefore, DEQ recommends reclamation or fugitive dust management on these dumps.

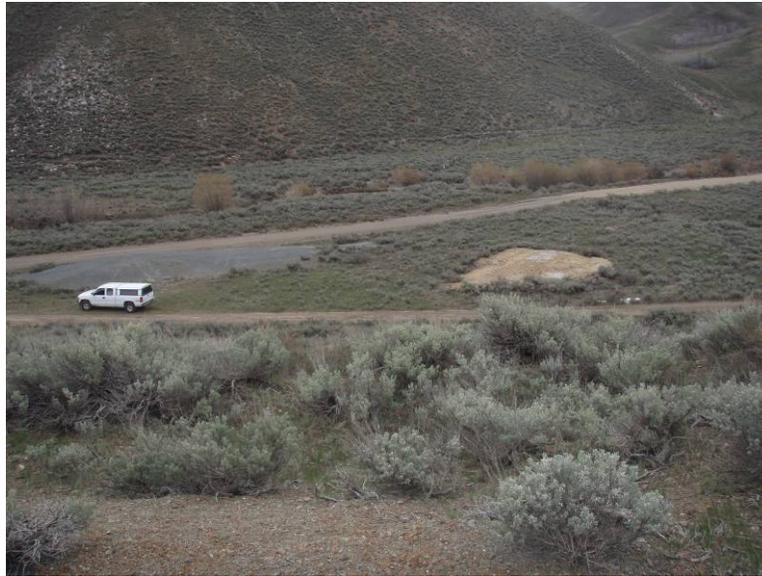
The picture below illustrates the view from the ore chute (loading bin area) and the size of Waste Dump #4 and Waste Dump #5. Waste Dump #5 showed signs of recreational use; motorcycle tracks can be seen above the truck. This dump is the closest to the road and most accessible to recreationists.

*Photo 20. Waste Dumps #4 (buff/tan colored) and #5 (grey).
(Photo by Schuld 5/10/10)*

The dust from Waste Dump #5 may pose a risk to recreationists, if they are in the area for long periods of time. Access controls may manage some of those risks, particularly for Off Road Vehicle users. If access is to remain unrestricted, DEQ recommends reclamation and/or fugitive dust management of mine dumps.

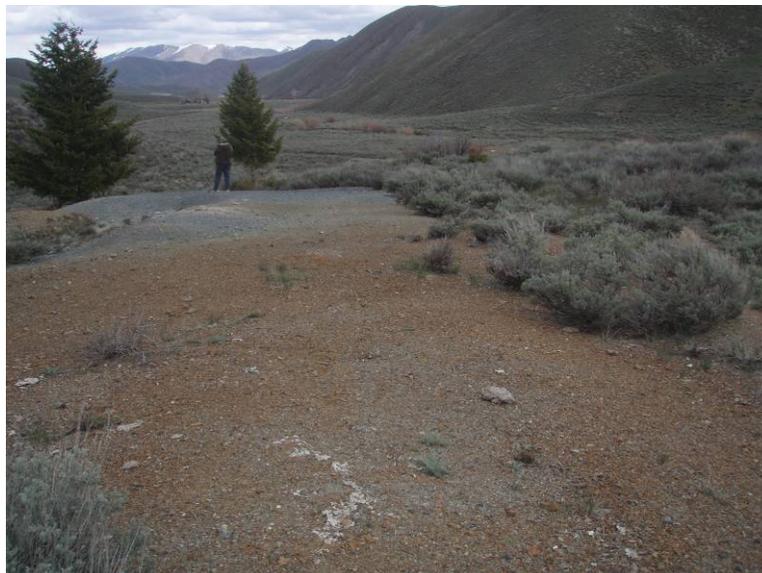
On a small ridge overlooking the intersection of Croy Creek Road and Liberty Gem Gulch Road there is another stockpile of ore and loading chutes which contain less than 1,000 cubic yards of ore. This area was designated Waste Dump #6. Sample LGWD6SS-1 was collected from Waste Dump #6.

Photo 21. Waste Dump #6. (Photo by Schuld 5/10/10)
