**Deadwood Mine
Preliminary Assessment Report
Valley County, Idaho
TDD: 99-02-0007**

SUBJ: Site Recommendations
Deadwood Mine
Near Lowman, Idaho

**DEADWOOD MINE
PRELIMINARY ASSESSMENT REPORT
VALLEY COUNTY, IDAHO**

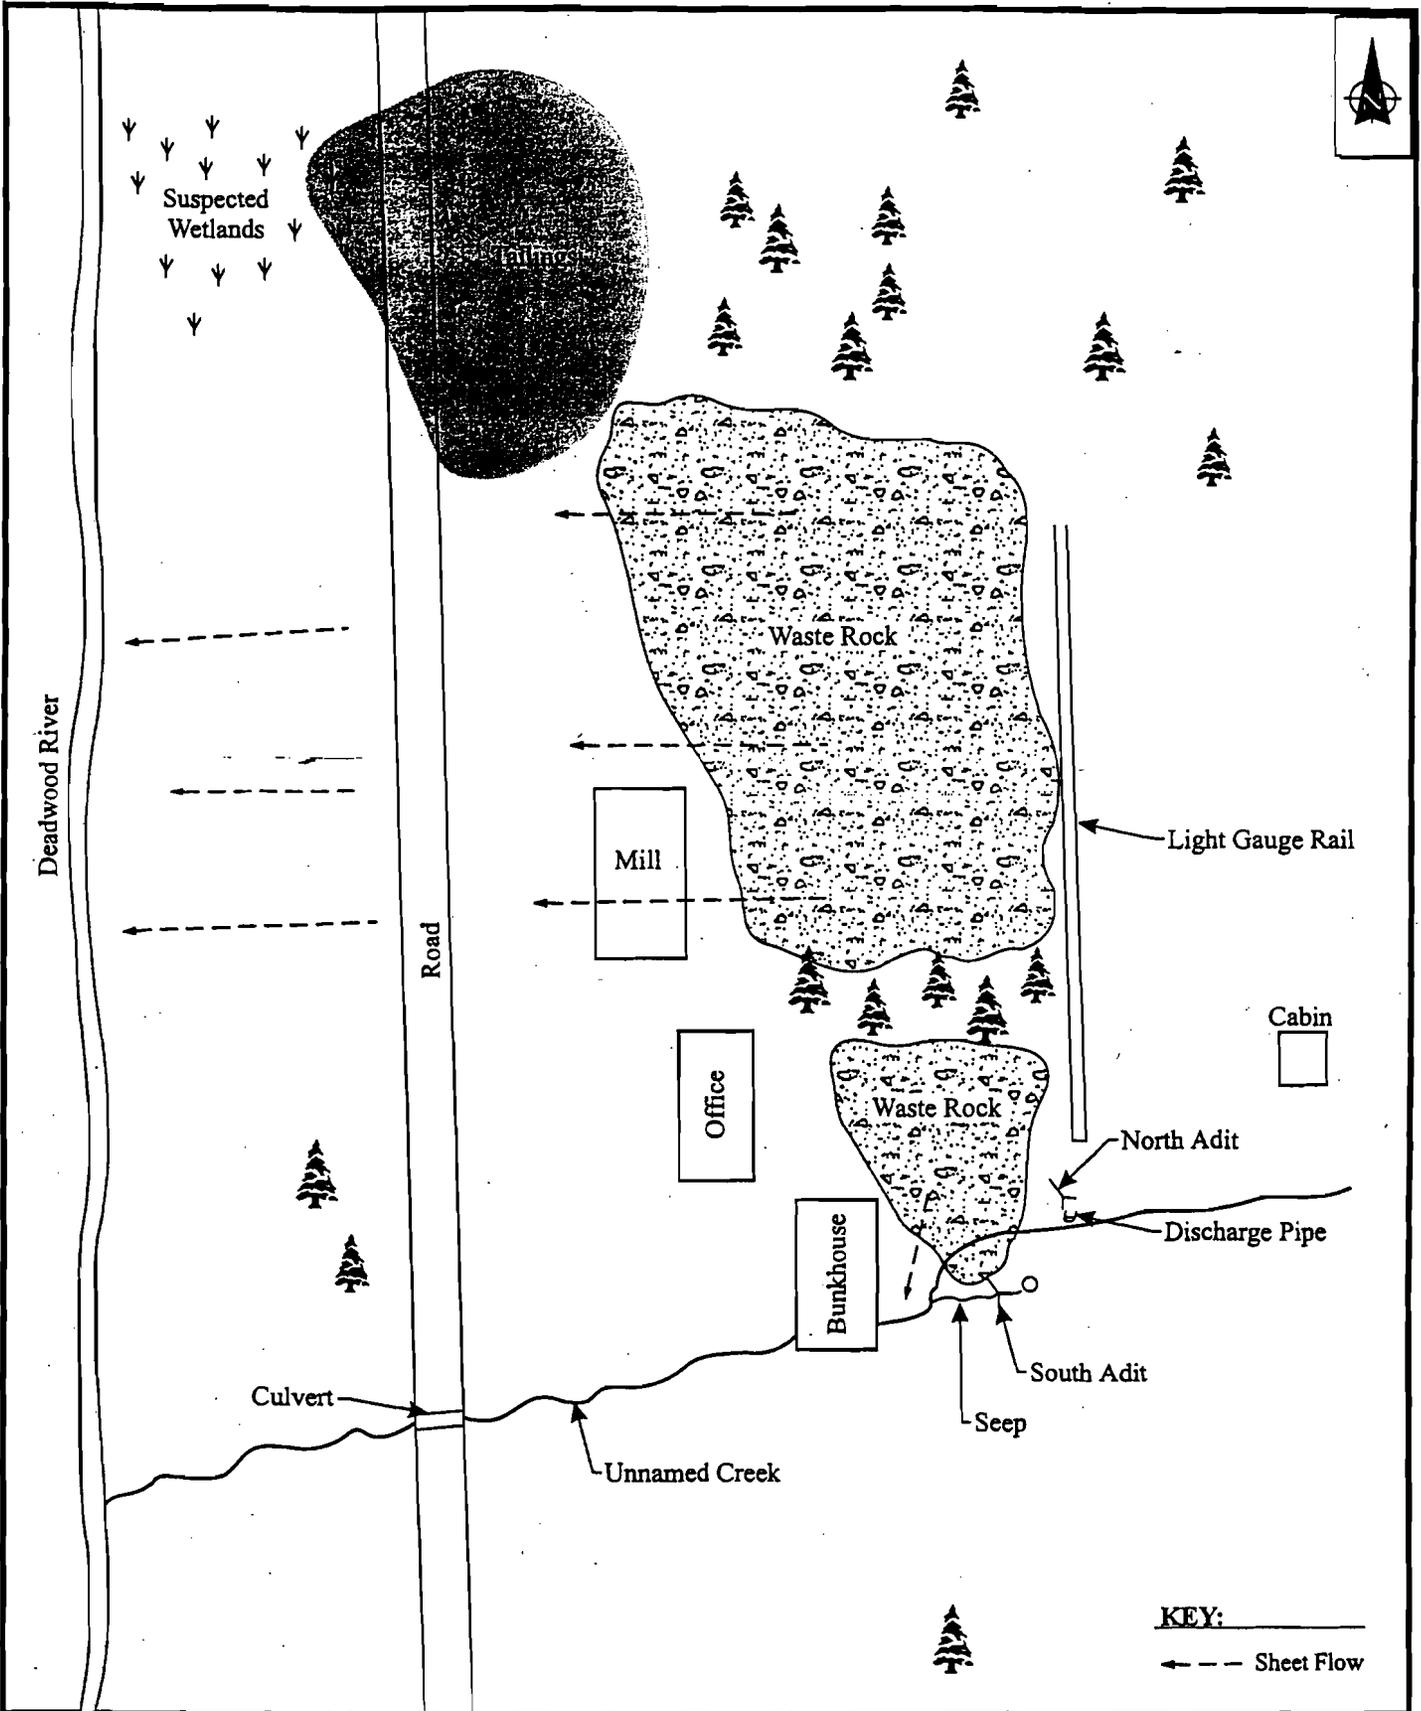
Figure 2-3
SITE MAP

portion of the mill building once stood. The former office building is a three-story building that is in good condition. It appears that this building may have housed a laboratory. Inside the building is a boiler. Pipes associated with the boiler are insulated with a material resembling asbestos. Adjacent to the office is a former bunkhouse, another three-story building in fairly good condition. It appears that this building has some fire damage. Upslope from the bunkhouse is a small cabin. There are two adits on the site located upslope from the former bunkhouse. There is an unnamed creek on the south end of the site that flows beneath the southern side of the bunkhouse and discharges into the Deadwood River (Figure 2-3).

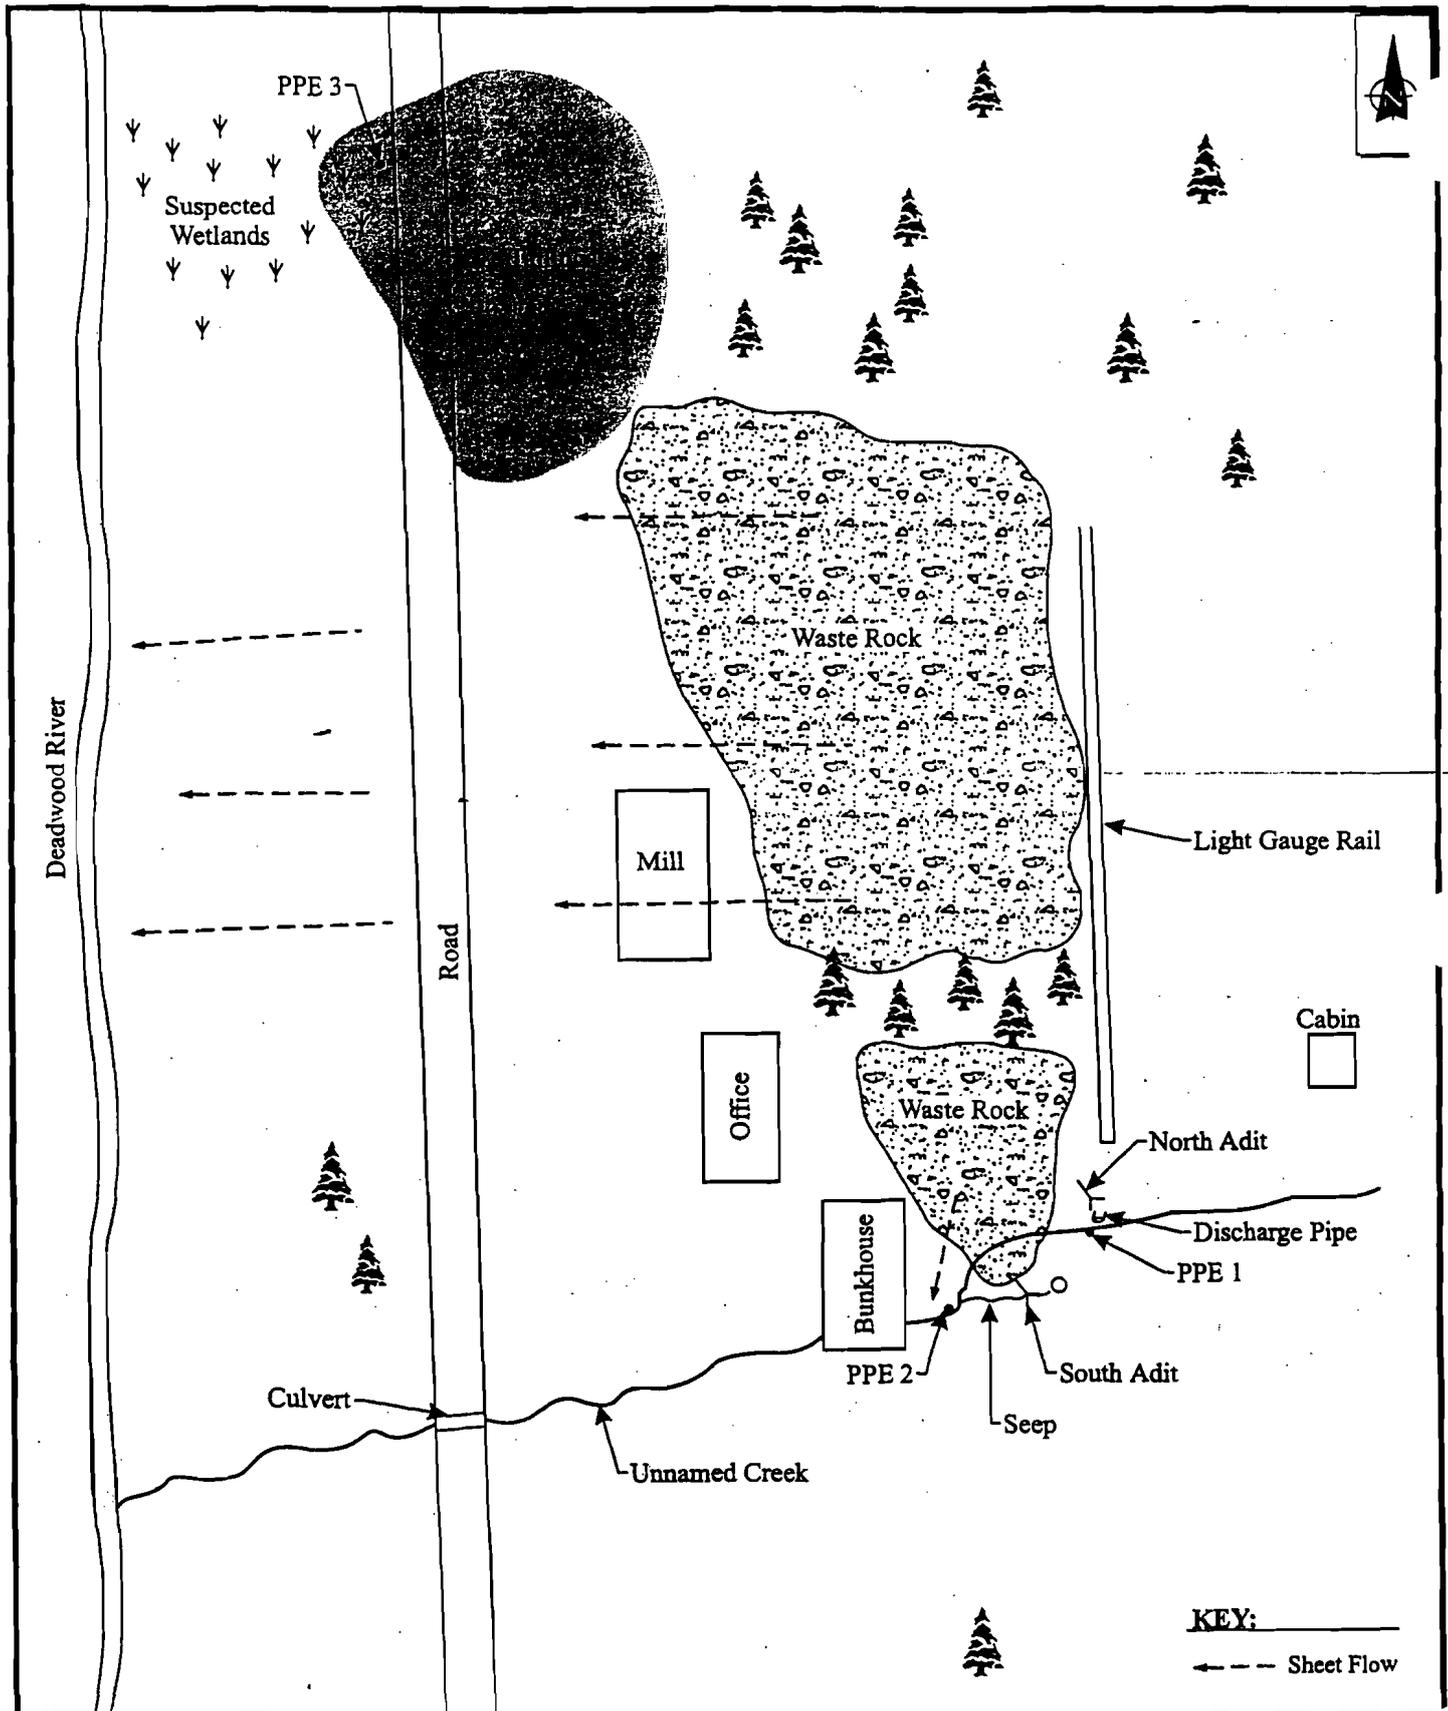
Figure 3-3
 SITE MAP

The unnamed creek also flows through the south end of the waste rock pile and is expected to be perennially flowing, because during low flow conditions in early fall it was flowing (Figure 3-3). Water from the south adit and a seep flows downgradient via a small channel into the unnamed creek approximately 50 feet from its discharge point (PPE 2). Surface water runoff from the tailings and northern portion of the waste rock also may drain by sheet flow into potential wetlands adjacent to the Deadwood River approximately 12 miles from its discharge point into the Deadwood Reservoir (PPE 3). The 15-mile target distance limit (TDL) extends from PPEs 1 and 2 on the unnamed creek to the Deadwood River, from PPE 3 in the wetland adjacent to the Deadwood River for 12 miles to its discharge point in the Deadwood Reservoir, and then for 3 miles in the Reservoir.
