***Stream Channel Analysis  
North Fork Coeur d'Alene River Subbasin***

***Submitted to:***  
*Glen Rothrock*  
*Idaho Department of Environmental Quality*

***Completed by;***  
*Sue Perkins, Geologist, Geomorphologist*  
*Watershed Professionals Network*  
*Boise, ID*

***June 2007***

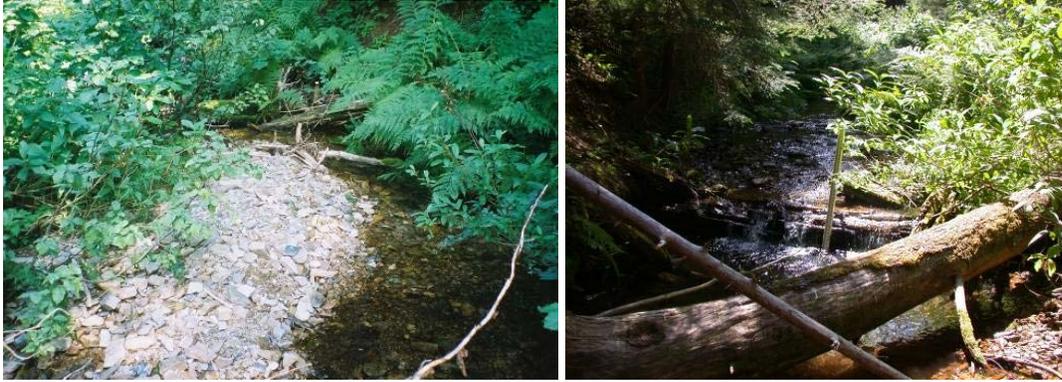
**Figure 2. Forced bars (left) and LWD steps (right) in Big Elk Creek upstream of the 914 crossing.**

Coarse sediment load appeared moderate in the upstream tributaries and upper Big Elk Creek. There were wood-forced gravel bars and sediment wedges upstream from LWD steps (Figure 2). This was partly an artifact of the relative abundance of LWD. Where there was no LWD, the creeks had a plane-bed channel without bars and the sediment load appeared lower. Channels steeper than 4 percent had abundant grade controls in the forms of LWD or boulder and cobble steps. These features provided significant roughness elements to dissipate energy and reduce erosion. These steeper tributary streams either never downcut (e.g., most of US Creek; Figure 3) or have formed a new floodplain and restabilized after downcutting (e.g., uppermost Big Elk Creek; tributary upstream of US Creek; Figure 3). The steeper tributaries are currently not entrenched to slightly entrenched. Although narrow, the valley bottoms are wide enough to allow floodplain development next to the small tributary streams. Floodplain connection no doubt contributes to the lack of current downcutting.

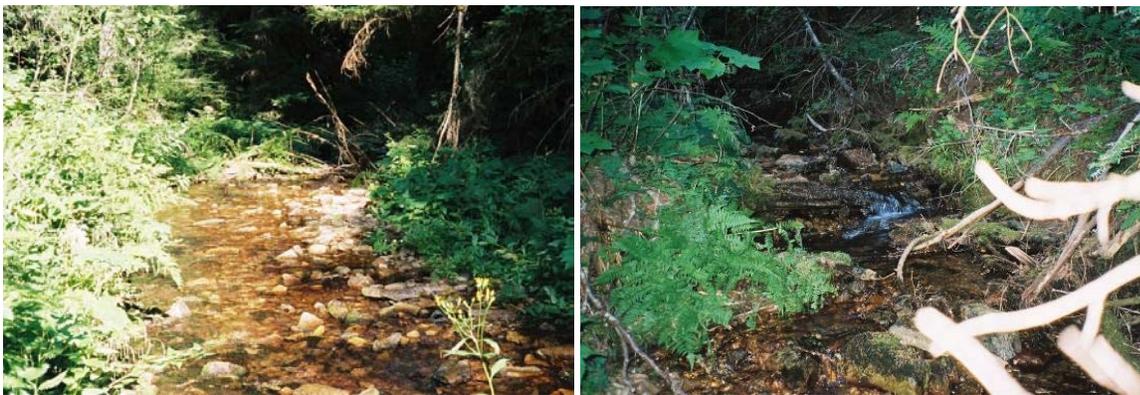
**Figure 3. US Creek (left), which has never downcut and a steep tributary to Big Elk Creek, upstream of US Creek, which downcut slightly and subsequently formed a new floodplain and restabilized.**

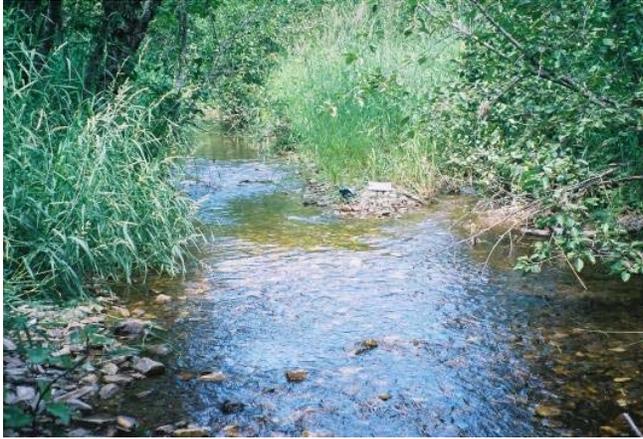
**Figure 6. Surface sediment size in Big Elk Creek downstream of the bend is predominantly very coarse to coarse gravel with small cobbles.**

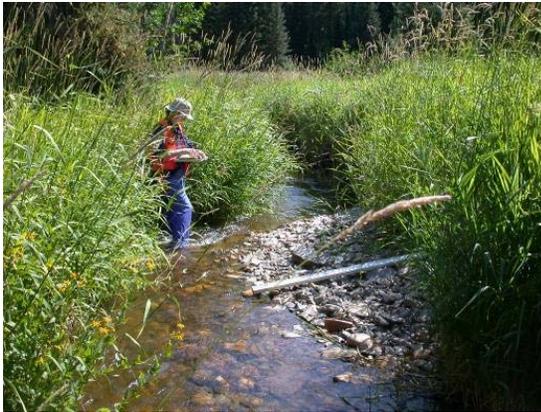
**Figure 8. Predominantly narrow, stable channel in the meadows area of Big Elk Creek.**

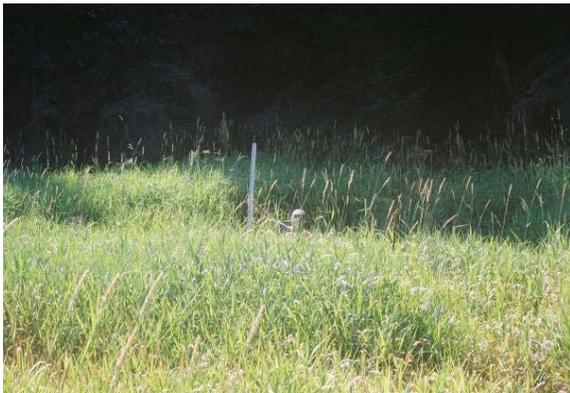
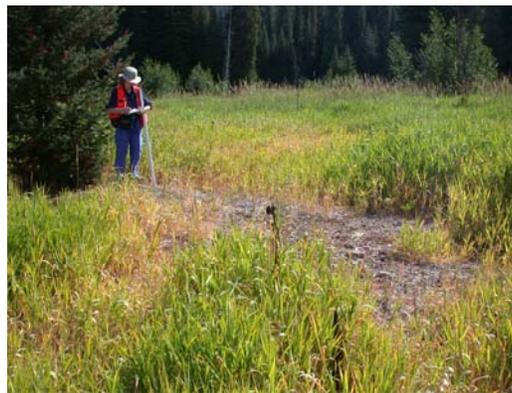
**Figure 9. Avulsed channels in the meadows area of Big Elk Creek.**

There were several abandoned channels on the floodplain, remnants of past avulsions (Figure 9). The most recently abandoned channel dead-ends at a gravel plug that is about 50 feet wide and a foot higher than the adjacent floodplain. The current, narrow channel is located over 35 feet southeast of the blocked former channel, and its bed is nearly 4 feet below the top surface of the gravel deposits. Apparently the creek easily cuts a new channel in the meadow when coarse sediment load exceeds the transport capacity of a particular stream reach and plugs the previous channel location. Excess coarse sediment (whether from upstream tributaries or from accelerated bank erosion during a large flood) tends to be stored in the meadow rather than transported downstream.

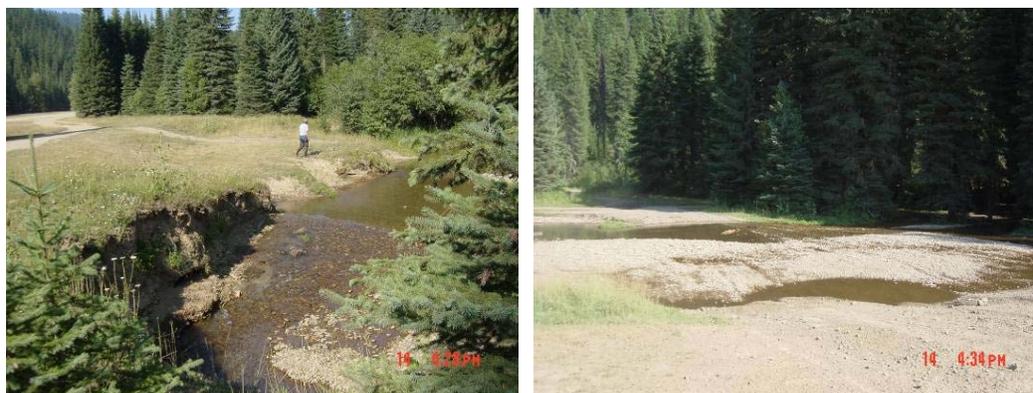
Figure 11. Disturbance of the channel and banks of Iron Creek near the airstrip by ATVs.

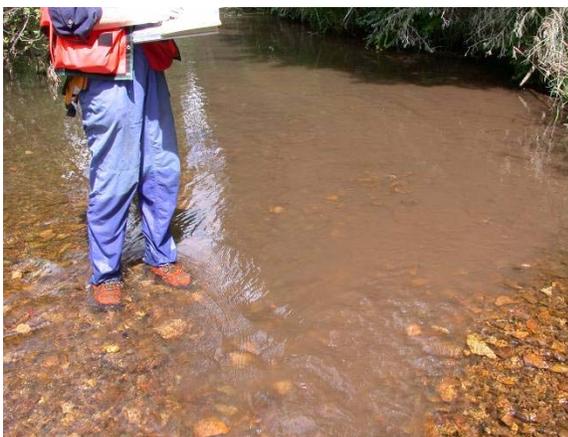
**Figure 12. Fine sediment from ATV erosion in Iron Creek near its mouth**

Coarse sediment load appeared high on Canyon Fork Creek upstream of Nicholas Creek (a known RSI site) and on the west fork of Moose Creek. Most coarse sediment from these particular tributaries does not reach the Little North Fork. Iron Creek at and downstream of the airstrip had a high fine and coarse sediment load, attributed to erosion of the streambed and banks where numerous ATV trails cross the channel (Figure 12)

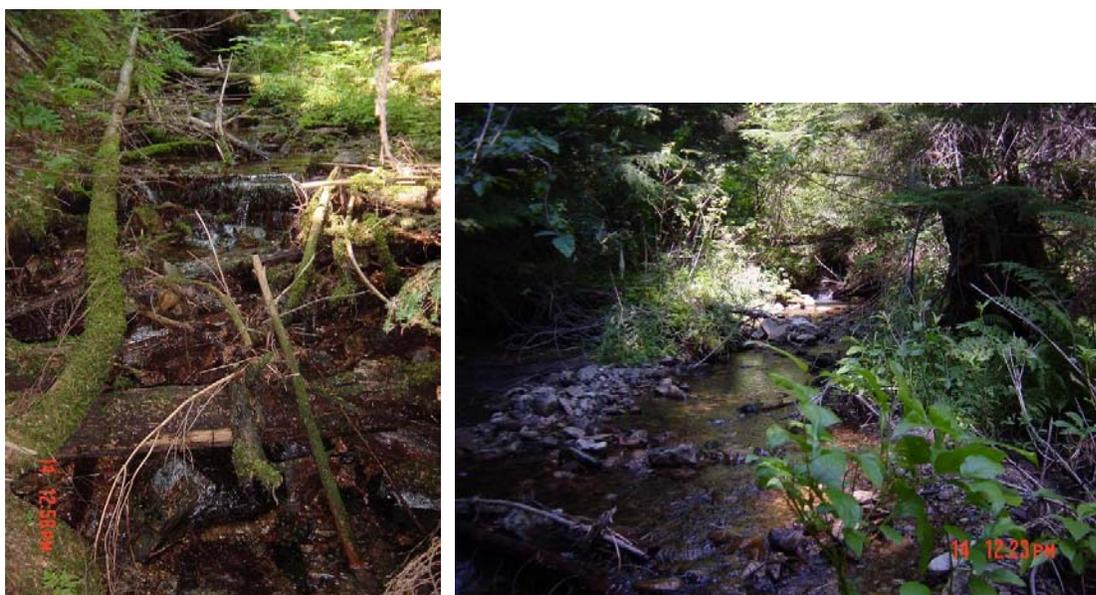
**Figure 13. LWD provides grade control in steep headwaters of Lewelling Creek (left). Evidence of former downcutting is found in some of the tributaries, such as the site on Lewelling Creek pictured on the right where an old stump was found on an entrenched floodplain.**

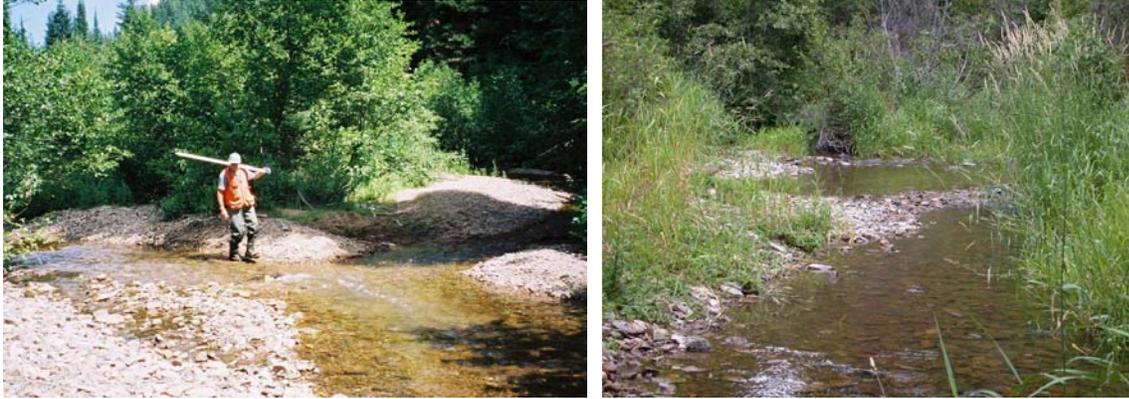
**Figure 15. Tributaries differ in ability to deliver coarse sediment to mainstem. Hudlow Cr. (left) flows down a channel on Little North Fork floodplain where the creek deposits its sediment load. Sediment will be stored on the floodplain until the mainstem migrates to the depositional area. Other tributaries, such as Iron Creek, pictured on the right, store sediment in their own floodplains and do not deliver much sediment to the mainstem.**

Only Tom Lavin, Sob, Lewelling and probably Honey Creeks remain steep and deliver most of their coarse sediment directly to the Little North Fork. These creeks have no significant sediment storage zones and are steep and confined, allowing them to deliver large cobbles all the way to the Little North Fork (Figure 15). Burnt Cabin Creek, which enters just below the detailed study area, also delivers its coarse sediment load directly to the Little North Fork.

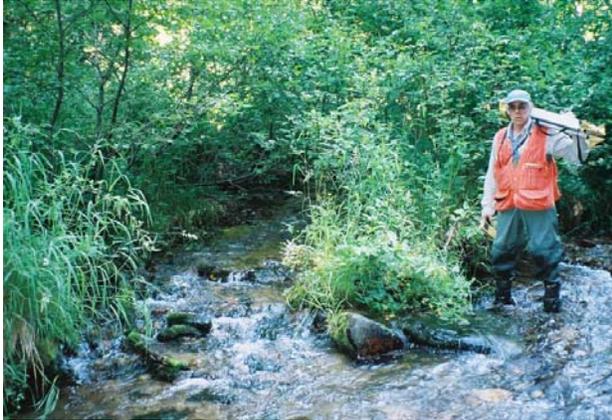
**Figure 17. Split channel at mouth of Tom Lavin Creek.**

There were no unvegetated alluvial fans on the Little North Fork at tributary junctions, but a low, split-channel area of former gravel deposits was observed at the mouth of Tom Lavin (Figure 17) and Lewelling Creeks. The river easily absorbs coarse sediment from the tributaries due to their small size.

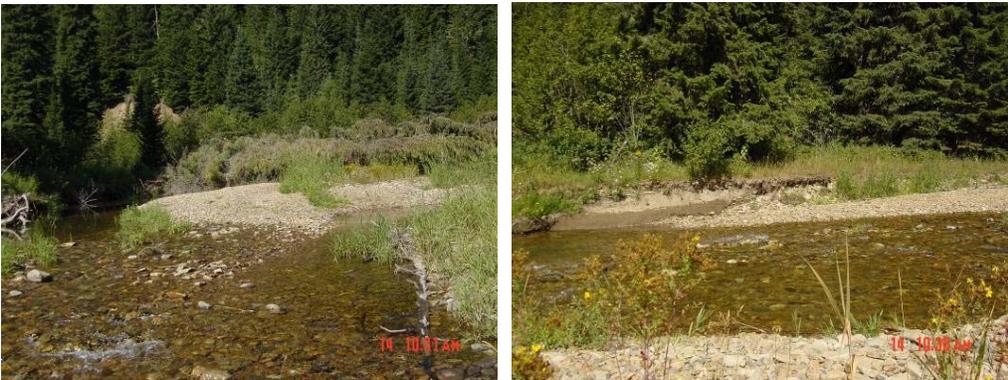
Figure 22. Photos of the perched channel located at cross-section B on the Little North Fork downstream of Nicholas Creek. Seventy (70) percent of active channel area is covered with gravel bars.

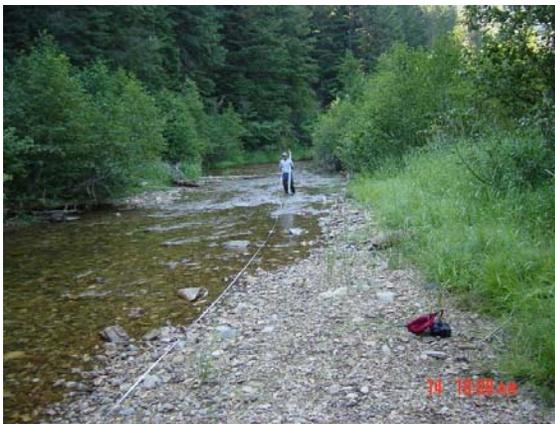
**Figure 24. The original lower channel at cross-section A on the Little North Fork downstream of Nicholas Creek was occupied in 1937 and has recently been reoccupied. Roughly 5% of its area is in bars.**

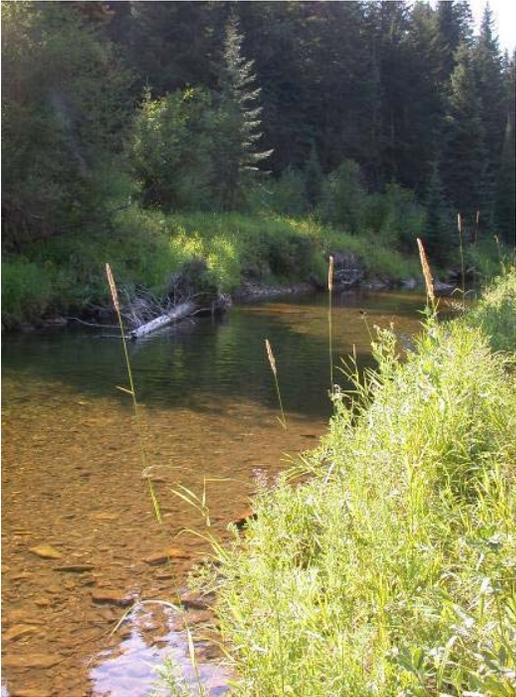
Figure 26. Little North Fork above Burnt Cabin Creek.

Interestingly, there was no apparent difference in entrenchment or river appearance below the splash dams in the first mile above Burnt Cabin Creek. The river there was only slightly entrenched, having one to two levels of low floodplain and a high terrace on the valley margin (Figure 25, Figure 26). Splash damming has been known to cause extensive bank erosion (Russell, 1984). Apparently damage to the banks along with an abundant sediment load from upstream caused enough sediment deposition to counteract any initial downcutting that was caused by floods released by the dams.

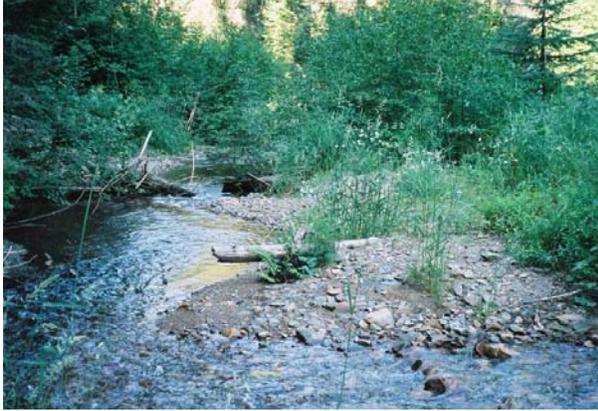
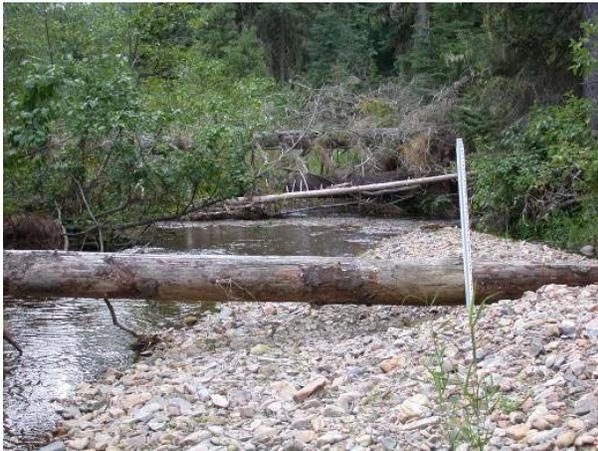
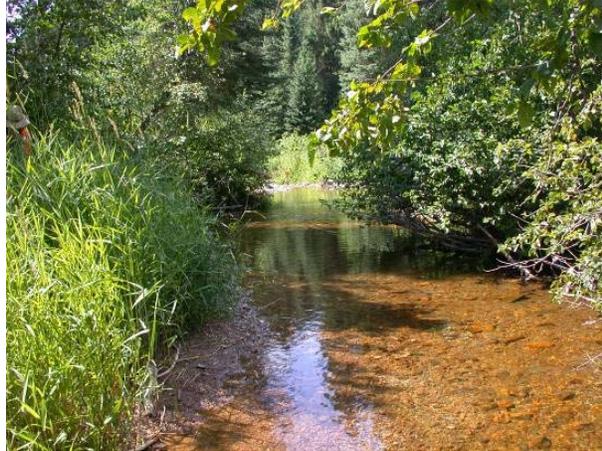
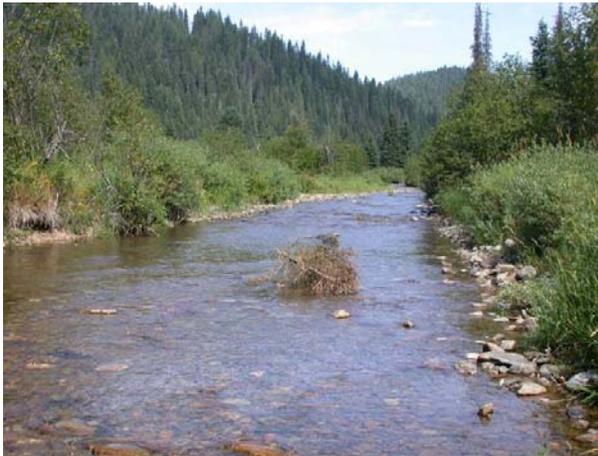
**Figure 27. Functional wood contributes to the storage of sediment storage upstream of Tom Lavin Creek (top). Sediment storage by LWD is intermittent in middle reaches: example near Lewellyn Creek (middle pictures). Sediment storage by LWD is rare downstream of Iron Creek (channel width effect) (bottom picture).**

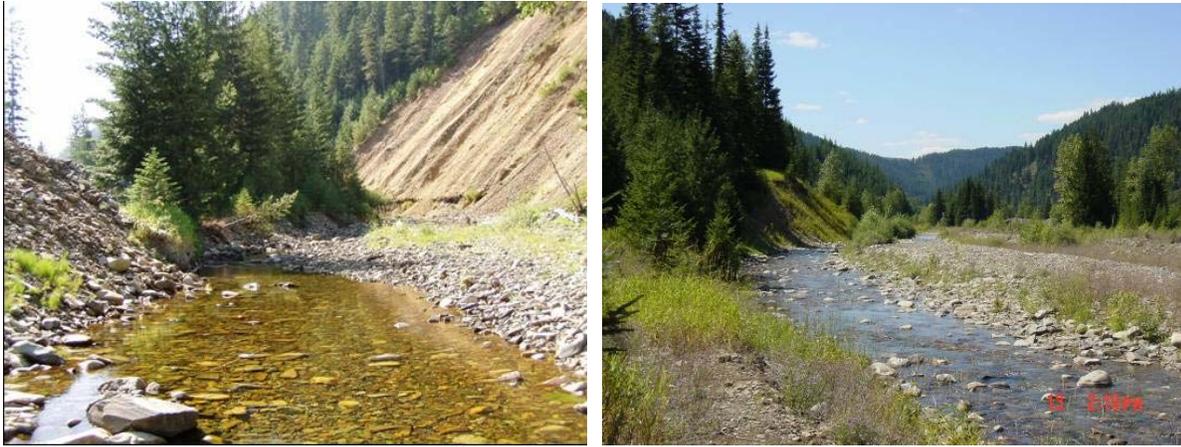
**Figure 31. Dredge spoils confining Prichard Creek and valley wall landslides delivering to the creek.**

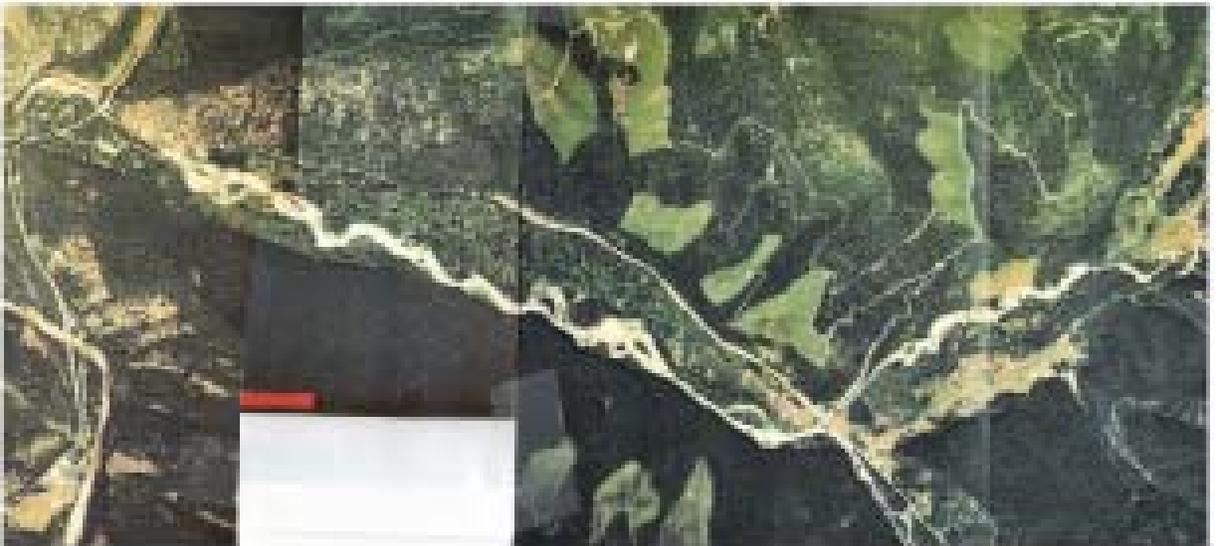
Figure 35. 1937 and 1996 air photos showing lower Prichard Creek and Eagle Creek.

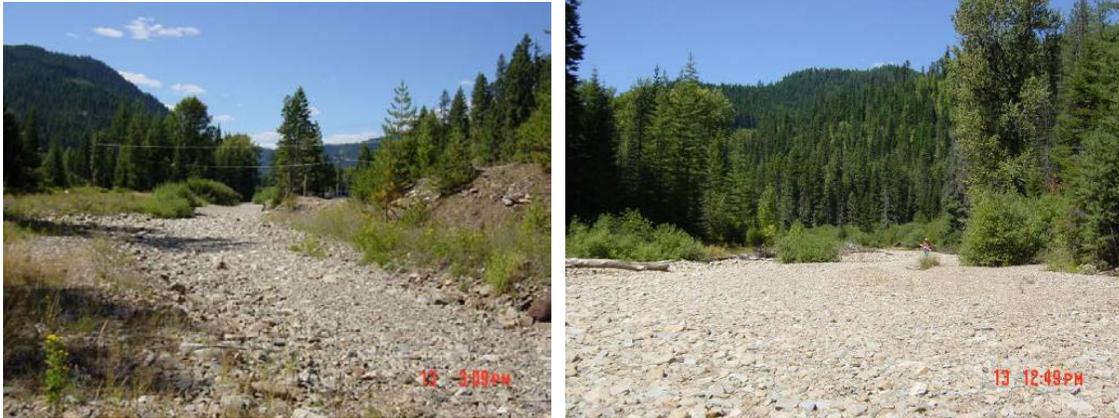
Figure 36. Areas where the stream runs subsurface due to high volumes of deposit along the lower dredge spoils in Prichard Creek upstream of the confluence with Eagle Creek (left) and in Eagle Creek, downstream of the forks (right).

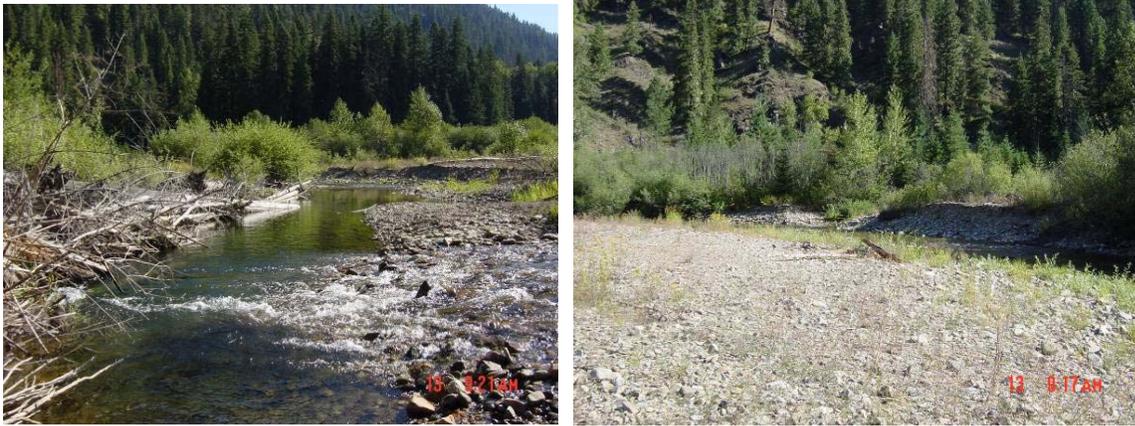
Figure 38. Photos of a braided portion of Prichard Creek downstream of Eagle Creek.

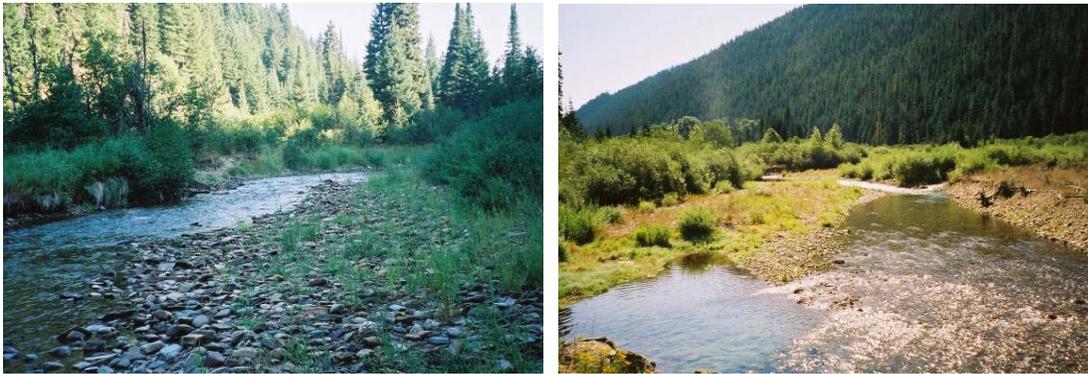
**Figure 40. Photos of recently downcut areas in Prichard Creek downstream of Eagle Creek.**

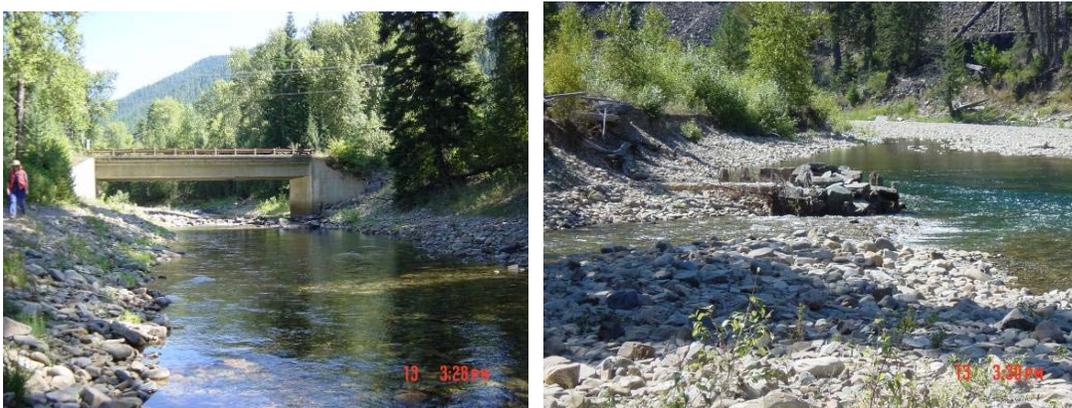
**Figure 41. Mouth of Prichard Creek where the stream is downcutting through former deposits.**

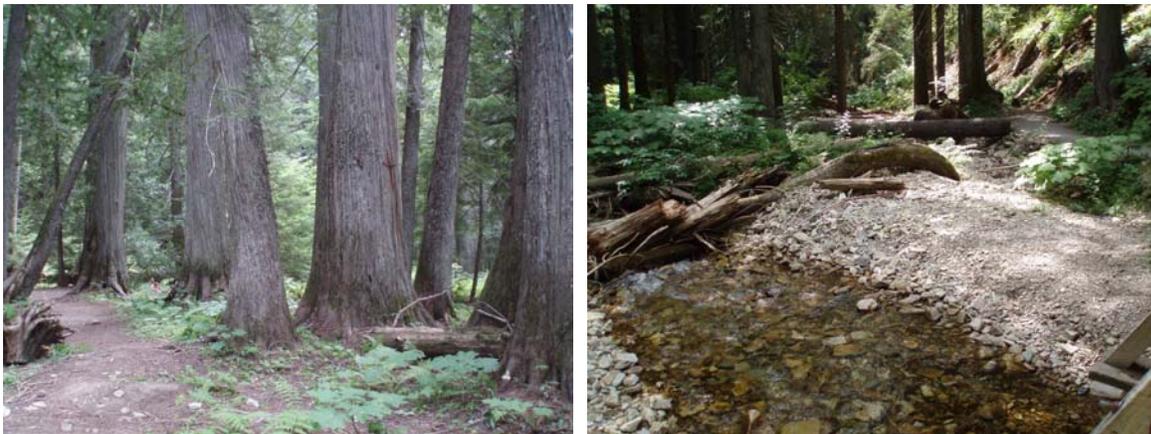
Figure 44. Gravel bars and gravelly floodplain soil in an undisturbed, old-growth cedar forest in Settlers Grove, West Fork Eagle Creek.

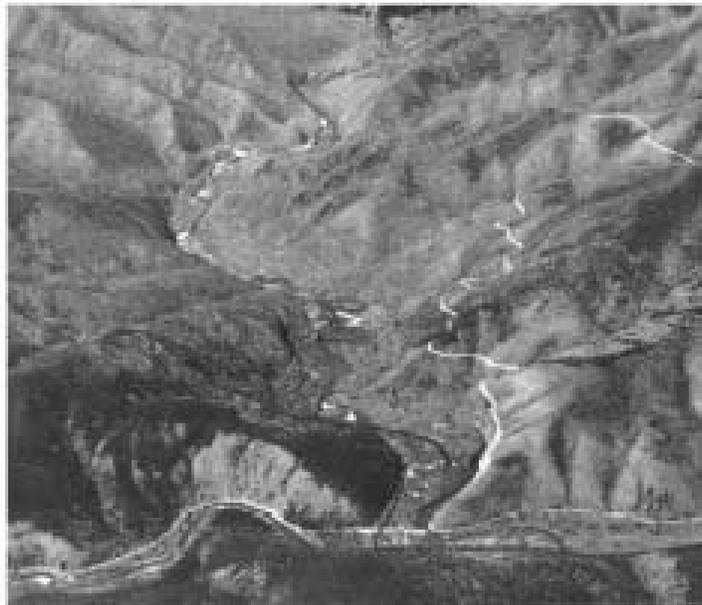
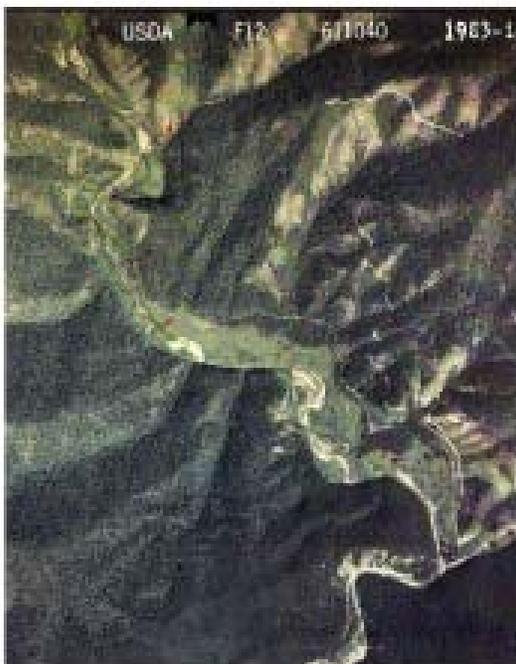
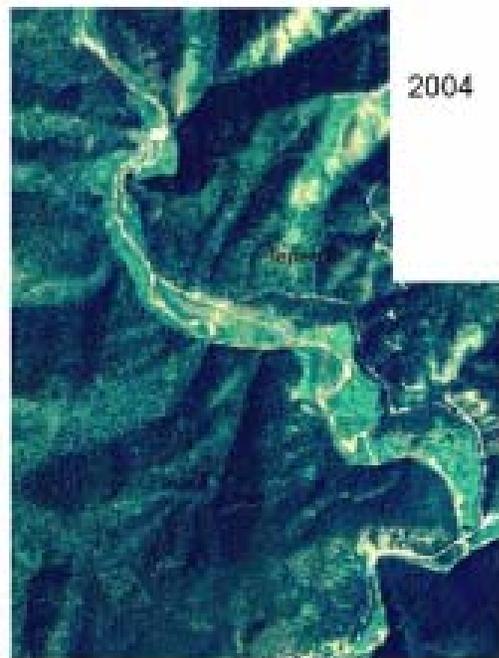
1935 Oblique

**Figure 46. Air photos of lower Independence Creek showing channel widening in 1983 (lower left photo) compared to 1935 (oblique) and 2004 (lower right) photos.**

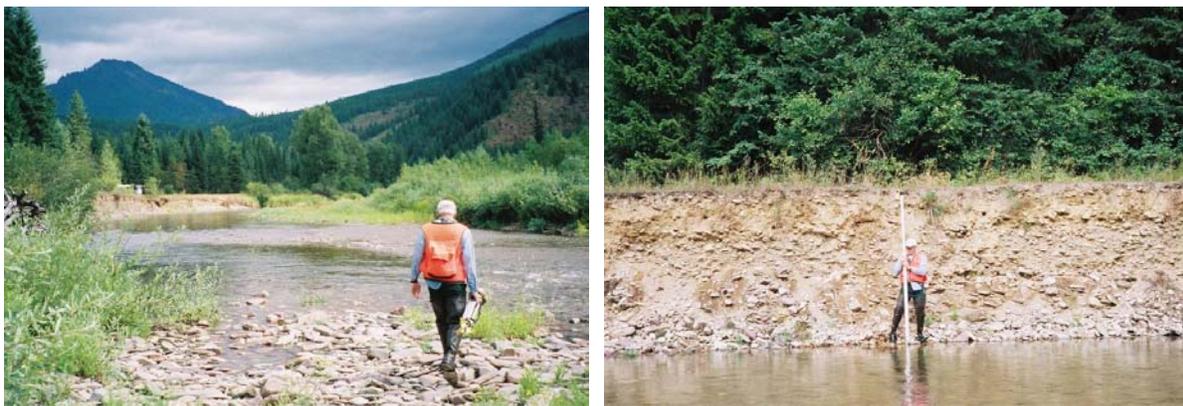
Figure 49. Response reach near Minor-Brett Wilson, cross-section A with mid-channel bar in view (left) and downcutting at the left end of the cross-section below an older terrace (right).

depositional zone upstream from the avulsion and includes a mid-channel bar that was probably reworked in the 1996 flood (Figure 48, Figure 49). The cross-section showed that the river had downcut 2 feet since 1996, and had downcut 4 feet below an older terrace that had recently-burned forest on it in the 1930s. This terrace had once been an active gravel bar since it was composed of gravel-cobble sediment. Cross-section B was located downstream and crossed both avulsion channels (Figure 50). The evidence for vertical change at XS B was indeterminate. Although the east river channel is lower than the abandoned west channel, the most-probable bankfull indicators on the east and west channels had similar elevations.

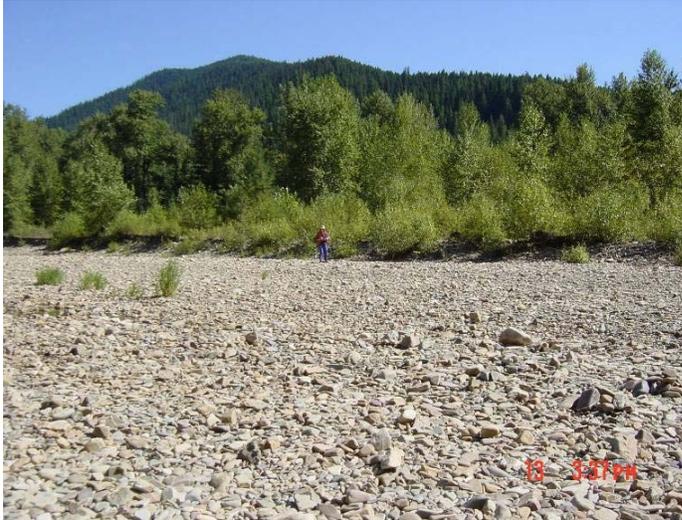
**Figure 54. Bars in North Fork below Prichard Creek were at their greatest magnitude in the 1975 photos. There has been some channel downcutting since, but the bars are still active.**

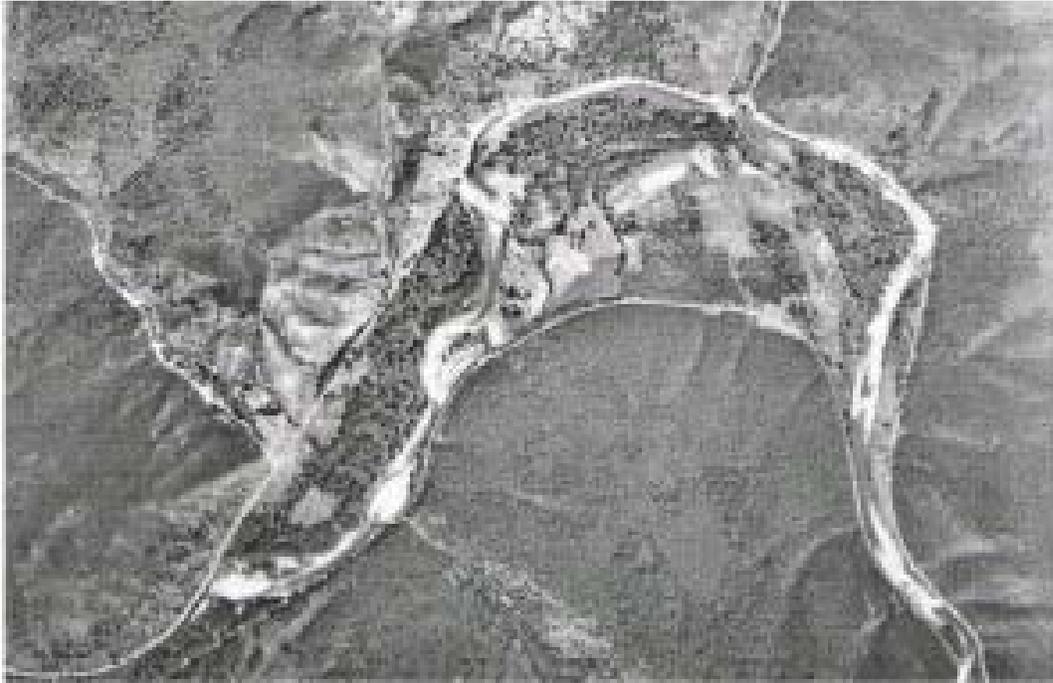
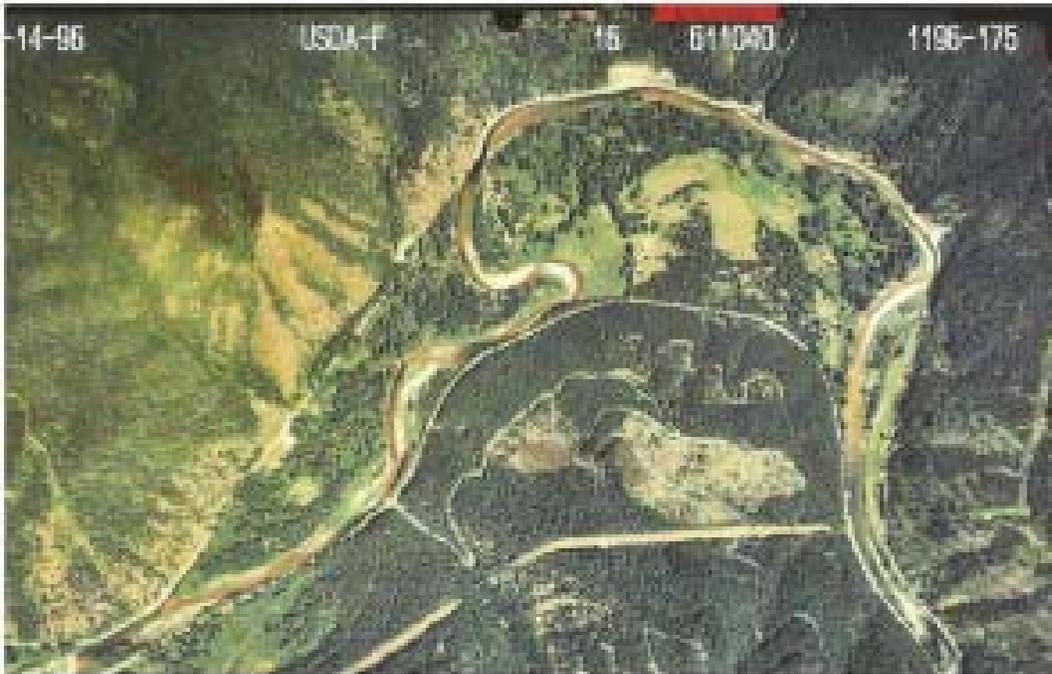
**Figure 55. 1937 (top) and 1996 (bottom) photos of Lower North Fork Coeur d'Alene River at Grizzly Creek. Not the change from a braided to meandering pattern.**

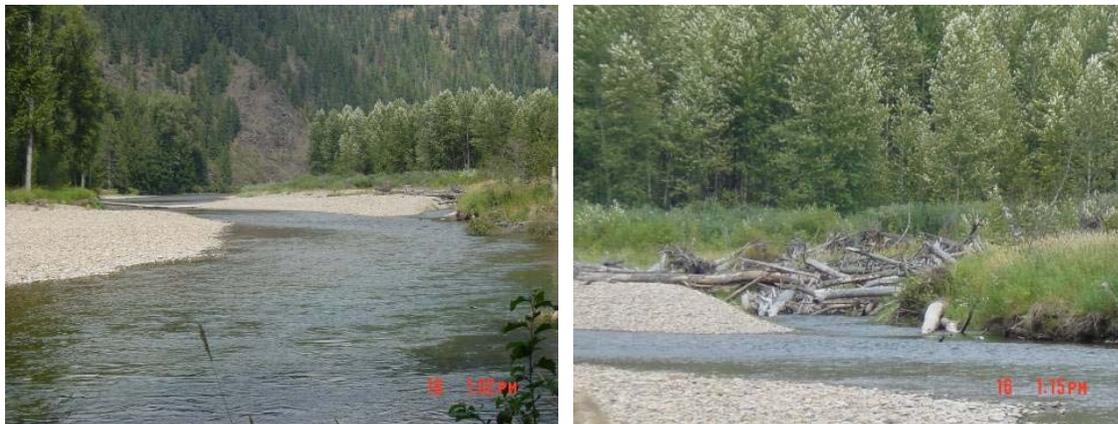
**Figure 57. North Fork Coeur d’Alene River near the confluence with Grizzly Creek in 2006, 2 years after an oxbow was cutoff.**

The response reach east of Grizzly Creek had an island-braided pattern with wide bars in the 1930s. It gradually changed to a meandering pattern with narrow bars by 1996 (Figure 56, Figure 55). This is the only place on the lower river that still has unrestricted channel migration and floodplain connection, though it was narrowed by roads at the downstream end. These changes indicate a decline in sediment load. A oxbow cutoff shortly before 2004 led to formation of new gravel bars and side channels, but the active-channel width is still much narrower than in the 1930s (Figure 57, Figure 58).

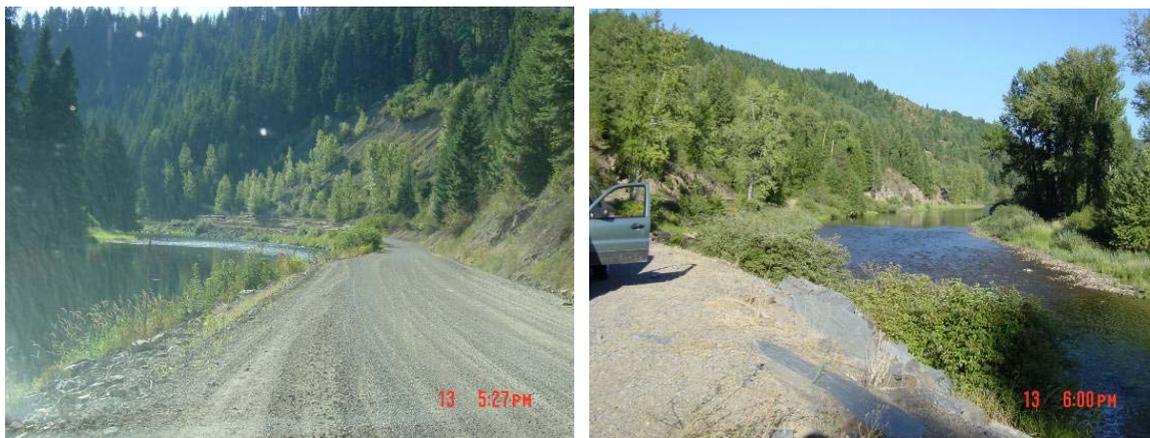
Figure 60. The lower Coeur d'Alene River typically has few gravel bars and armored banks along roads.

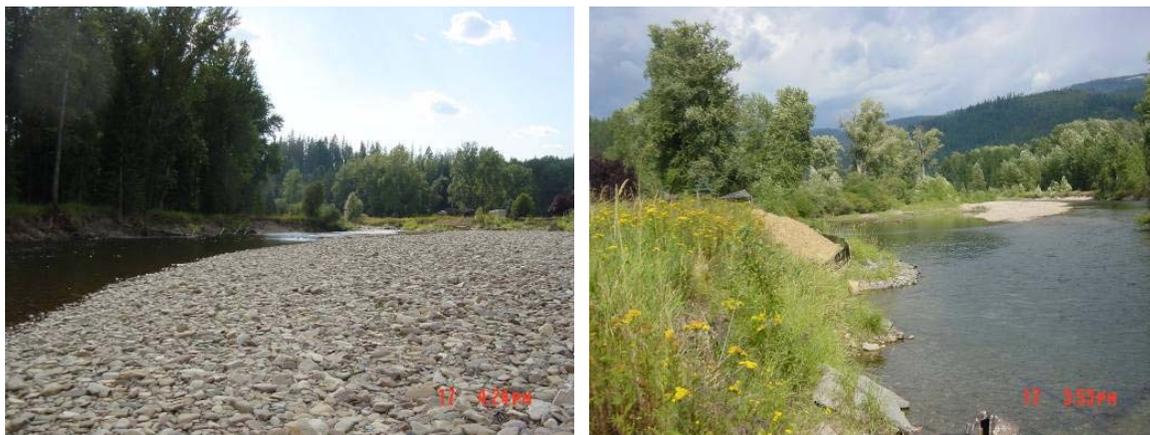
**Figure 62. North Fork CDA River upstream of the Little North Fork gravel deposition zone.**
