Subject: Site Assessment of the Alaska Mine, Cuprum Area, Adams County, Idaho

ABBREVIATED PRELIMINARY ASSESSMENT

Site Name: Alaska Mine

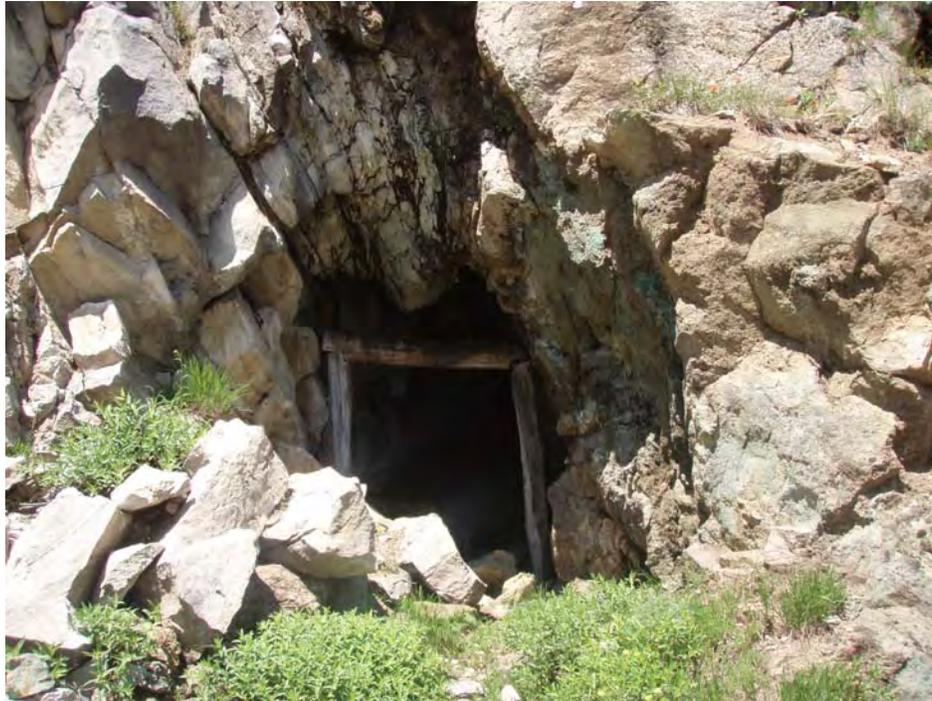
The Alaska Mine is located on private land with USFS mixed ownership. The adit is open and may be an attractive nuisance. The area is well vegetated around the adit with no sign of water

discharging from the adit during the time of DEQ’s site visit. A second adit was collapsed with no water discharging.

The Alaska Adit is open and there were no signs posted against trespass at the time of DEQ’s site visit.

DEQ offers the following health and safety recommendations relating to the aforementioned mine. Open adits pose a safety hazard to the general public who often wish to enter and explore them.

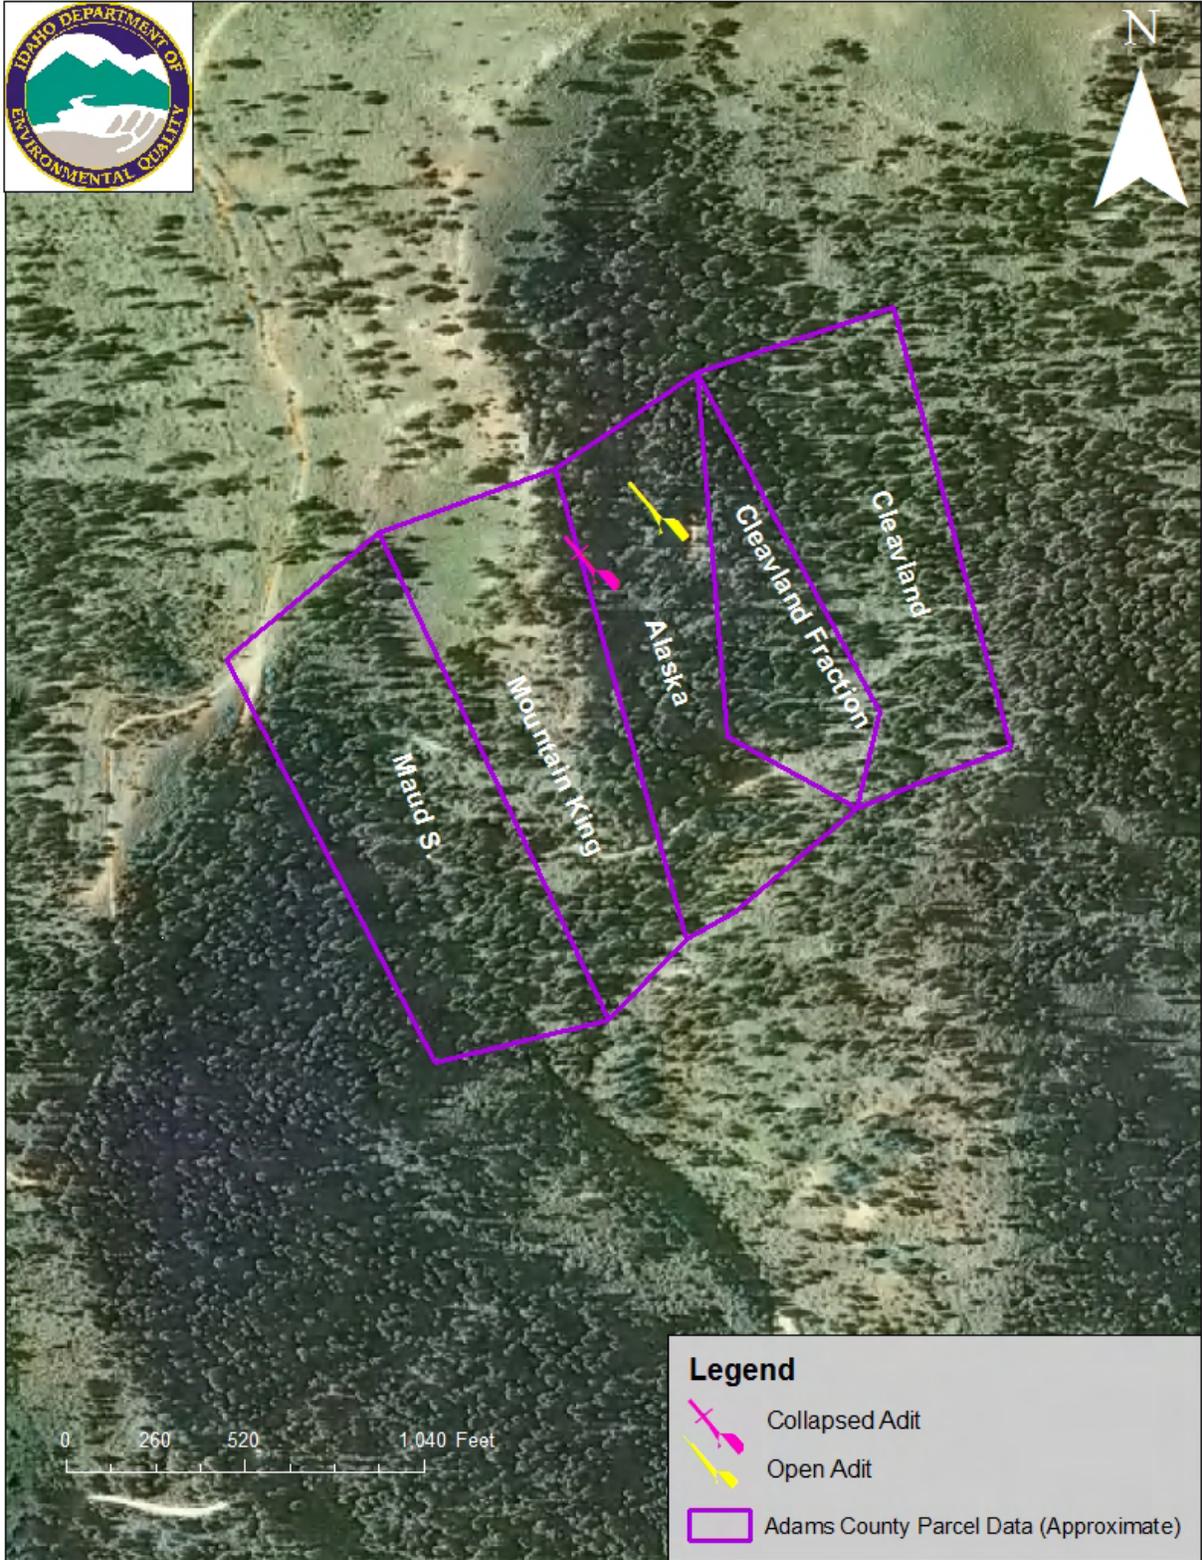
Map 2. Alaska Mine claim with adits identified and adjacent claims (Map Source: 2009 Natural Color 1-meter National Agriculture Imagery Program (NAIP) Idaho Map)

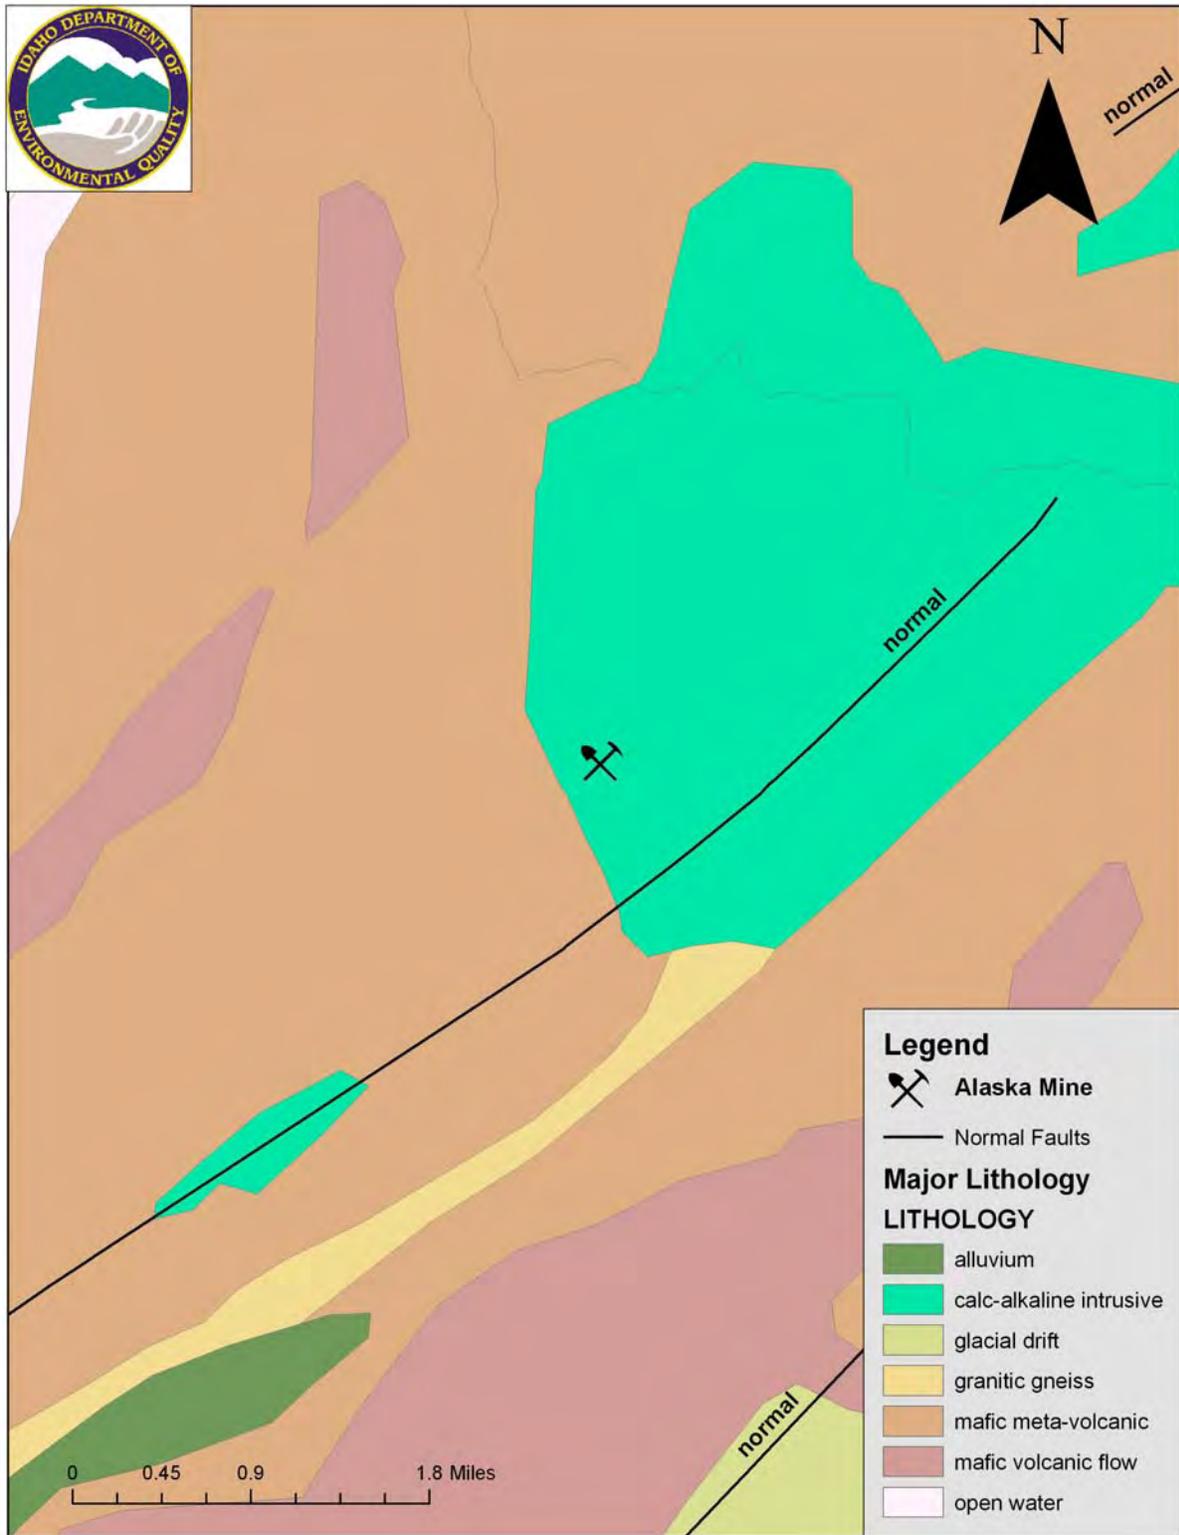
Map 3. Major lithology of Alaska Mine and surrounding area (Map Sources: SDE Feature Class, USGS 1995 and Idaho DEQ GIS ArcSDE 9.2 Geodatabase)

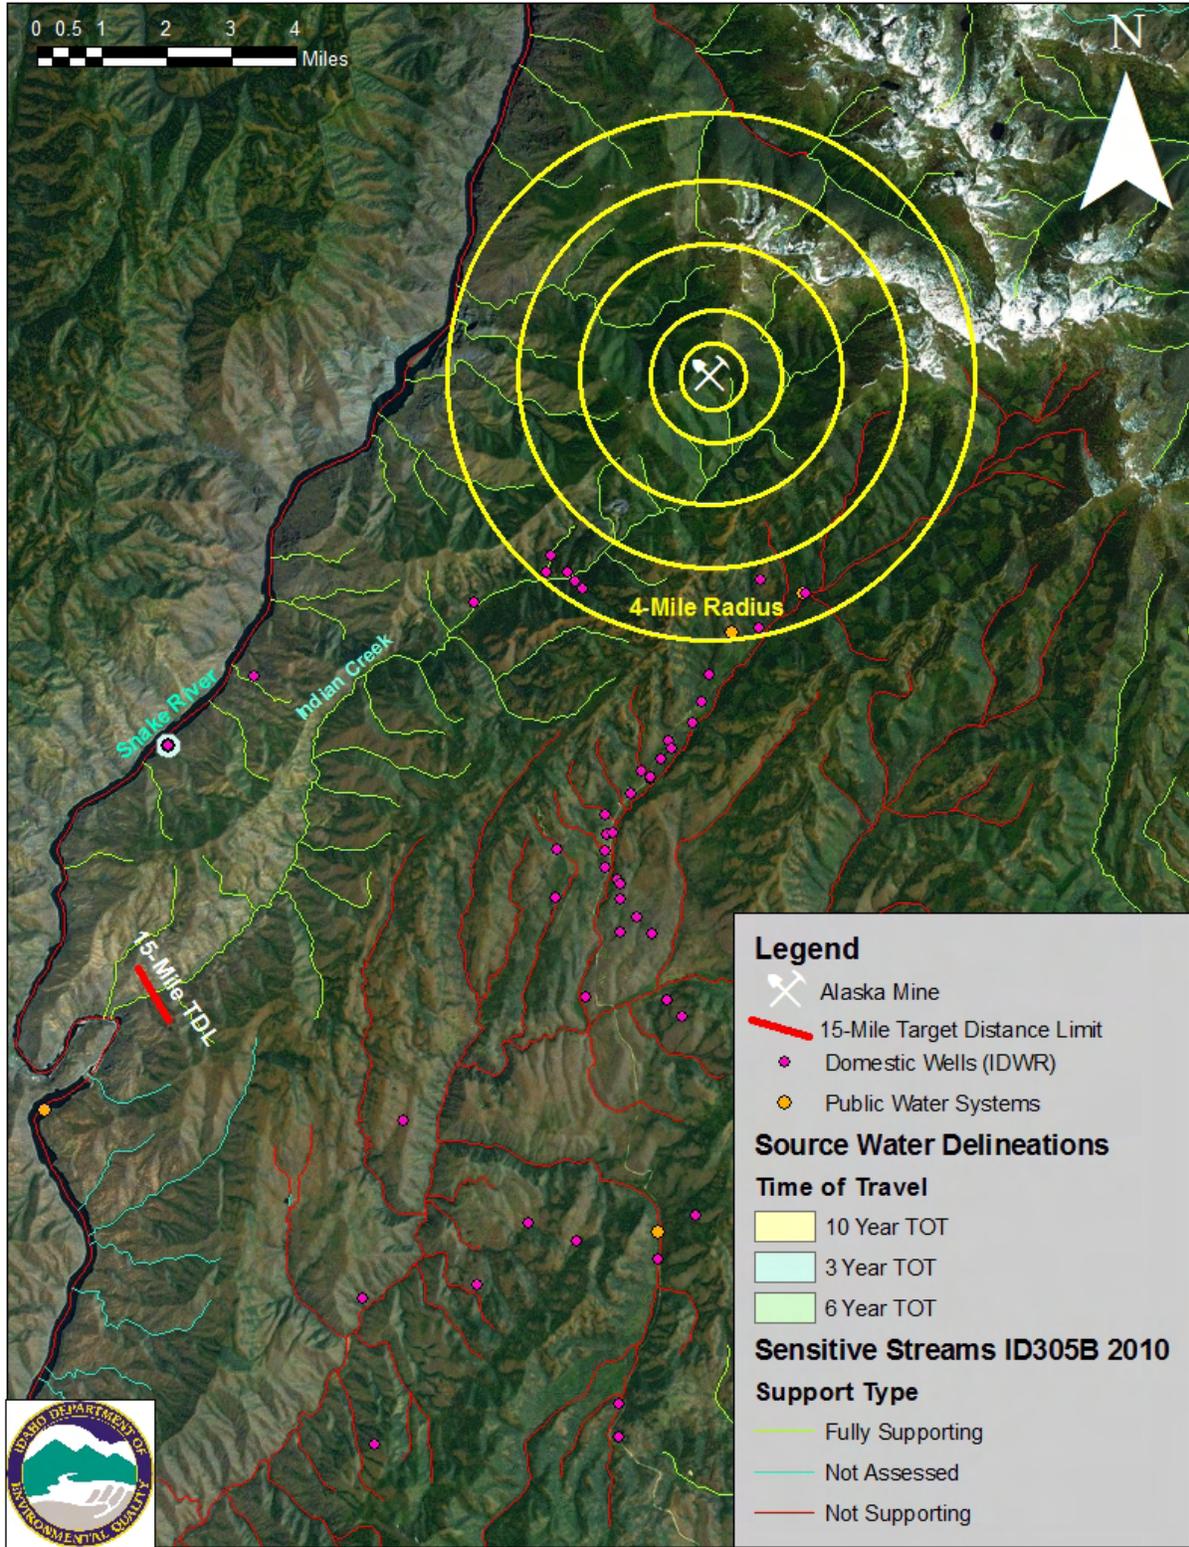
Map 4. One public water system is located within the four mile radius; however it is segregated by structural geology. No significant wetlands exist within the 4-mile radius or 15-mile target distance limit (TDL). Indian Creek is fully supported. (Map Source: World Imagery ArcGIS)

There are no direct airborne or surface or ground water pathways to any potable water sources or residences. There are several recreational home sites within two miles and the town of Cuprum has the nearest full time residences. Cuprum is at least five miles from the Alaska Mine. The nearest surface water pathway is Indian Creek, which is approximately one mile from the mine. The mine site is a dry site with no water present. No evidence of ore or mineralized rock remained at the site.
