Abbreviated Preliminary Assessment for Genesee Landfill

Latah County

**State of Idaho
Department of Environmental Quality**

December 2012

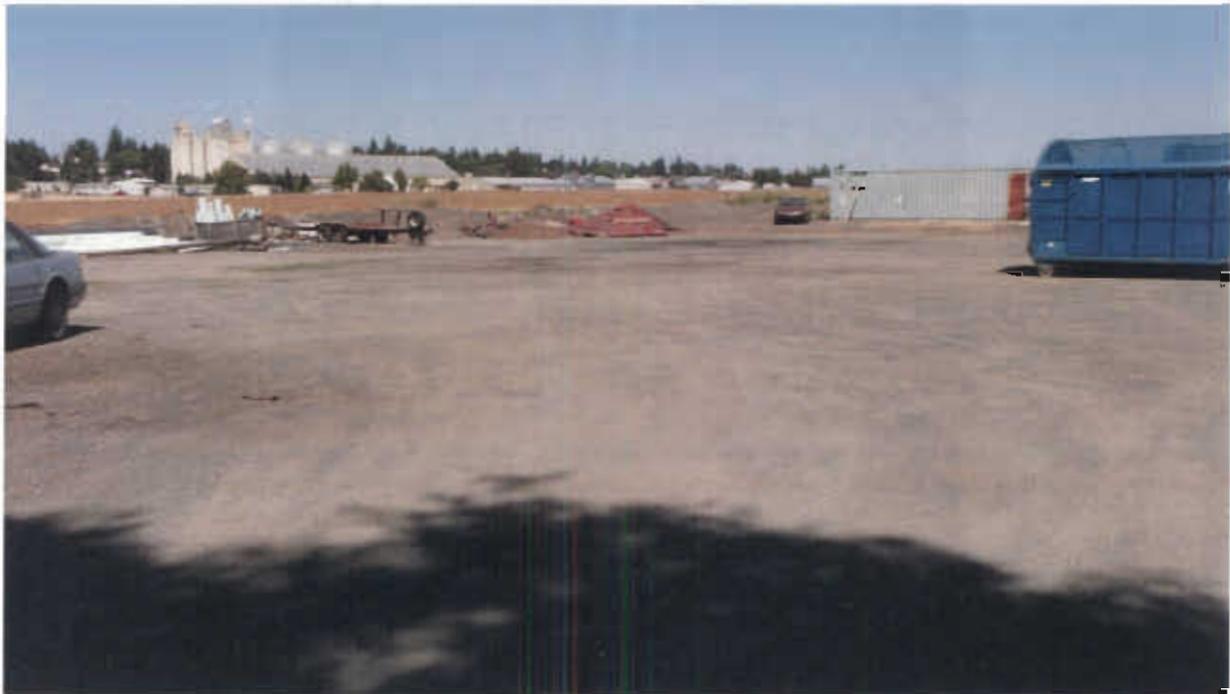
Photo 1. Current use for the Genesee Landfill site is storage for the road district.

The current use of the Genesee Landfill is storage for the road district. Bulk waste is still gathered periodically at this location and hauled to an approved landfill. The city may have covered the old landfill. There is a garbanzo bean crop that surrounds the site. There is no vegetation on the landfill area because of current uses. Various piles of asphalt were observed on-site at the time of DEQ’s visit. Cow Creek is located approximately 200 yards south of the property. The landfill area on the site is dry and no surface water pathways were observed on the site or from the site to the creek.

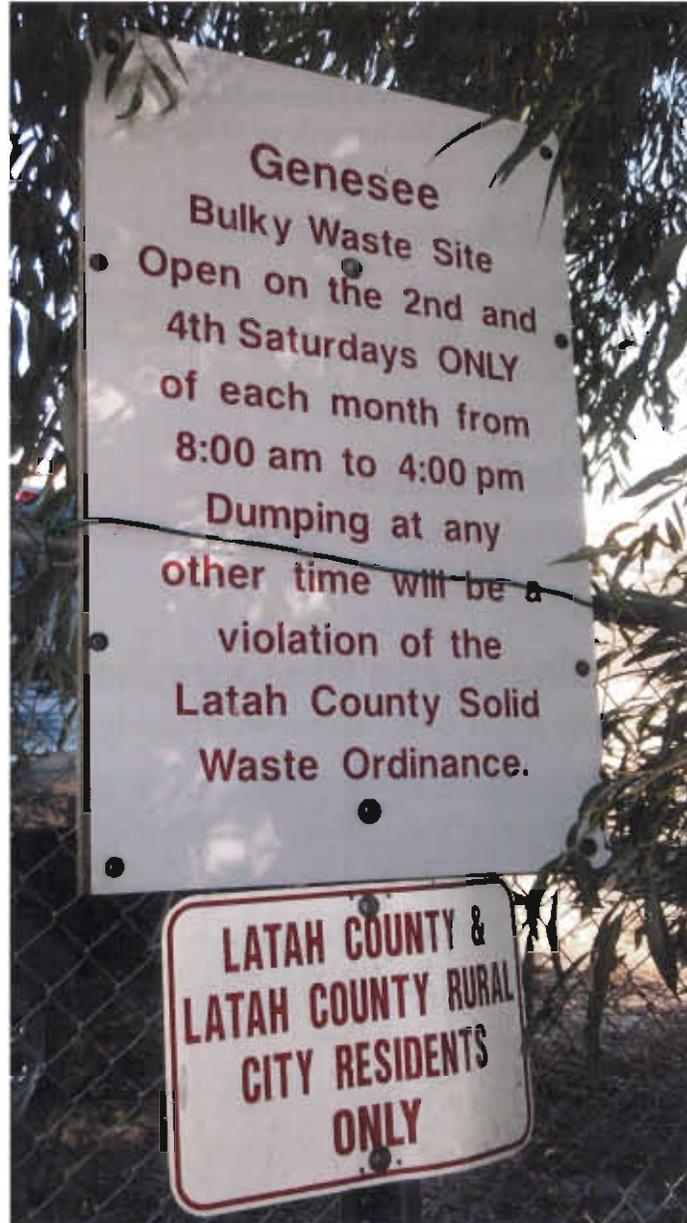
Photo 2. Bulk waste is still gathered periodically at the Genesee Landfill and hauled to an approved landfill.

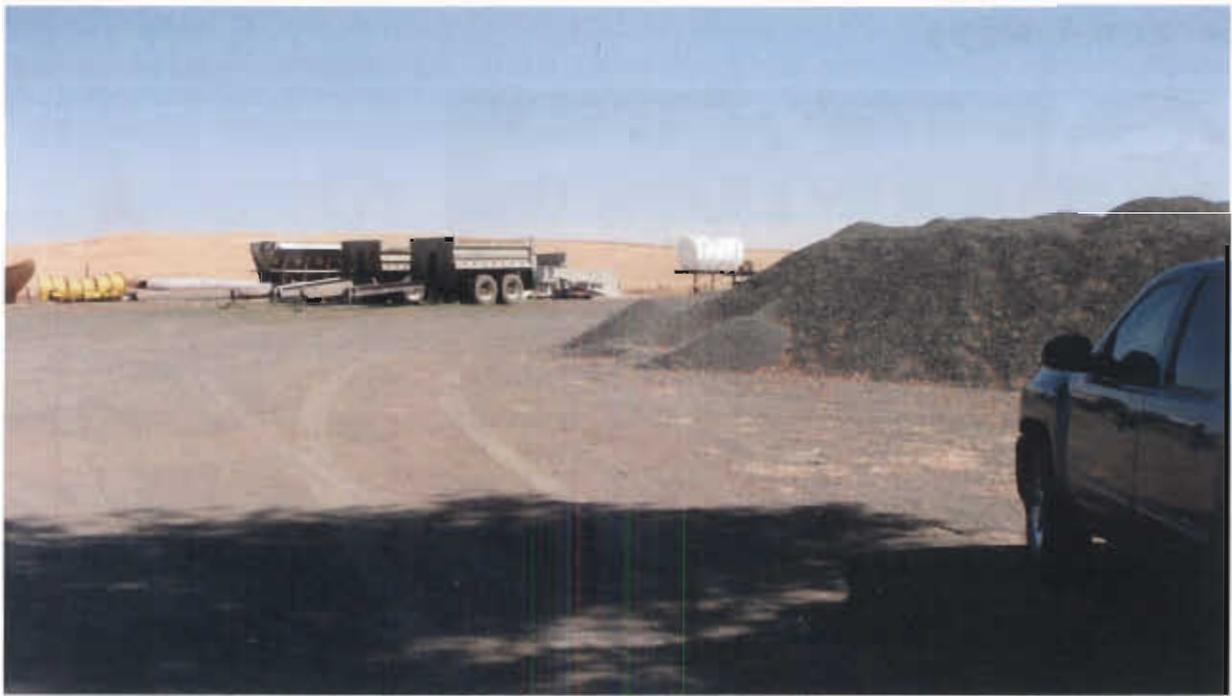
Photo 3. View of gravel storage on the site.

The area surrounding the Genesee Landfill was well vegetated and healthy. The farmland on the site has been converted to vehicle storage and gravel storage for the local road district.

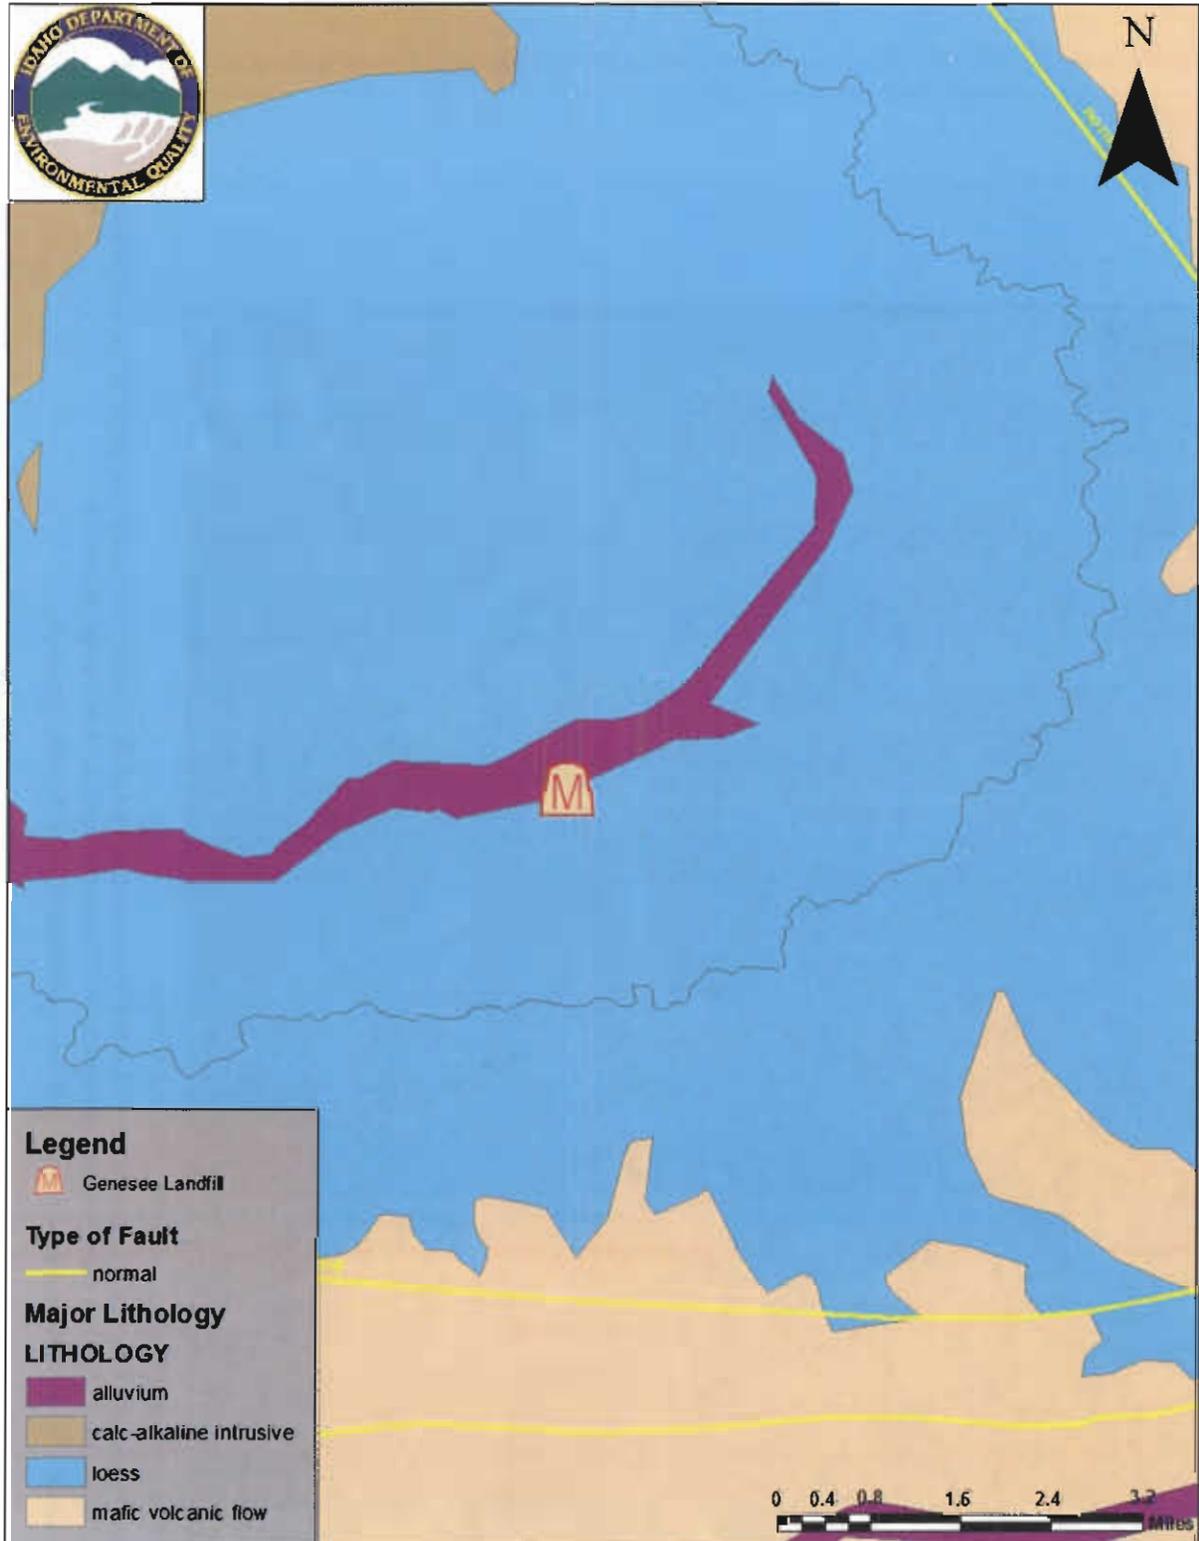
Figure 2. Map of major lithology in the vicinity of the Genesee Landfill.

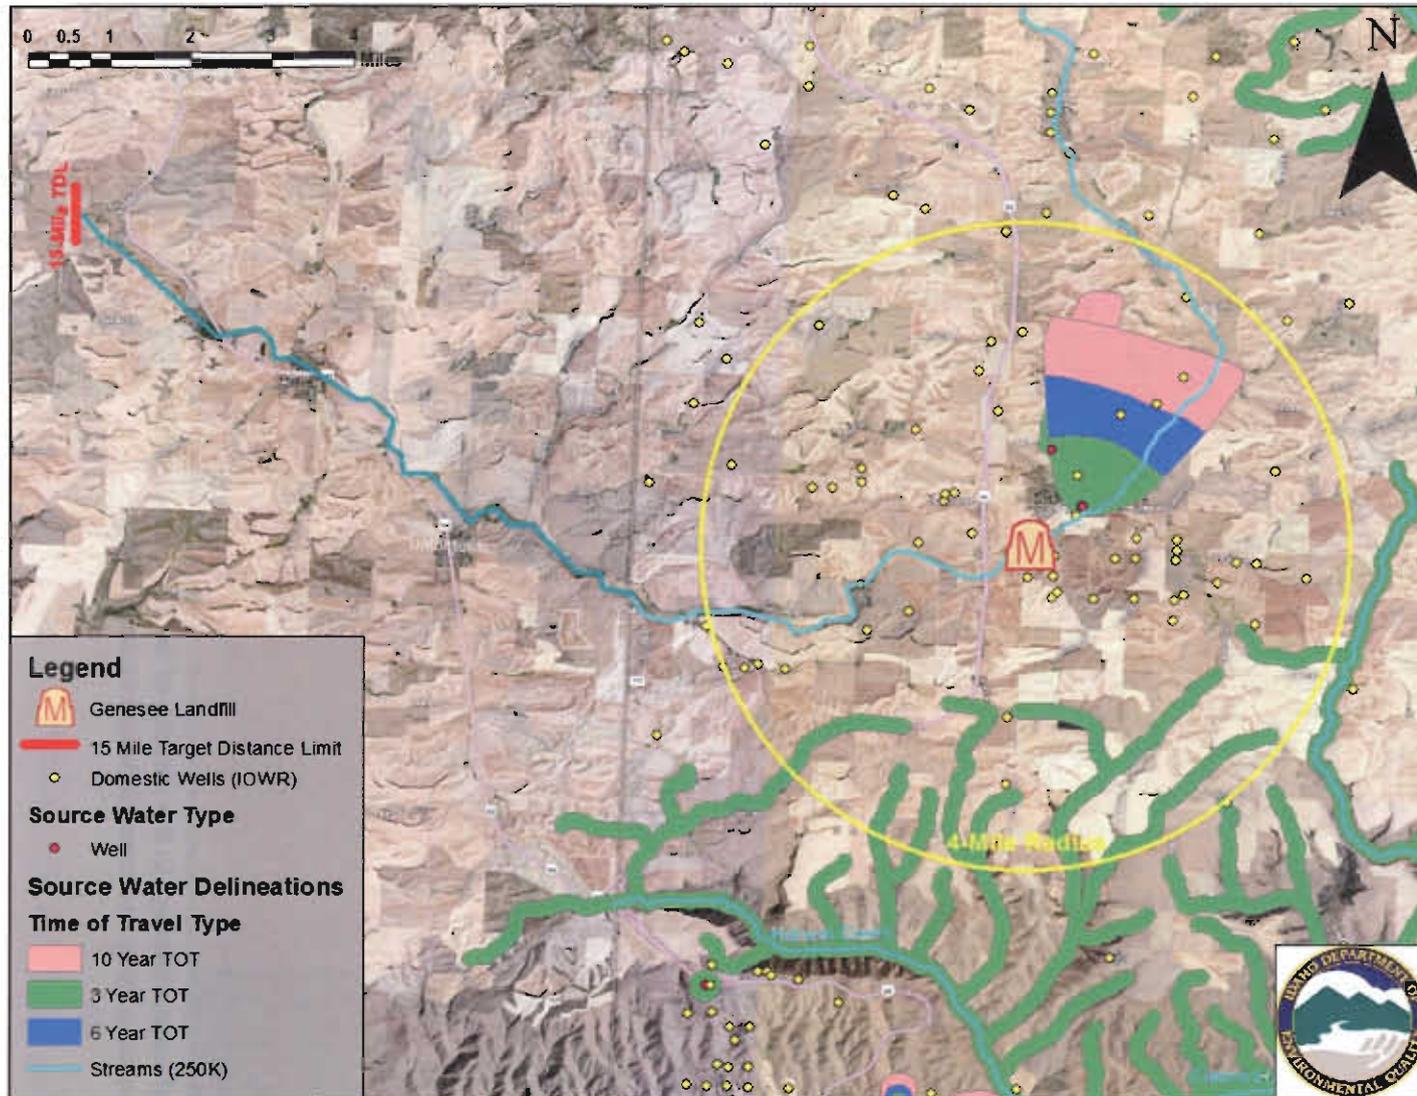
Figure 3. Domestic well and public water system locations.

There are approximately 58 domestic well locations and 3 public water systems (PWS) within the 4-mile radius (PWS are located upgradient from the Genesee Landfill site). There are no significant wetlands within a 2-mile radius or in the general area.

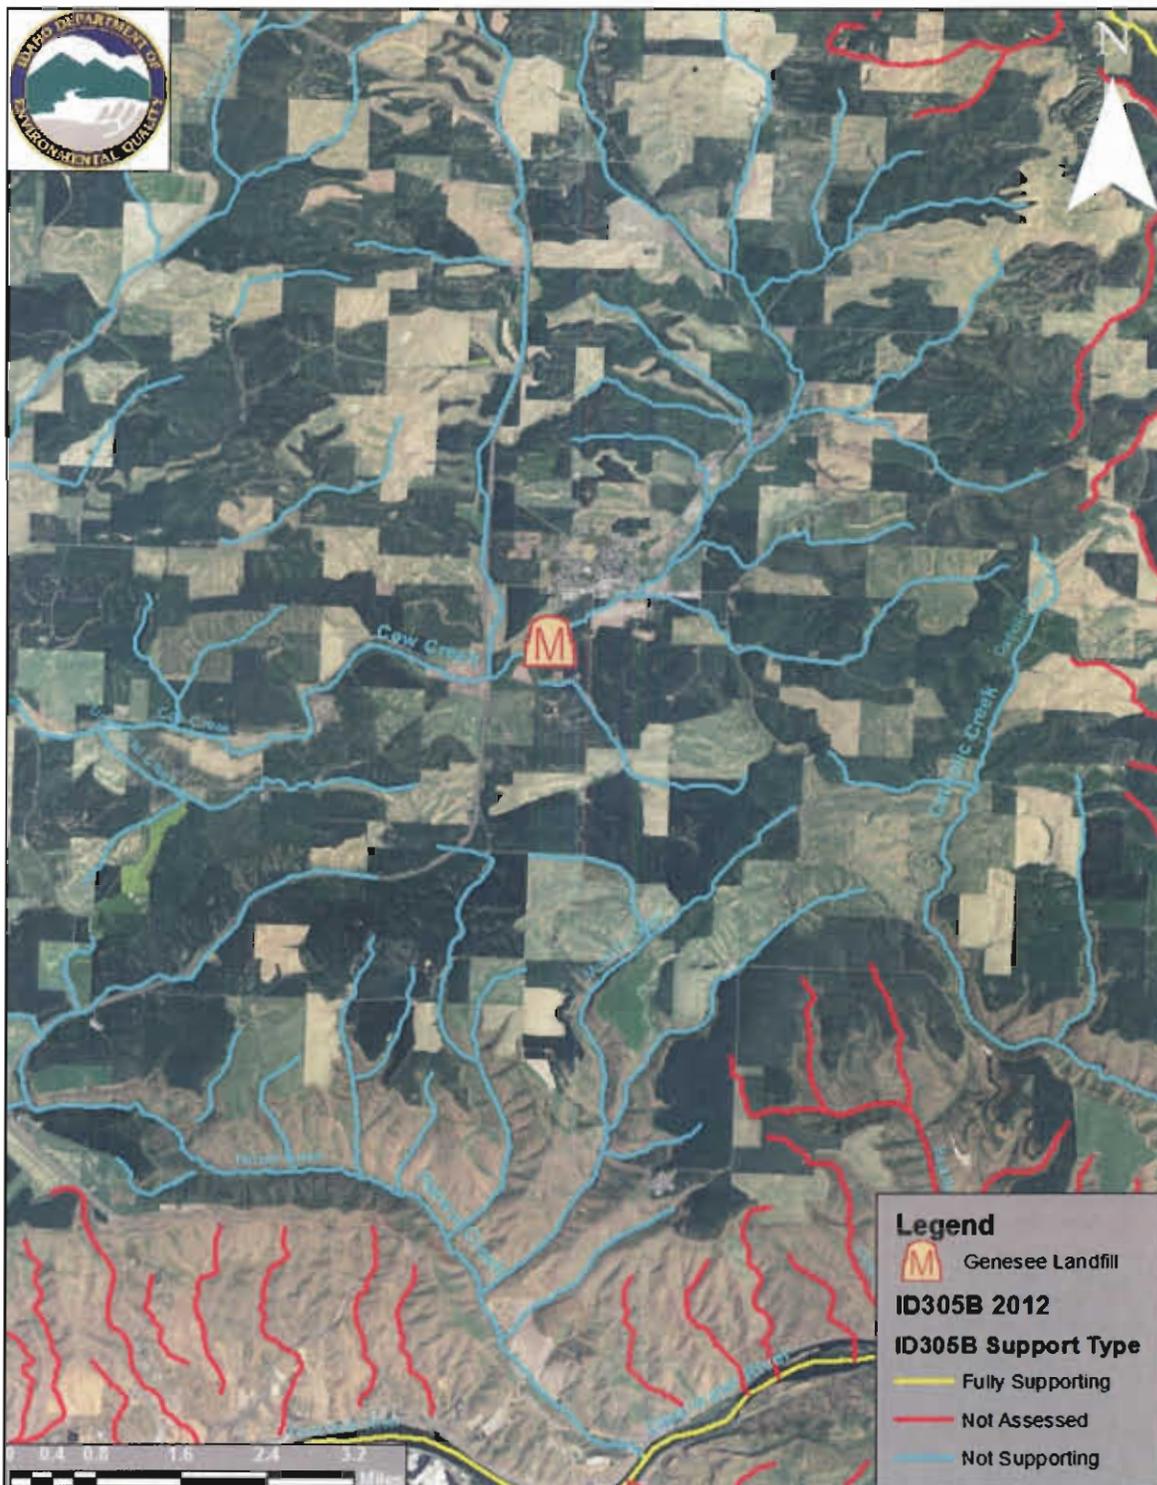
Figure 4. Sensitive streams located in the vicinity of the Genesee Landfill.

Cow Creek (source to Idaho/Washington border) is listed as "not supporting" for cold water aquatic life. The causes are: nutrient/eutrophication biological indicators, physical substrate habitat alterations, temperature, and water.

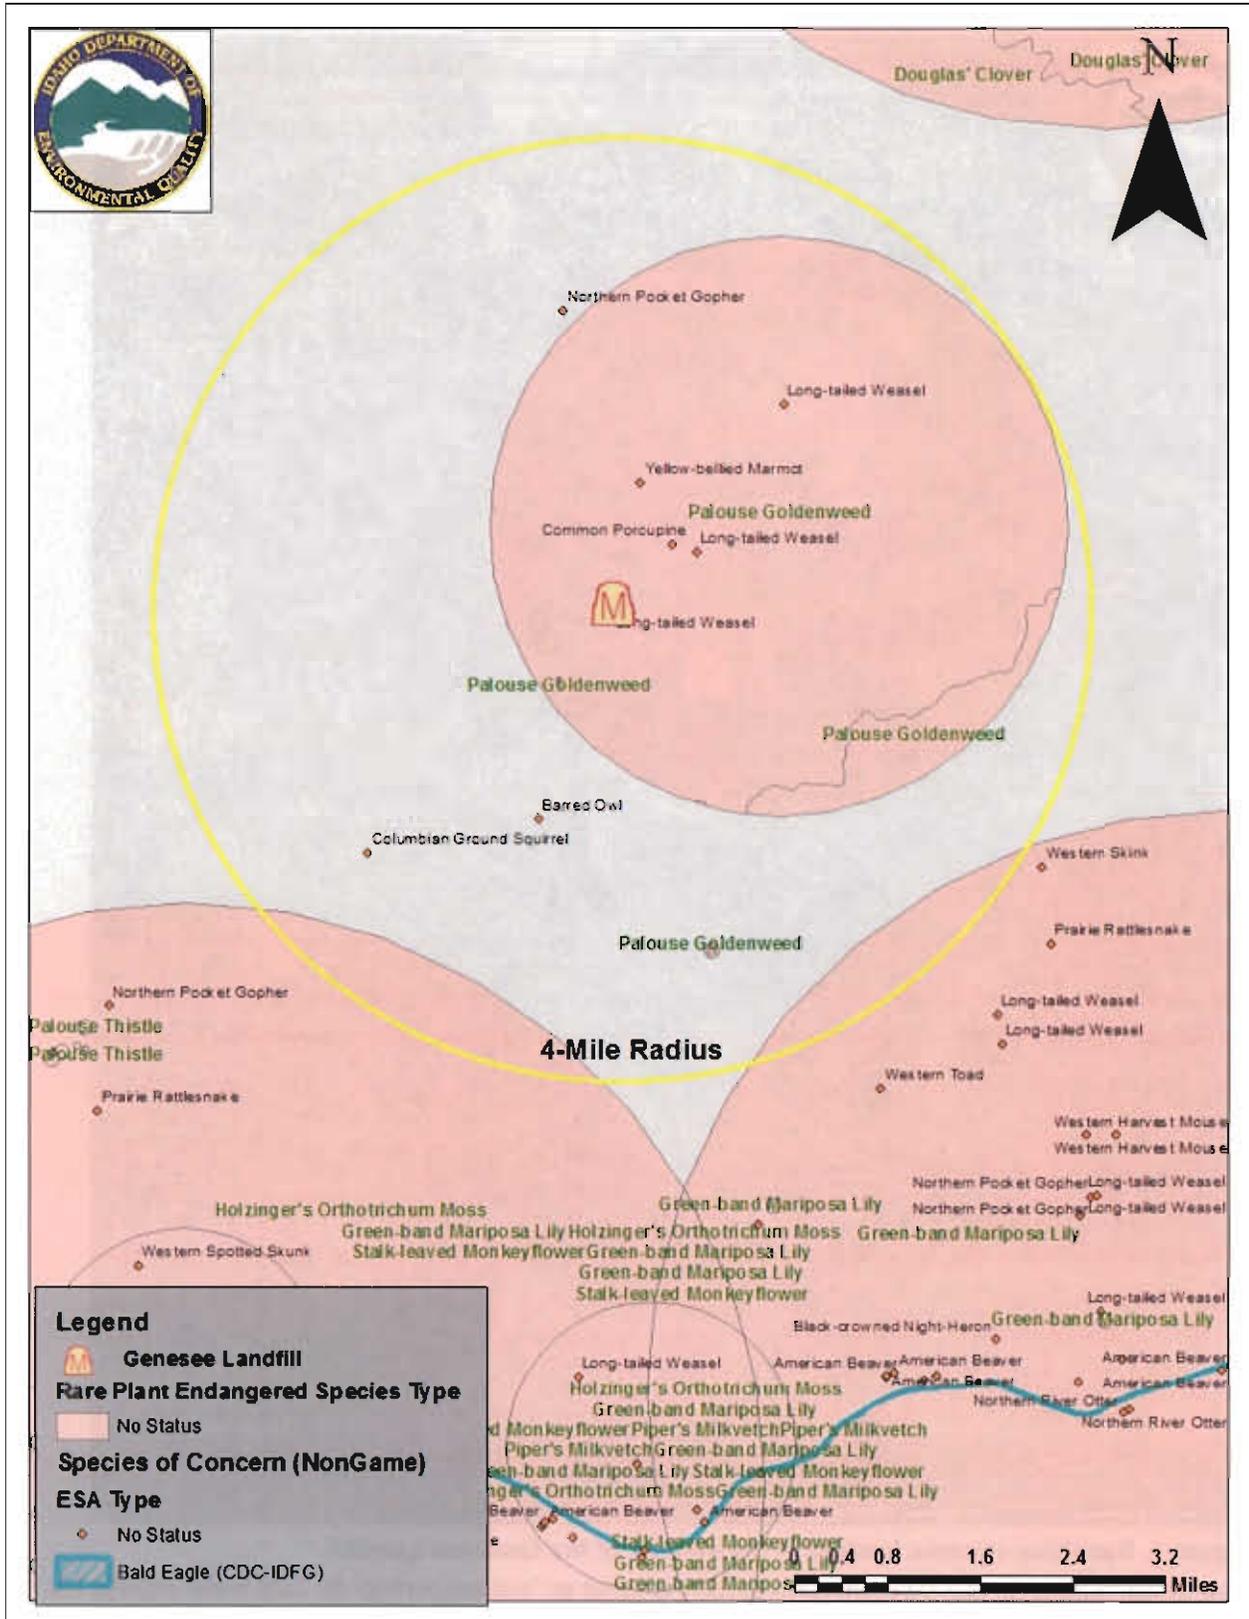
Figure 5. Plant and nongame animal sensitive species within 4-mile radius and surrounding area of the Genesee Landfill.

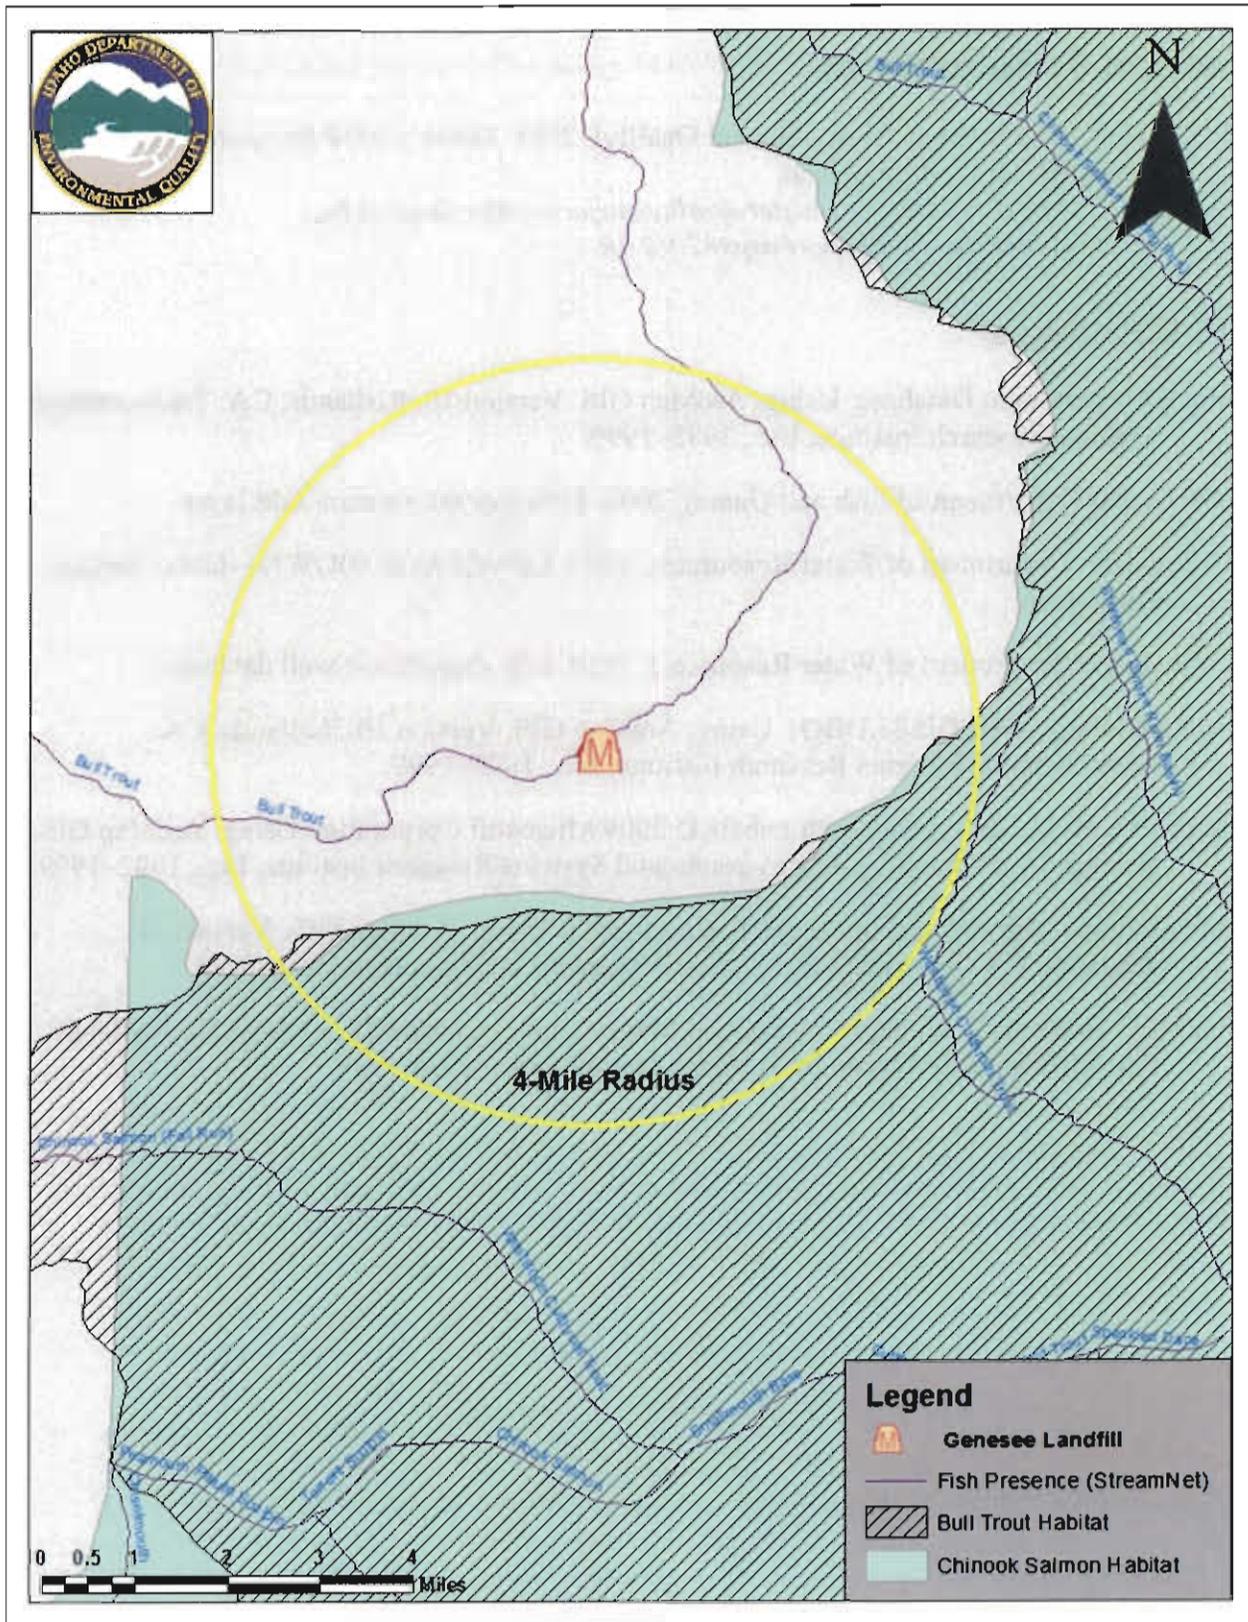
Figure 6. Fisheries within 4-mile radius and surrounding area of the Genesee Landfill.
