**Reconnaissance-Level Investigation of Sediment  
Sources and Channel Morphology,  
and Recommendations for Management,  
Pine Creek, Shoshone County, Idaho**

**Bureau of Land Management  
1808 North 3rd Street  
Coeur d'Alene, Idaho 83814**

20 June 1996

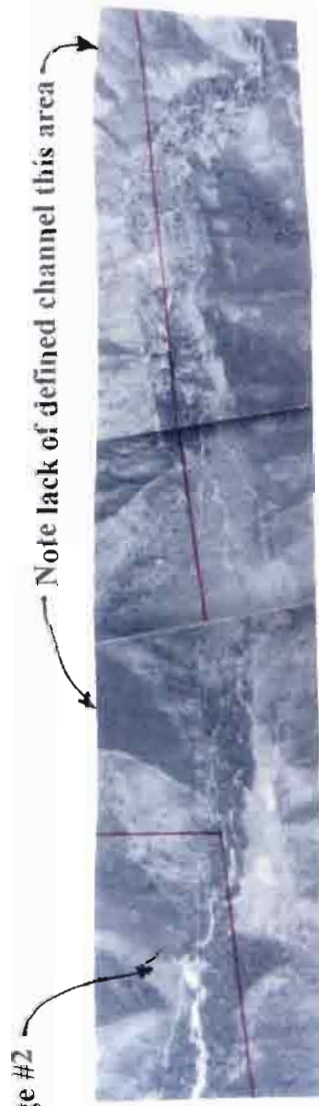
FIGURE 2

In 1957, the channel was somewhat more open at the confluence of Calusa Creek and at a number of points downstream (Figure 2). These changes are noticeable but small. However, beginning at a point about 1000 ft upstream of the Langlois Creek confluence, the channel is noticeably more open and has clearly visible meanders. The open channel continues downstream

The 1968 photos show open channel the entire length downstream of the Calusa Creek confluence (Figure 2). In many locations, the channel is narrow, and the meanders appear to be migrating downstream. In several reaches, the channel has widened dramatically, presumably aggrading. This channel widening presumably reflects the effects of the December 1964 flood. These flood flows also jumped the main channel and flowed down the road along the west side of the valley for a distance of about 6,000 ft, rejoining the main channel at the confluence of Langlois Creek. Below the second county road bridge, channelization had been undertaken, but this work was evidently ineffective, as evidenced by channel widening and migration in a number of places.

In 1975, very little change is evident from 1968 conditions overall, but a number of specific changes from the 1974 flood are evident (Figure 2). For example, the 1974 flood flowed down the road and also through the wooded right bank floodplain about 2000 ft downstream of the Calusa Creek confluence. The channel margins of the open meander sequence of 1968 had been colonized by young riparian vegetation. At the Langlois Creek confluence, the main (right) channel appears to have become the less used channel and is more vegetated. Downstream of the second county road bridge, there was extensive damage to the levee system, including several new breakouts upstream of Ross Gulch. One new channel developed to the left of the main channel along the lines of the braid channel noted in 1933. This channel provided a straighter course for the river, and was used as the main channel when the levees were strengthened and rebuilt following the 1974 flood.

By 1984, the left channel flowing down the road (from the Calusa Creek confluence) appears to have been abandoned and flow had returned to the right channel, although it followed some new courses in the riparian zone (Figure 2). Channel widening had occurred and the meander pattern was altered from many tight meanders to fewer large wavelength meanders. In 1991, the channel had continued to widen, but in general showed little change from 1984 (Figure 2).

Historical vertical aerial photographs of the West Fork Pine Creek from a point downstream of the Calusa Creek confluence to County bridge #2 downstream of the Langlois Creek confluence
