Beaver Creek Watershed Assessment Shoshone County, Idaho

March 2013

Idaho Panhandle National Forests Resource Advisory Committee
North Fork Coeur d'Alene River Watershed Advisory Group

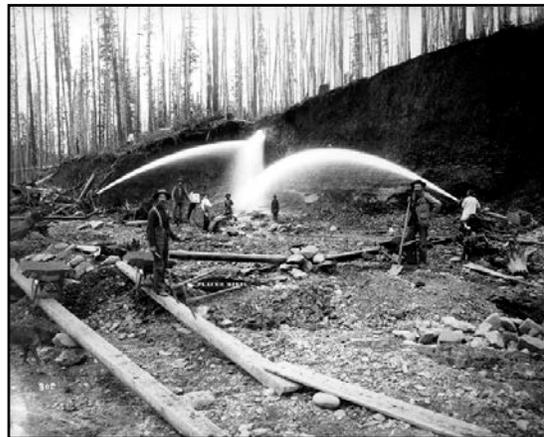
Early surface mining of placer deposits included hydraulic mining (Figure 6), which caused significant damage to stream channels and floodplains. Underground mines and associated mills were also developed in the watershed. Underground mine operations in the Beaver Creek watershed were for lead, silver, and zinc while gold was mined through placer surface mining. Precisely how many historic mining operations there were in this watershed is unknown. A 1998 inventory of abandoned mine lands identified 14 abandoned hardrock mines or prospects and 3 mills in the Beaver Creek Watershed (IGS 1998). The largest underground mines in the Beaver Creek Watershed were the Idora (Figure 7) and the Ray Jefferson/Carlisle and each had an associated mill (Ott and Clark 2003, Box et al. 2004). There were also small mines and prospects of varying size including the Red Monarch, Pony Gulch (where there was also a mill), Blue Sky, and Rooster Goose. Prior to 1925, ore was milled using a gravity or “jig” process. This process produced large quantities of coarse-grained, metals-rich jig tailings. Later, flotation milling was used and produced even larger quantities of fine-grained flotation tailings that generally contained fewer metals.

Figure 6. Hydraulic placer mining near Delta in the Beaver Creek Watershed (date unknown)

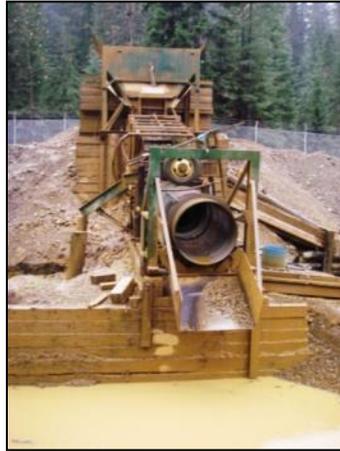
There are additional placer mining operations including trenching and small wash plants located on private land along Trail Creek from Potosi Gulch to the main Beaver Creek Road. These operations are visible from the Kings Pass Road and the Beaver Creek Road. Based on visual assessments from the road, these operations seem to be sources of sediment loading, temperature loading and habitat alteration detrimental to cold water aquatic life. Sediment from these operations is likely exported

downstream during high flow events into Beaver Creek. Improved application of mining best management practices and adherence to TMDL allocations could improve water quality in these areas.

Figure 9. There are several wash plants on private land in the Trail Creek watershed for sorting and washing gravels

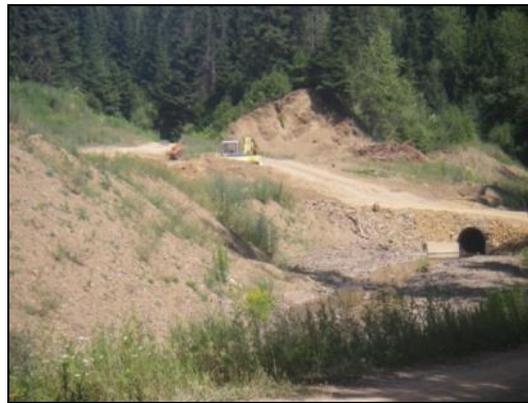
Figure 10. Mechanical dredging removes gravels to be washed and sorted for recovery of gold

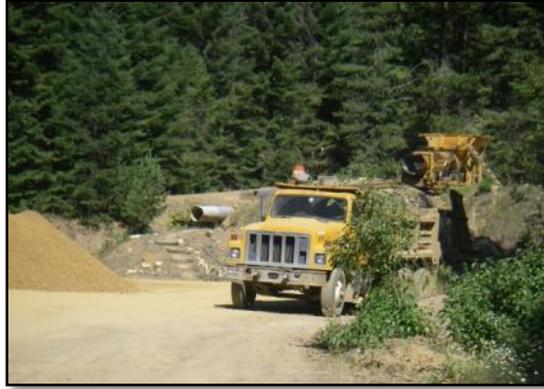
Figure 14. If mechanical placer mining applies adequate BMPs specified in state and federal permit programs, increased sediment discharge, temperature loading and channel degradation can be prevented

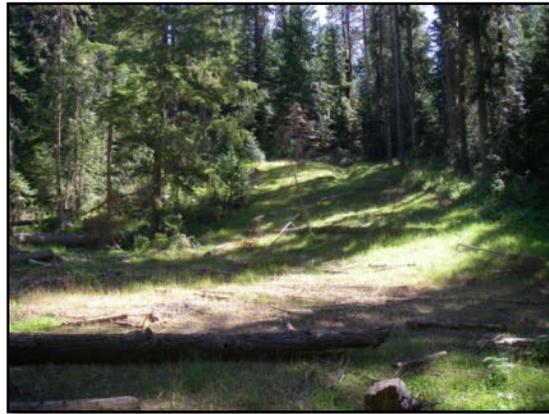
Figure 15. Reclaimed mechanical dredge mining sites can be resloped and revegetated, but reclamation remains challenging in this watershed due to soil conditions and expense

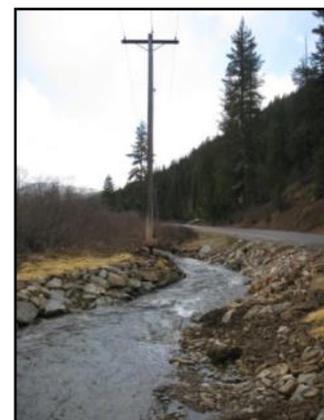
There are telecommunications lines both buried and overhead that run primarily along the Beaver Creek Road and are often adjacent to the stream. There have been instances with erosion putting poles and lines at risk. Telecommunications lines are visible on the ground along the Carbon Center Road and are at risk from road washouts during flooding.

Figure 18. Utility pole along Beaver Creek

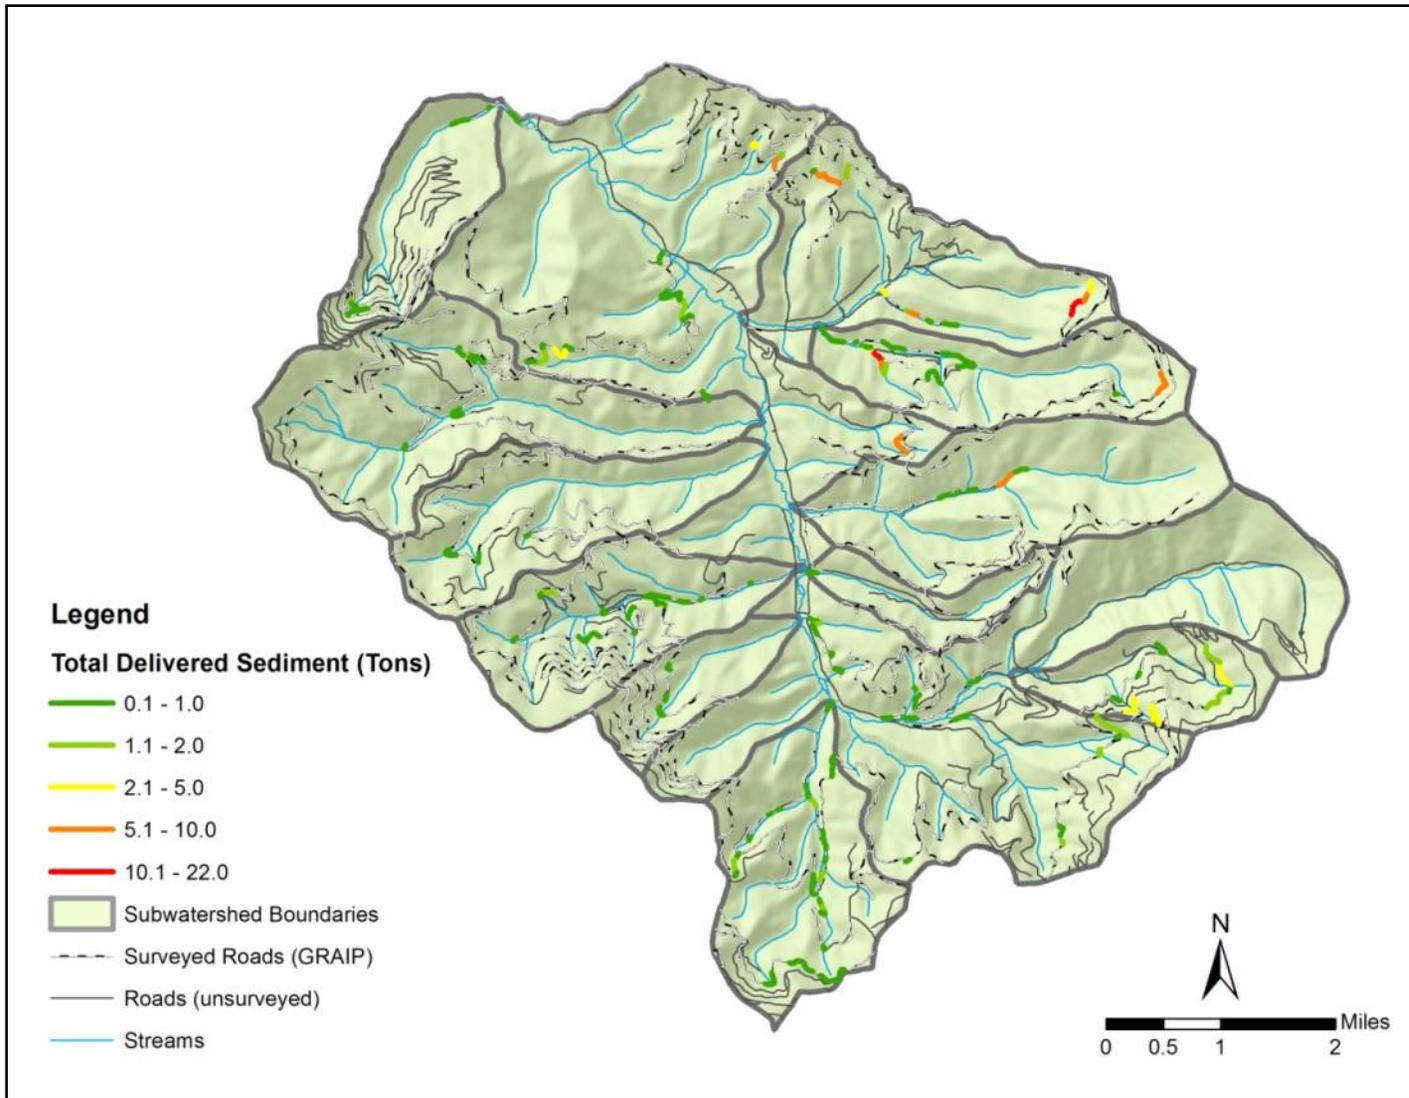
Only two miles of road were responsible for delivering half of the sediment to Beaver Creek, all of which came from only four subwatersheds (Table 4). Fourteen percent of the road-derived sediment originated from just one-half mile of road in Trail Creek, and only 9 segments from 6 different roads in Trail Creek contributed 34% of the sediment. Only 2 segments of a single road delivered sediment into Pony Creek, while 3 segments of 2 different roads delivered sediment to the Lower Beaver subwatershed—one in Cleveland Gulch and two in Prospect Gulch (Figure 22). A list of all roads that delivered sediment, and the amount of sediment delivered to each subwatershed, can be found in Appendix E.

Figure 22. Surveyed road segments responsible for delivering 100% of the sediment from roads to the Beaver Creek stream network, and the relative amount delivered

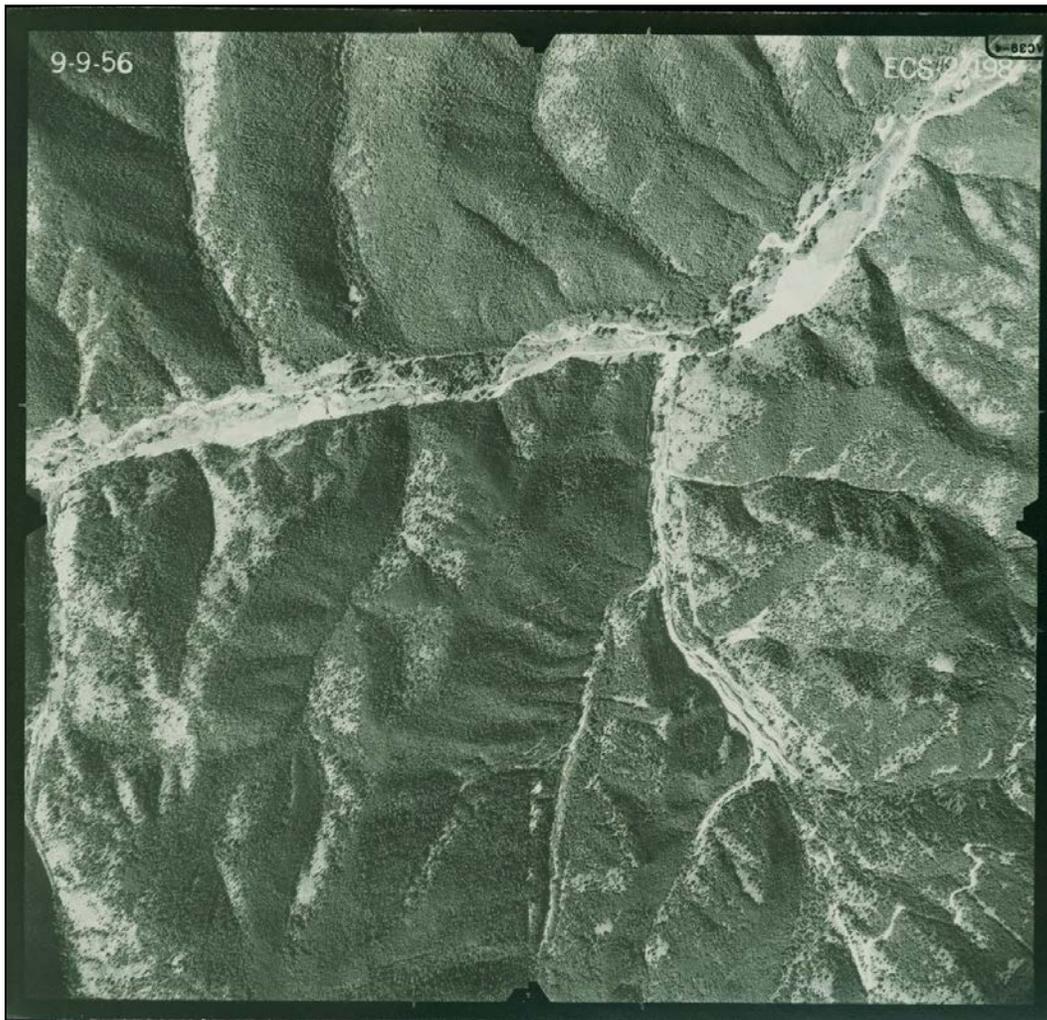
The railroad bed appears less distinct in these photos than in 1937, but is still a prominent feature in the floodplain. Areas where the railroad bed washed out are visible between Deer Creek and Alder Creek, just upstream of Trail Creek, and downstream from Prospect Gulch. Pastures and/or hay fields are visible between Prospect Gulch and Trail Creek (similar to 1937) and between White Creek and Pony Gulch along with several barns and other buildings. Photos from 1956 to 1958 show very little change.

Figure 32. Aerial photos from 1956 show extensive placer mining in the Trail Creek subwatershed.

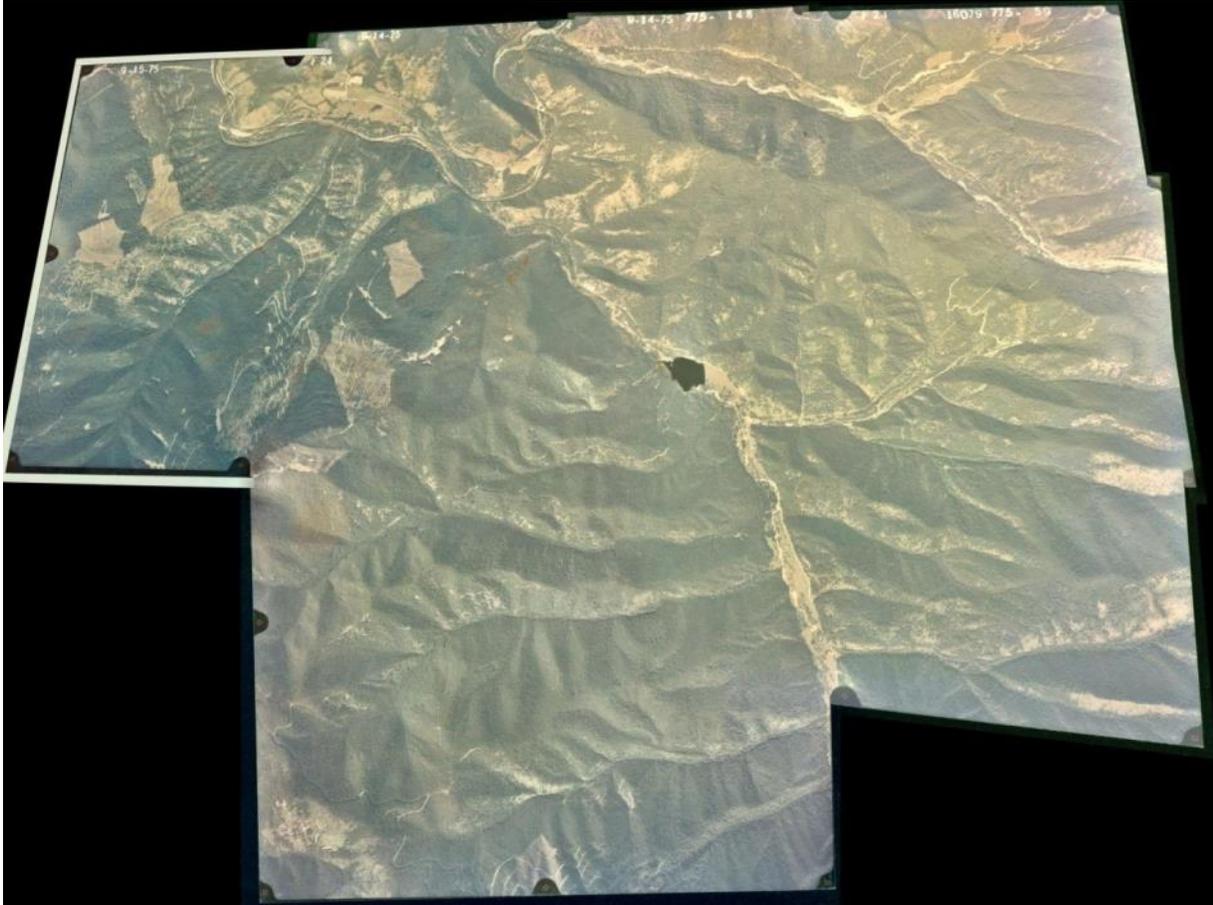
Figure 36. 1975 aerial photos cover most of the Beaver Creek watershed and reveal patterns of development and channel instability

Farther downstream, the bridge where Forest Road 933 is today appears much less distinct than in 1971 and may have been washed out during flooding. Downstream of this bridge site, where a historic floating dredge operated and the channel is constrained by the railroad bed, there is significant instability and overwidening of the channel including a channel avulsion that likely occurred during 1974 flooding.

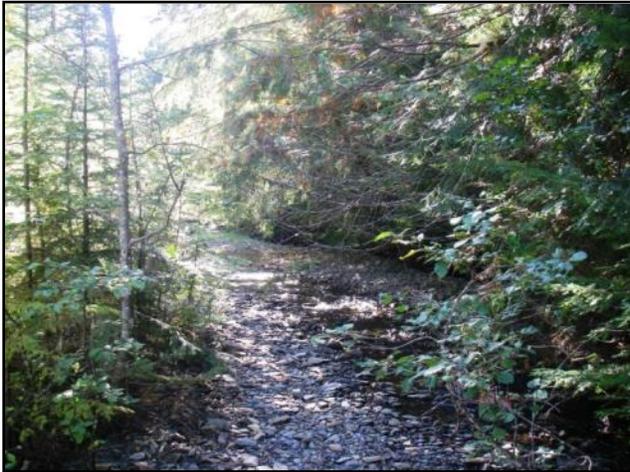
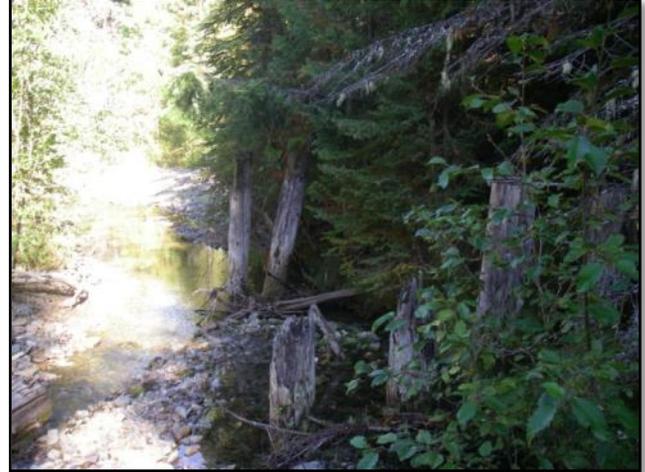
Figure 42. Upper Beaver Creek Site (2010SCDAB001), bottom of site looking upstream (left), top of site looking downstream (right)

The SHI condition rating of 1 at both sites below the 10th percentile of reference condition likely indicates poor habitat conditions and impairment of beneficial uses. Metric scores below 5 indicate possible evidence of physical habitat degradation. The lower Beaver Creek site had low metric scores for instream cover, channel shape, percent bank cover and percent canopy cover. The upper Beaver Creek site had low metric scores for instream cover, percent bank cover and zone of influence. These scores correspond to conditions observed at the sites and at other locations in the watershed. There are many locations along stream reaches throughout the watershed with low instream cover, uncovered banks,

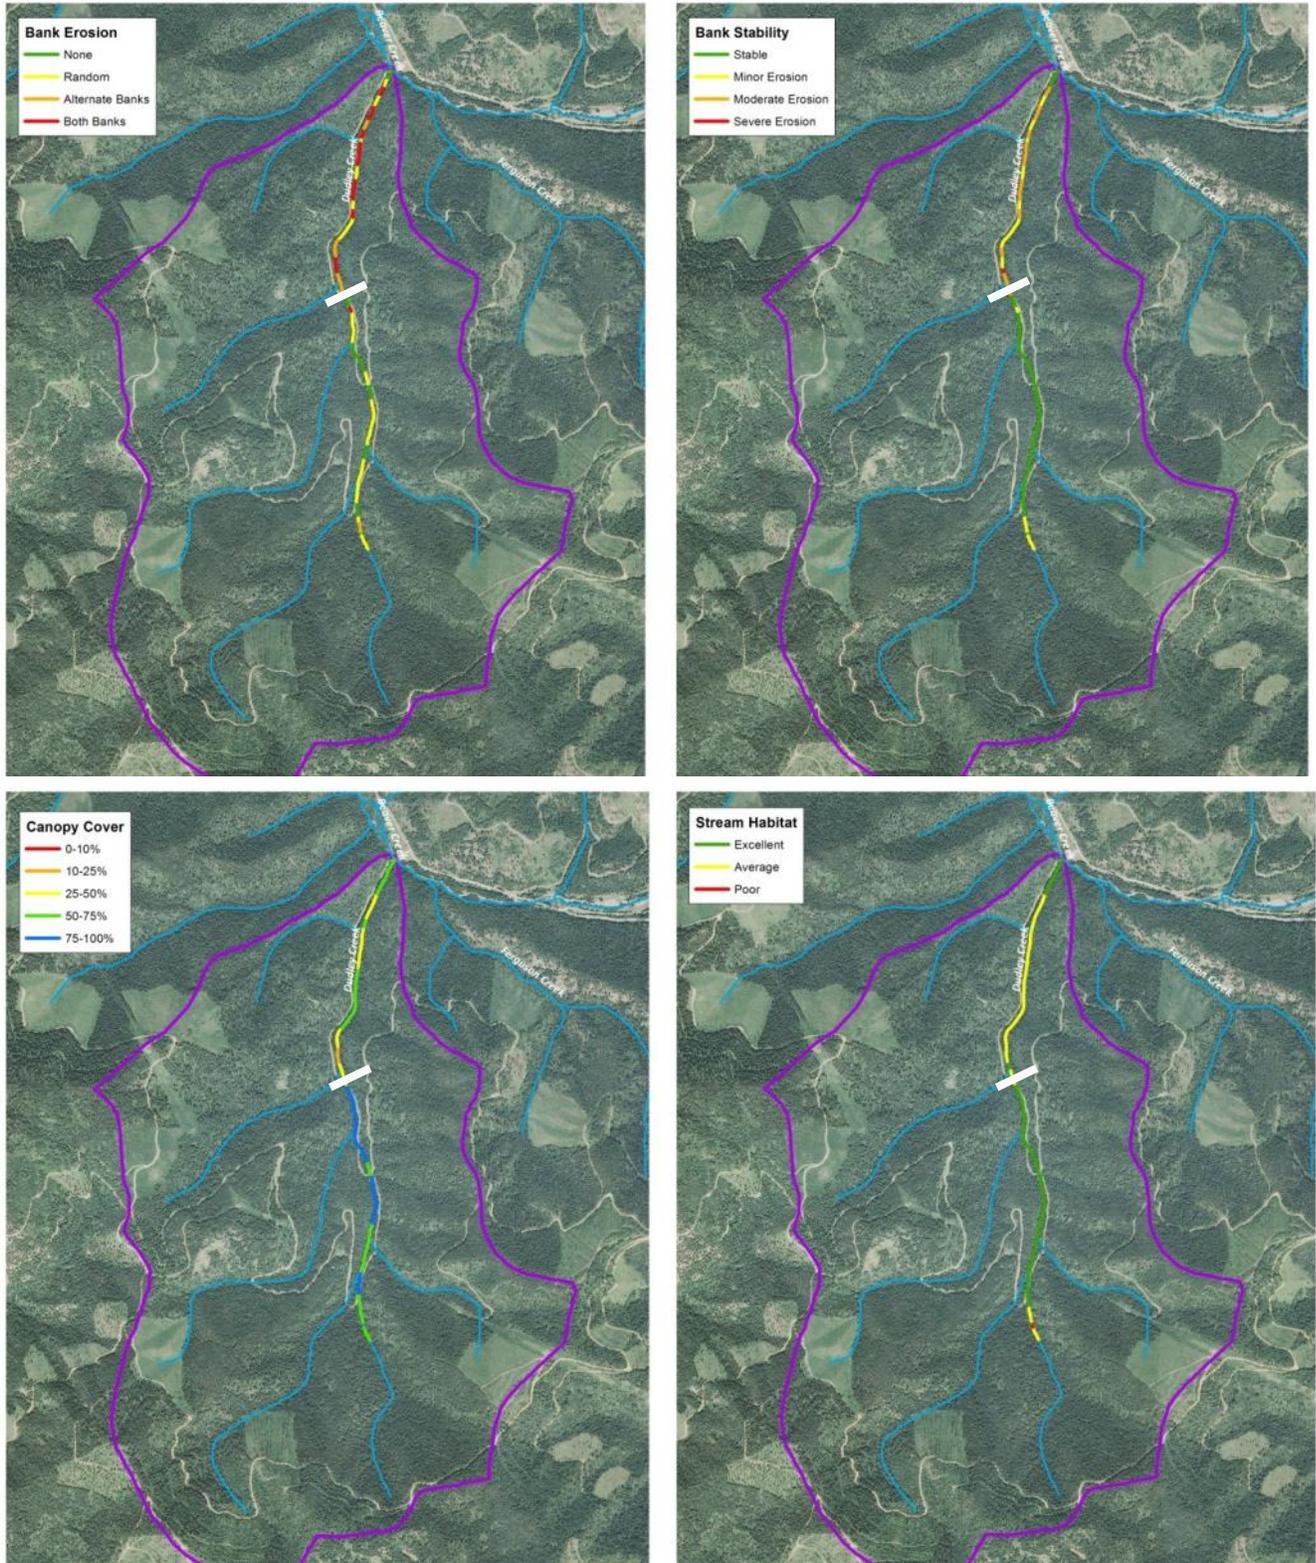
Figure 45. Bank erosion (top left) stability assessments (top right), canopy cover (bottom left) and habitat conditions (bottom right) for Dudley Creek

The Dudley Creek maps in Figure 45 represent channel conditions changing significantly downstream from the white line that intersects the channel. These GIS maps can assist management decisions, whether identifying further assessment needs or allocating resources for restoration work.

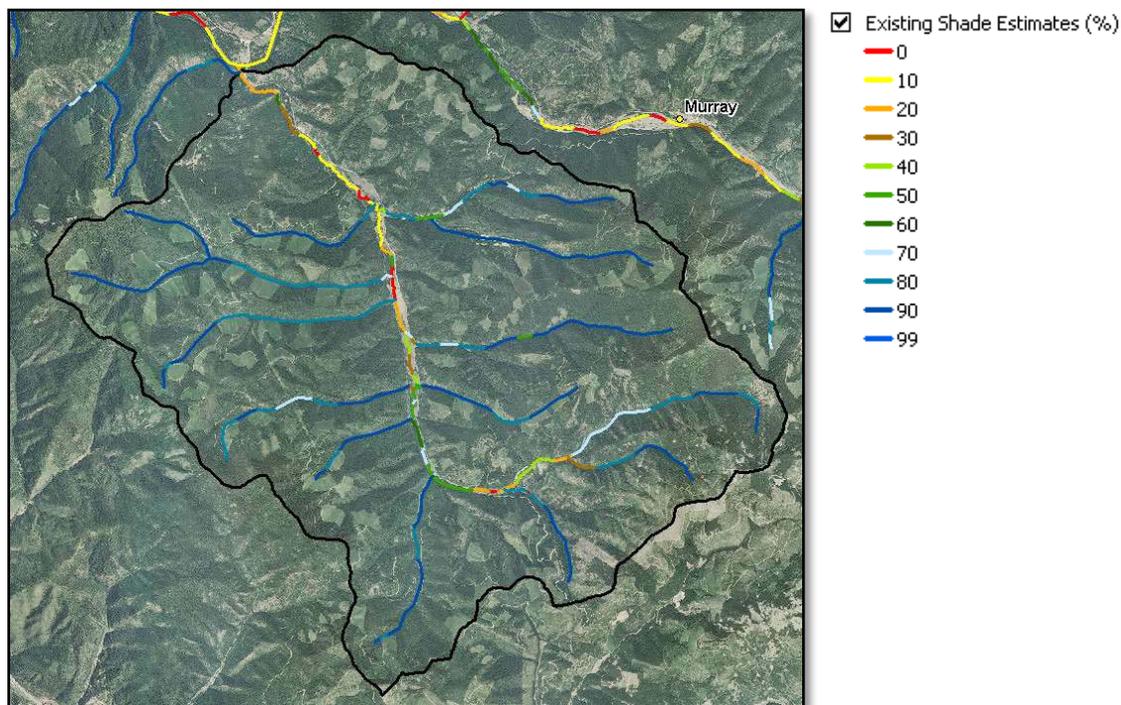
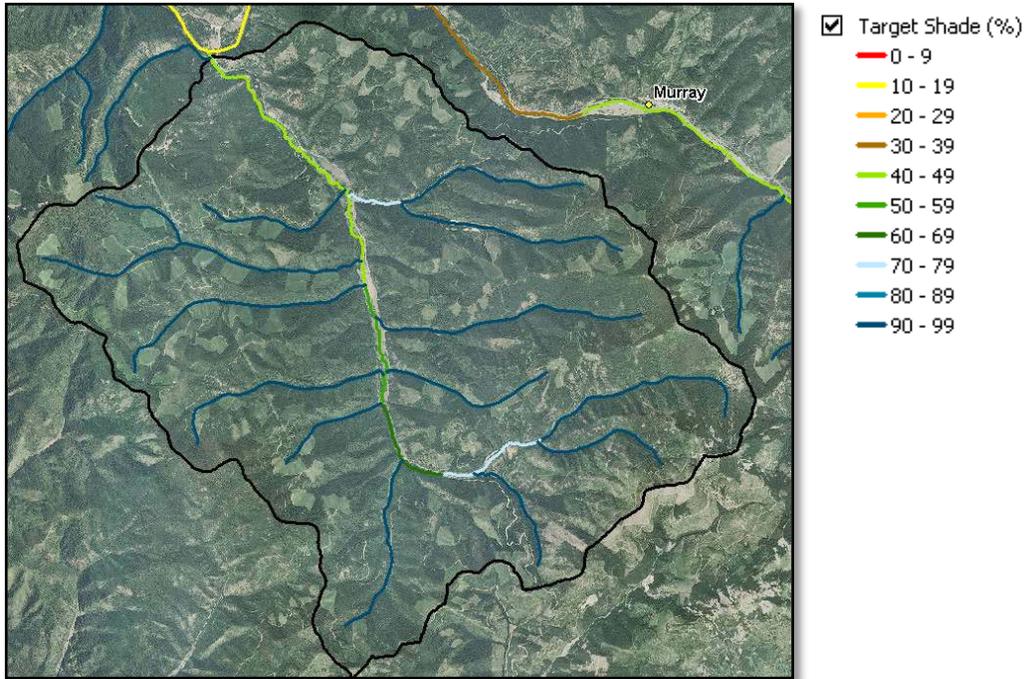
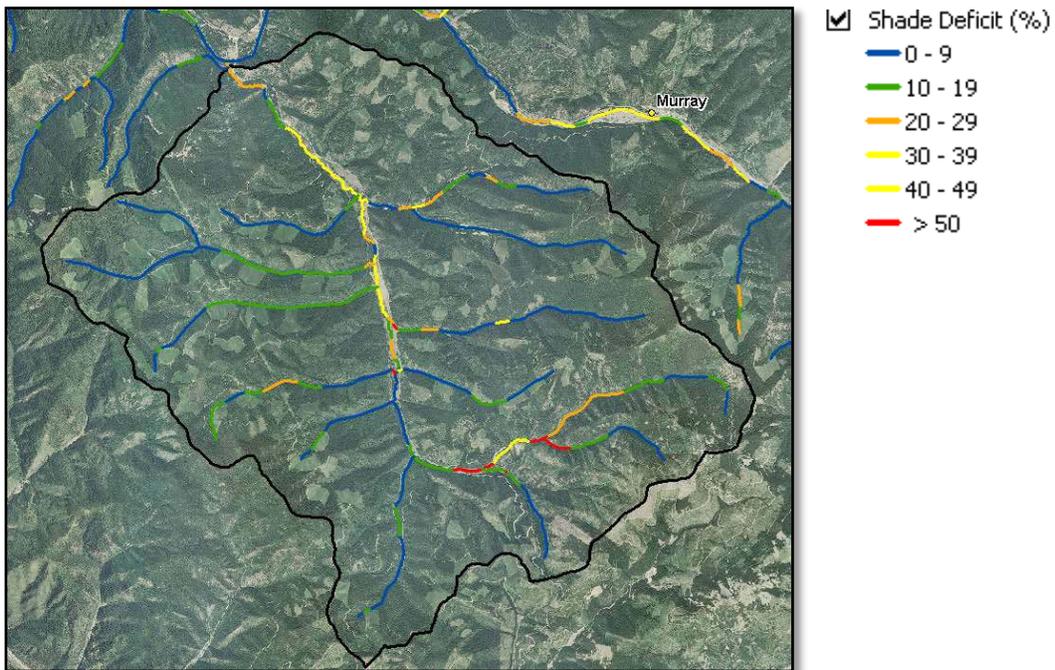
The entire mainstem lower Beaver Creek below White Creek was modeled as nonforest group 1 with a desired shade of 41-48% during April through September (Figure 47). Estimated existing shade in lower Beaver Creek below White Creek was 0-60% during April through September (Figure 48). The greatest shade deficit in lower Beaver Creek is found in the 2 miles of stream channel between 1.5 and 3.5 miles upstream from the North Fork Coeur d’Alene River confluence (Figure 49). Vegetation in nonforest group 1 includes a diverse plant community including late successional cedar-hemlock, black cottonwood, mixed conifers and shrubs.

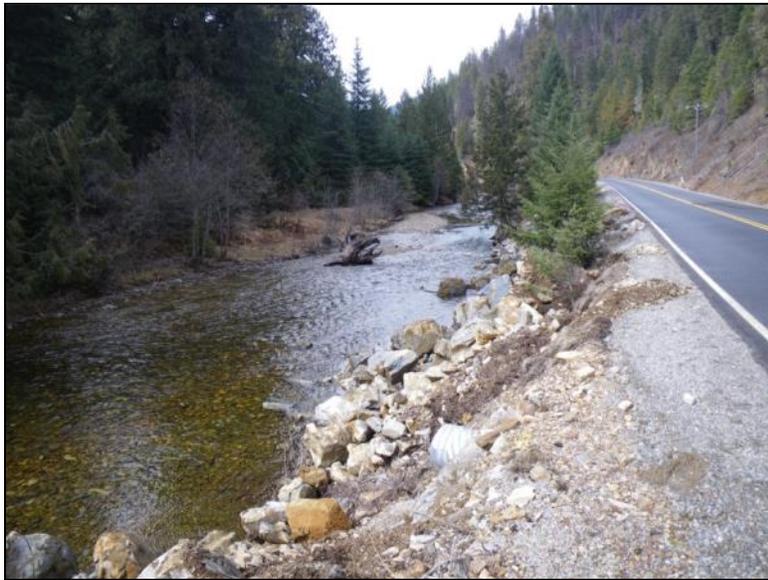
Most of FR 456 is within the Beaver Creek floodplain and there are multiple locations where the road is directly adjacent to the stream channel. At some of these sites, Shoshone County has completed bank stabilization or riprap protection of the road. There are 5-10 important sites of this kind affecting stream and road including some of the examples below.

Figure C. 12. Roadside maintenance area along Beaver Creek, April 2010.

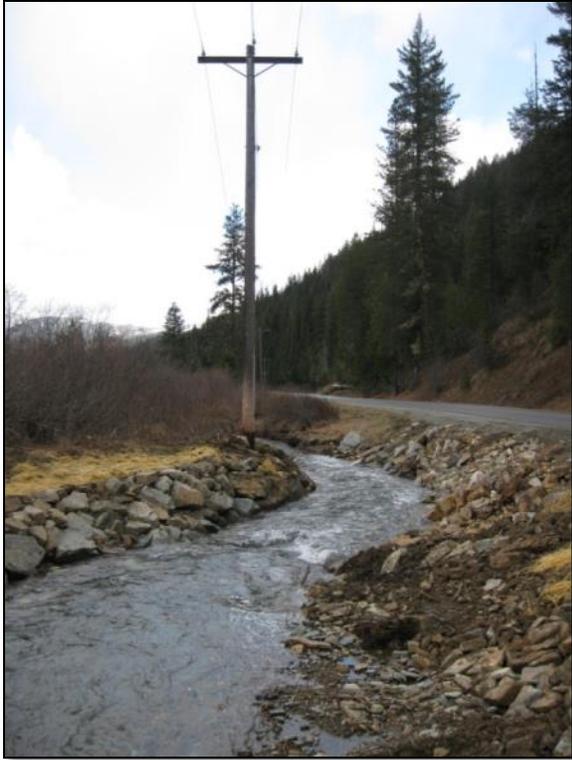
Figure C. 13. Roadside maintenance area on Beaver Creek, April 2011.

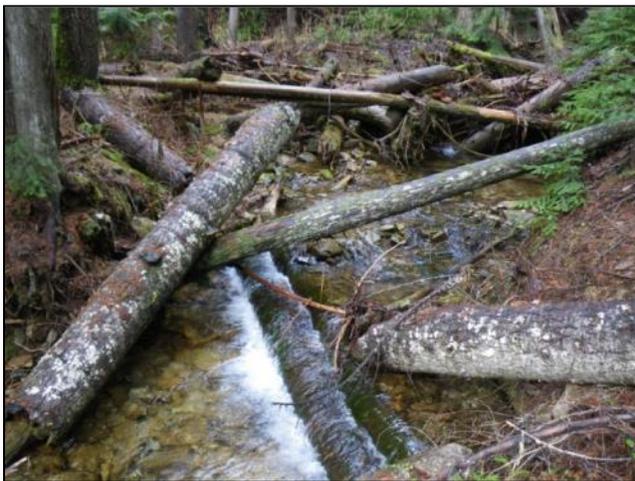
Figure C. 14. An example of instream habitat improvements completed by USFS in Carpenter Creek.
