Hem Creek 2009 Field Investigations

**State of Idaho
Department of Environmental Quality**

June 2012

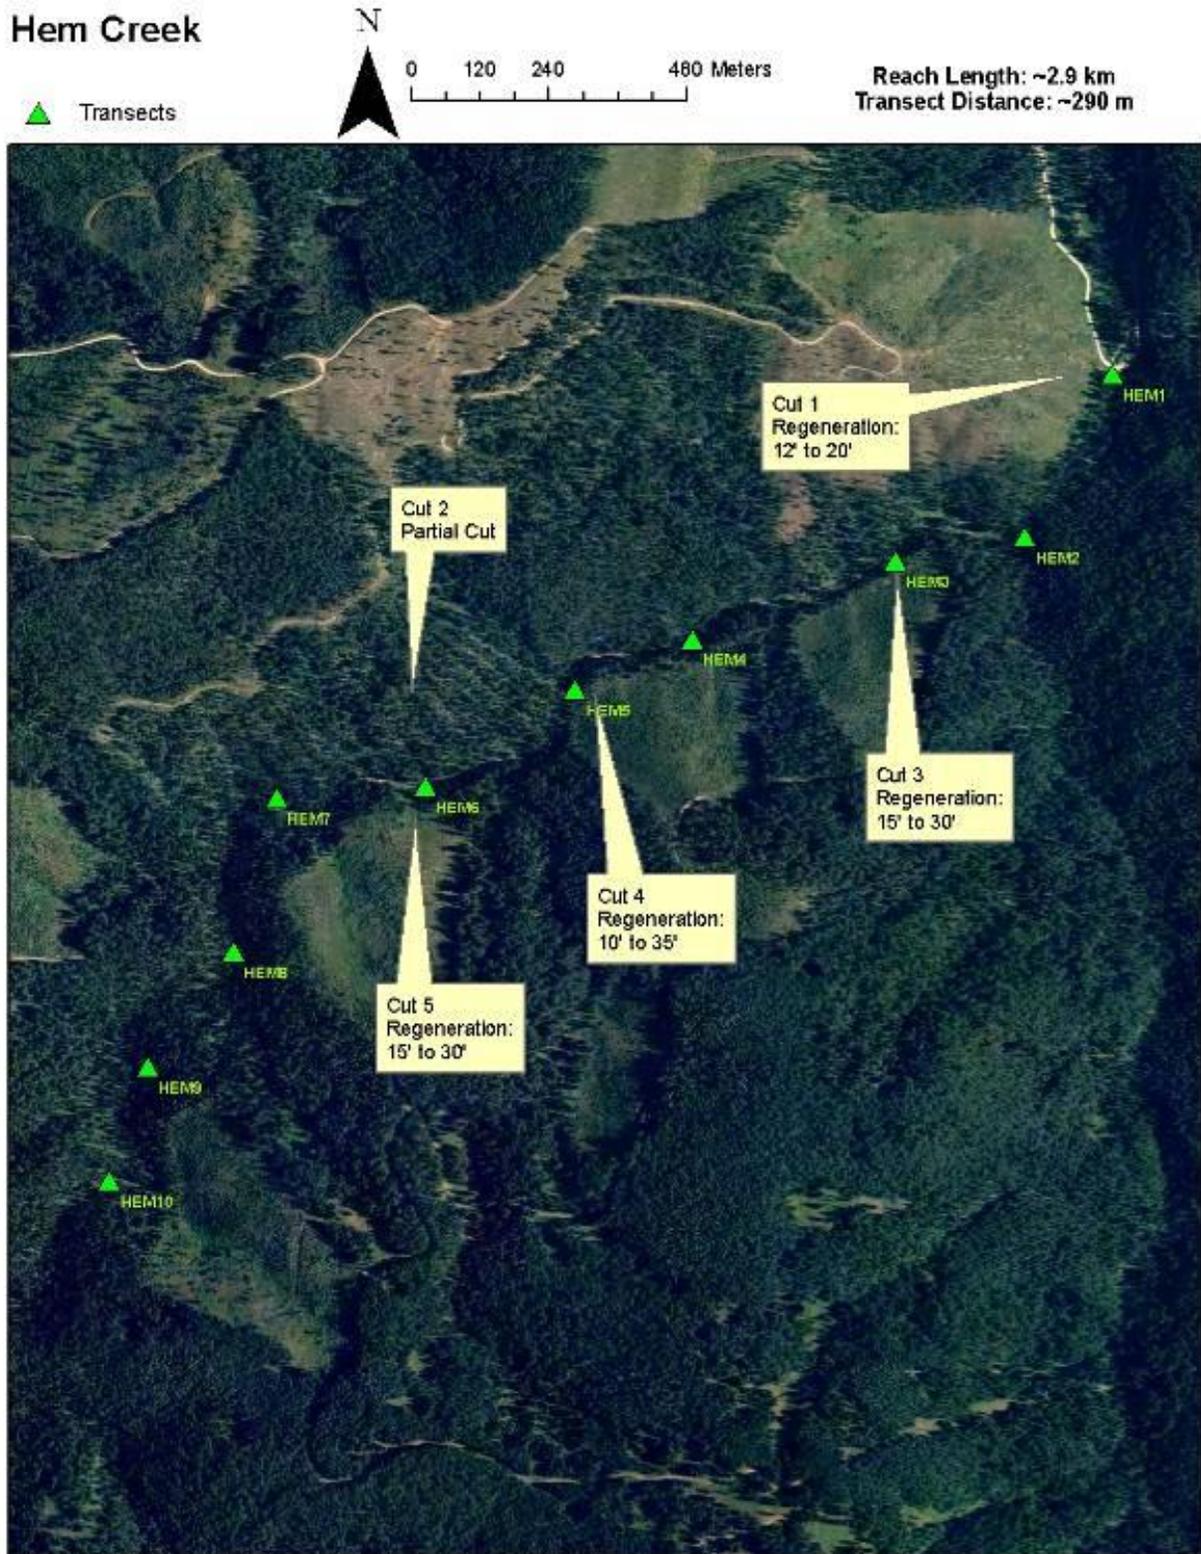
Figure 2. Hem Creek riparian assessment transects.

1. EPA asserted, based on a GIS stream layer that Hem Creek actually passed through one of the timber harvest units (cut 2 in Figure 2).
2. EPA asserted that there was an old riparian road along a portion of lower Hem Creek.
3. In predicting lost shade due to past timber harvest, EPA used tree height of only 5 feet, growing back after clear-cutting in some units, 13 years after harvest.

From desktop analysis, we identified a 2.9 kilometer (km) reach of lower Hem Creek as the area in the watershed potentially affected by timber harvest. This reach extends from just above Forest Service Road 5216 crossing near the mouth of Hem Creek to a point above all historic cutting units. We divided the reach into 10 approximately equidistant sections and established Global Positioning System waypoints for transects in the middle of each section (Figure 2, green triangles). Figure 2 also identifies the five historic timber harvest units adjacent to lower Hem Creek.

At no point along the lower 2.9 km of Hem Creek does the creek enter or pass through a cutting unit. The smallest distance from streambank to cutting unit found was 73 feet. This distance is consistent with forest practices at the time of harvesting (mid-1990s), which is a 75-foot buffer width for each bank. We believe EPA's misimpression of harvest unit infringement on these buffers can be attributed to their use of GIS analysis coupled with the inaccurate location of Hem Creek in the 1:100,000 hydrography layer used. The location accuracy of GIS data did not support the detailed level of their analysis.

In walking the lower 2.9 km of Hem Creek, the clear-cut units were visible from only a few locations, and the partial cut (cut 2 in Figure 1) was never visible from the stream. During our field visit (10 a.m. to 4 p. m. on September 23, 2009), the stream surface was at times lit by sunshine, but this was almost entirely due to the sun shining down between the forest cover gaps caused by the stream channel itself, not due to any missing trees in the riparian zone or beyond.
